FORM A
MONITORING AND MAINTANCE OF CAP AREAS FOR fYNOP ANNUAL
POST-REMEDATION CARE PLAN ACTIVITIES

This form is used to document the results of annual post-remediation care activities for engineering and institutional controls at the Former York Naval Ordnance Plant (fYNOP) in York, Pennsylvania. These activities are to be performed in accordance with the procedures in the approved Pennsylvania Land Recycling and Environmental Remediation Standards Act (Act 2) Final Report and Post-Remediation Care Plan (PRCP) contained in Appendix J of the Final Report.

**Re: Building 3 Stormwater Utility Soil Characterization
Harley-Davidson Motor Company Operations, Inc.
1425 Eden Road, York Pennsylvania**

**Re: Building 70 Sinkhole Repair and Soil Characterization
Harley-Davidson Motor Company Operations, Inc.
1425 Eden Road, York Pennsylvania**

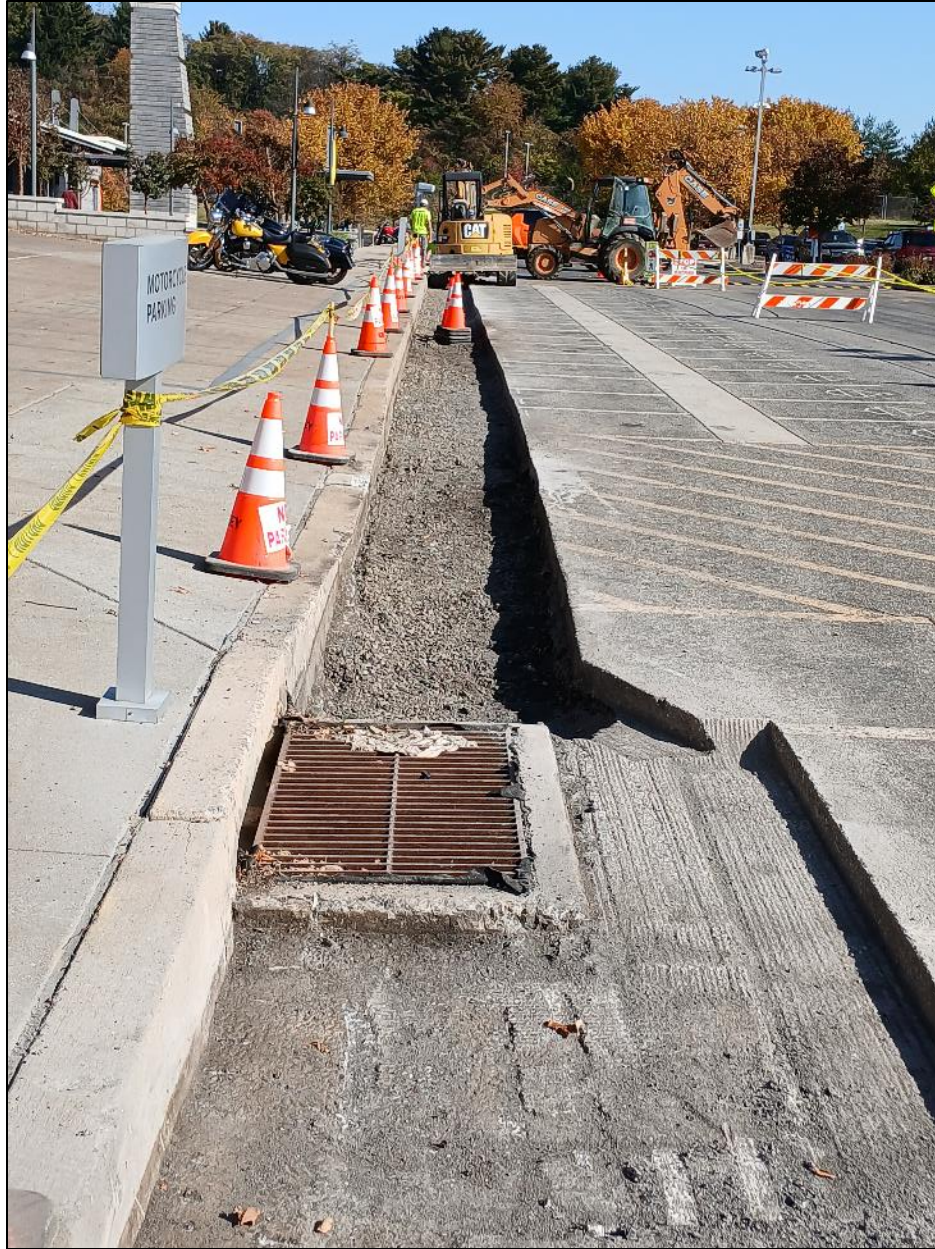
Photo 1: Photo looking east at existing stormwater inlet. Asphalt in utility installation area was milled.

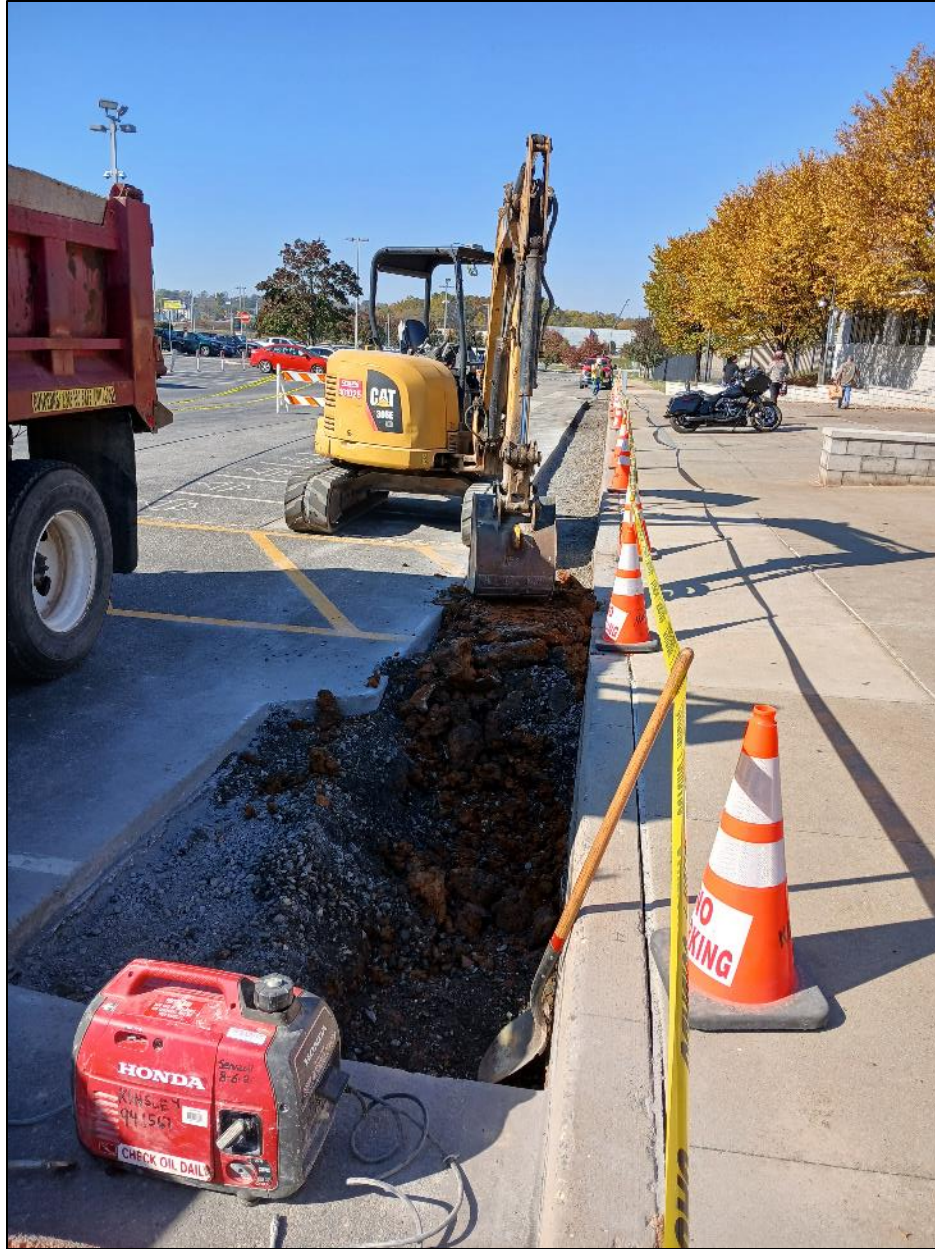
Photo 2: Excavation area where new stormwater inlet will be installed.

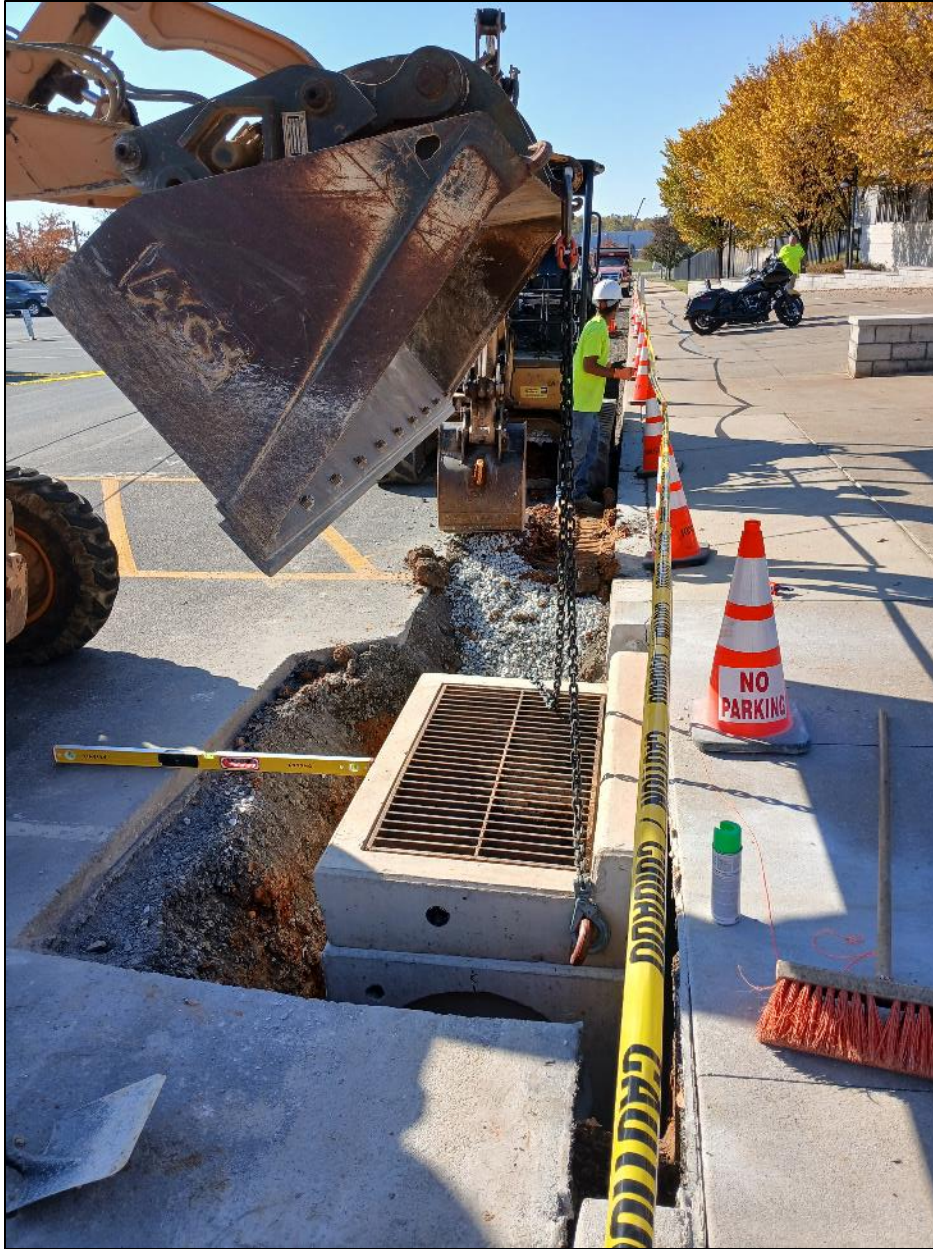
Photo 3: Installation of new stormwater inlet.

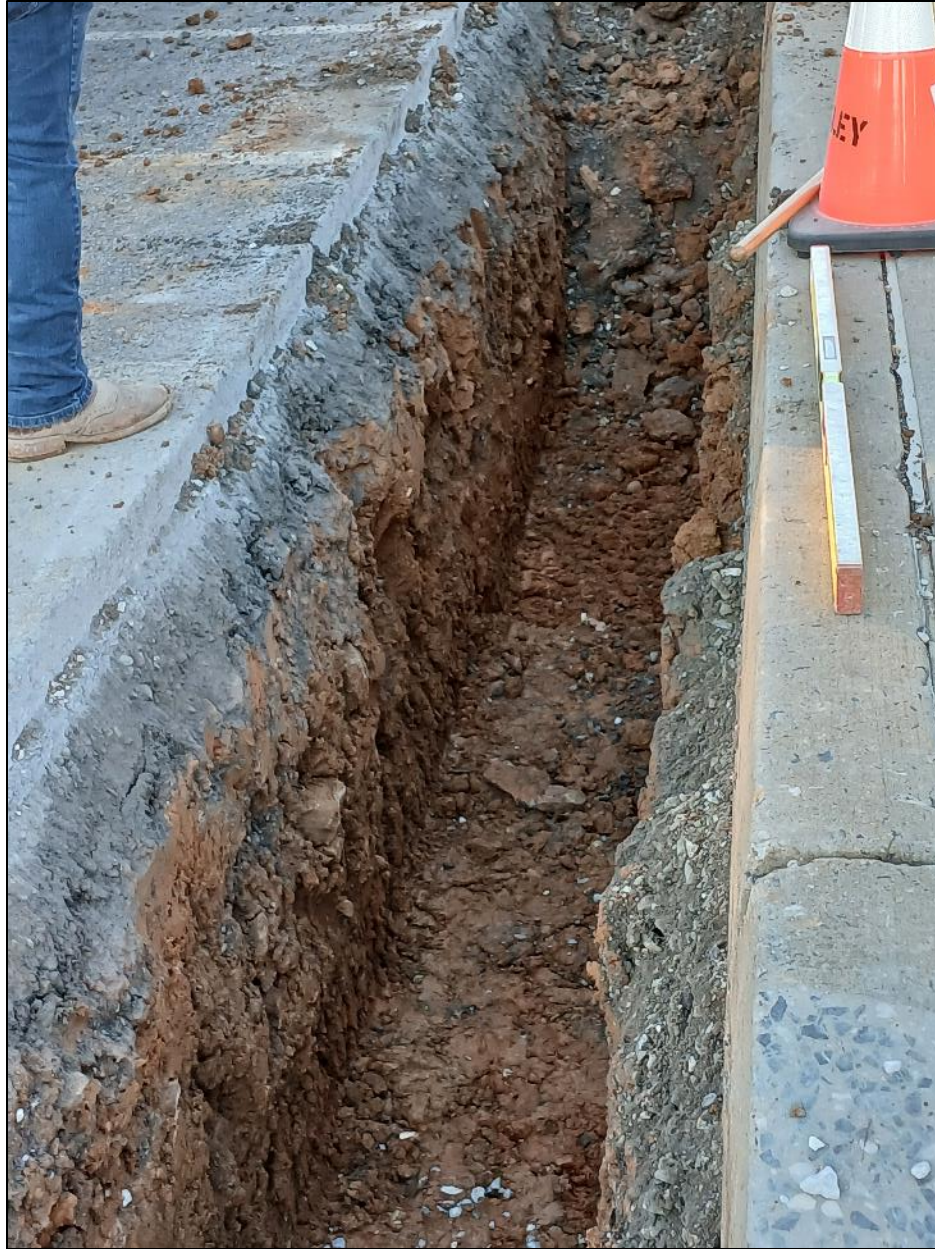
Photo 4: Photo looking west as stormwater utility excavation trench.

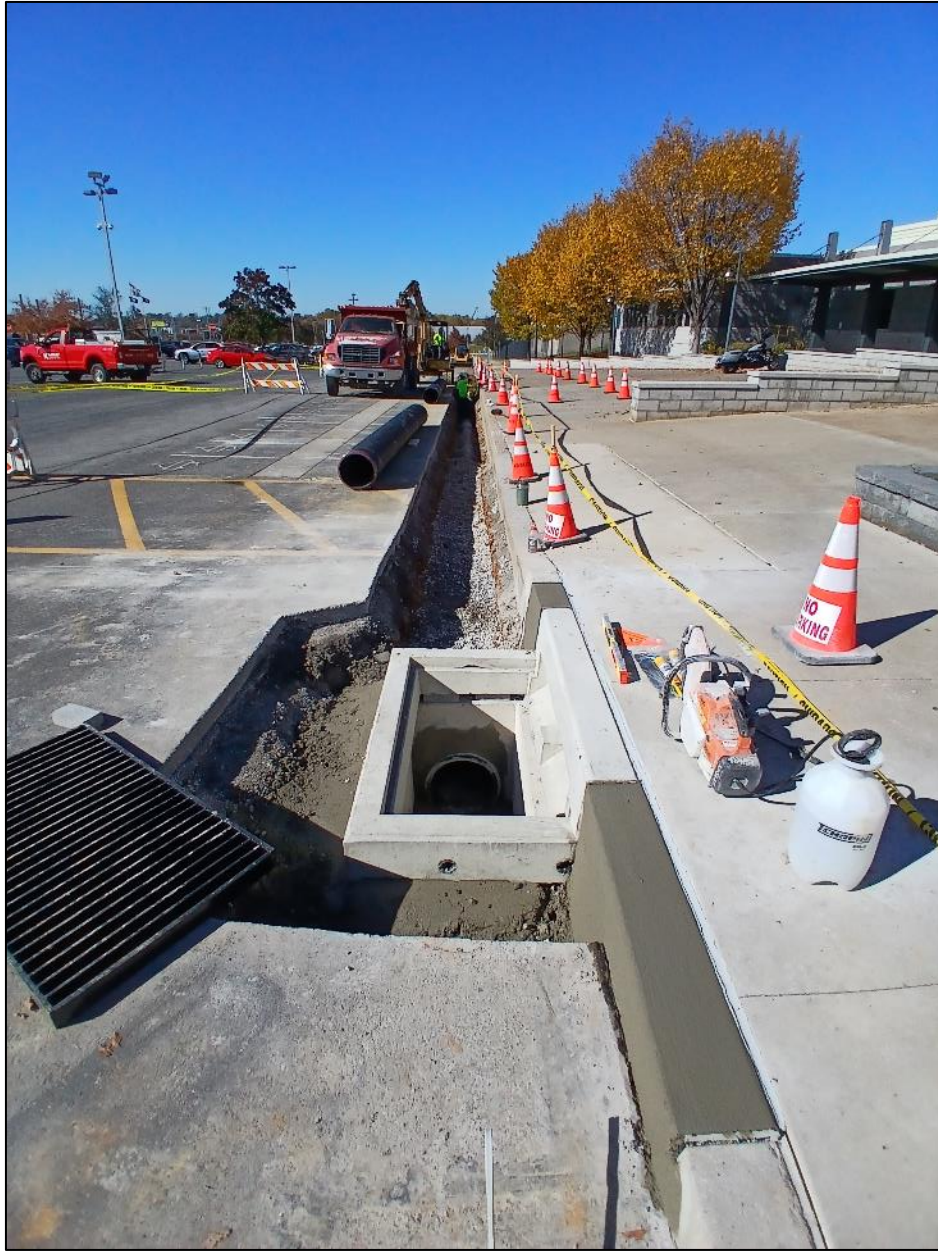
Photo 5: Photo looking west at new stormwater inlet, concrete repairs to sidewalk curb, and stormwater pipe trench.

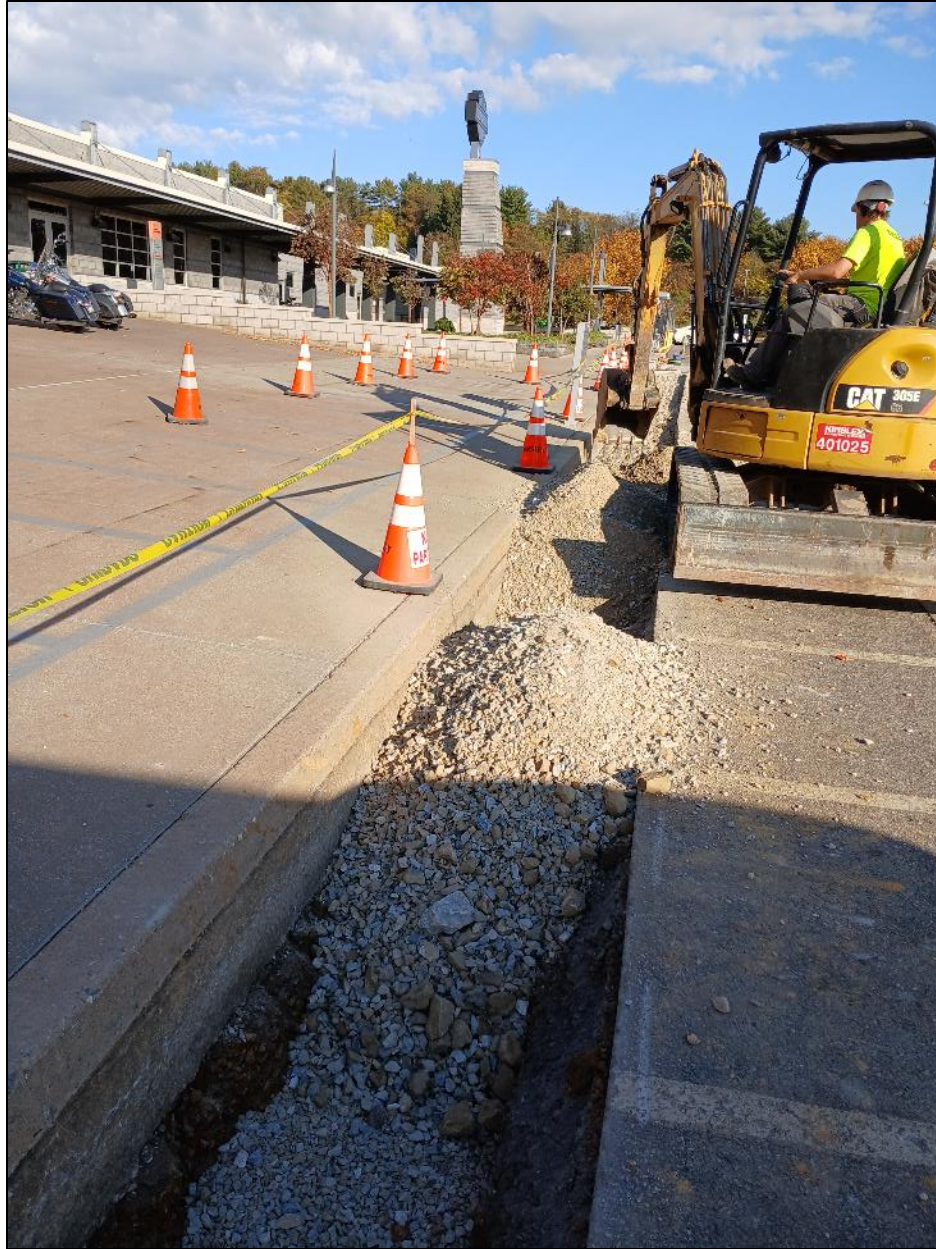
Photo 6: Stone backfill over stormwater installed stormwater pipe.

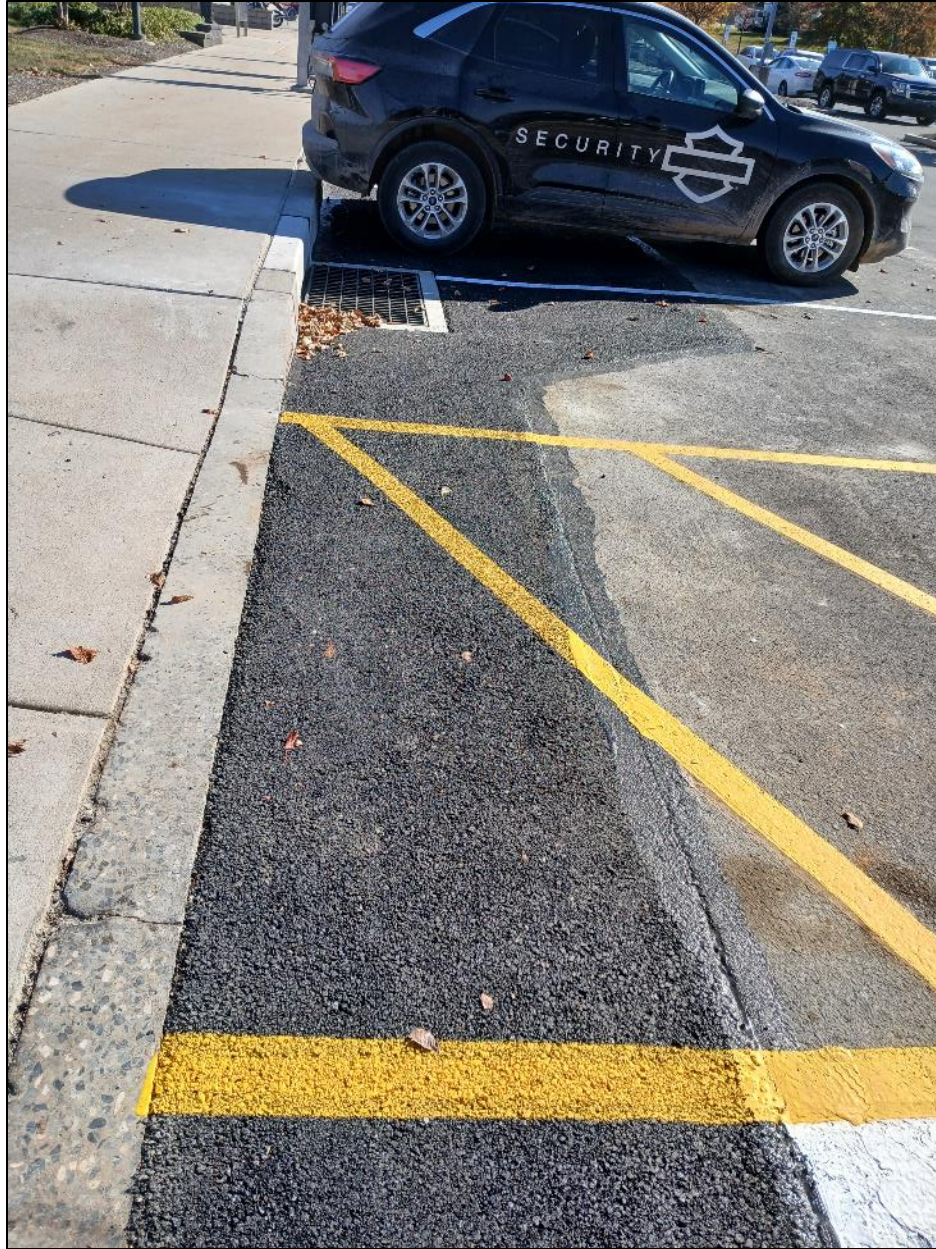
Photo 7: Photo looking east at asphalt installed around new stormwater inlet. Seam between new and old asphalt was sealed.

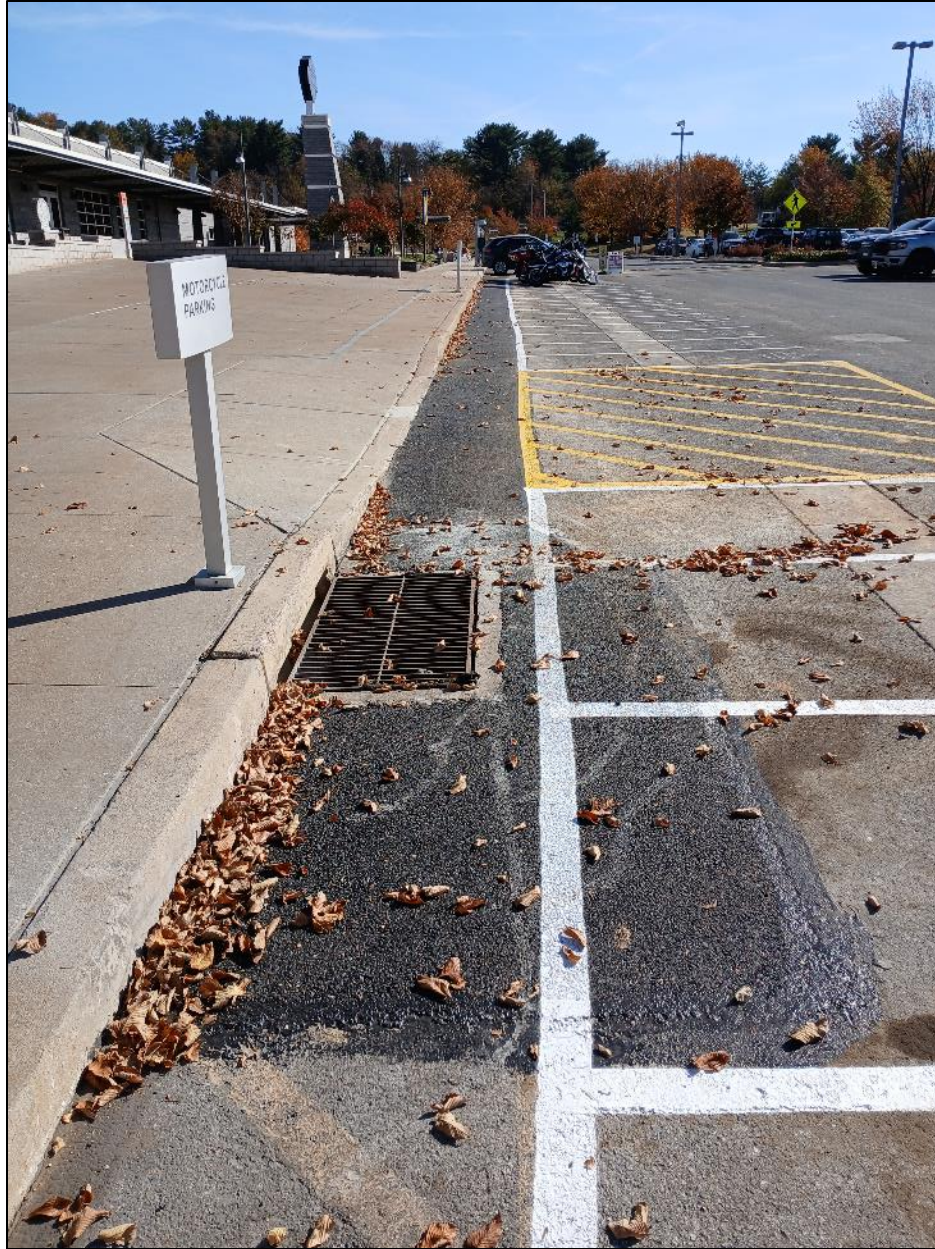
Photo 8: Photo looking east at existing stormwater inlet and piping trench that connect the new inlet. Asphalt is installed and the seams are sealed.

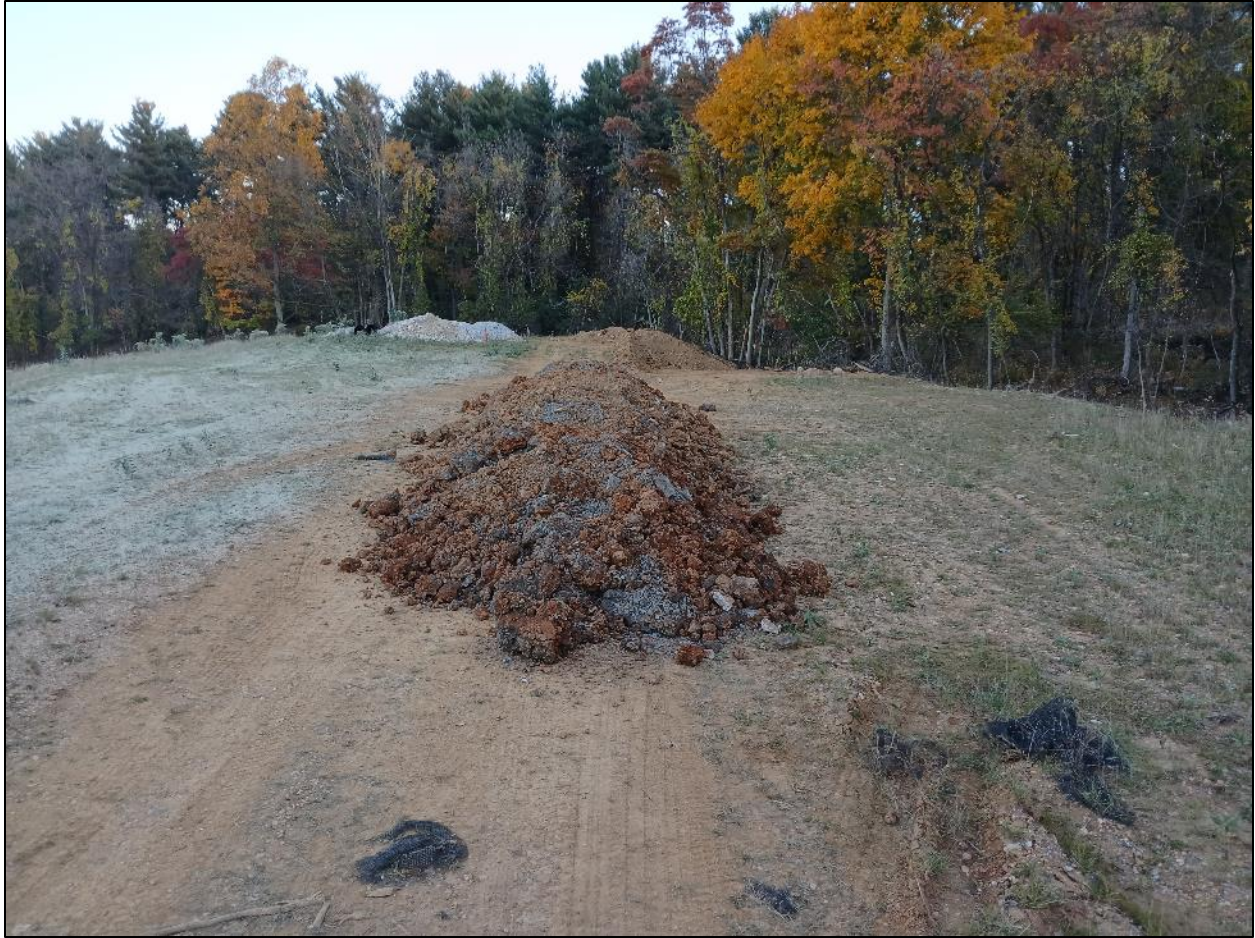
Photo 9: Photo looking north at excavated soil stockpile in the upper 80.

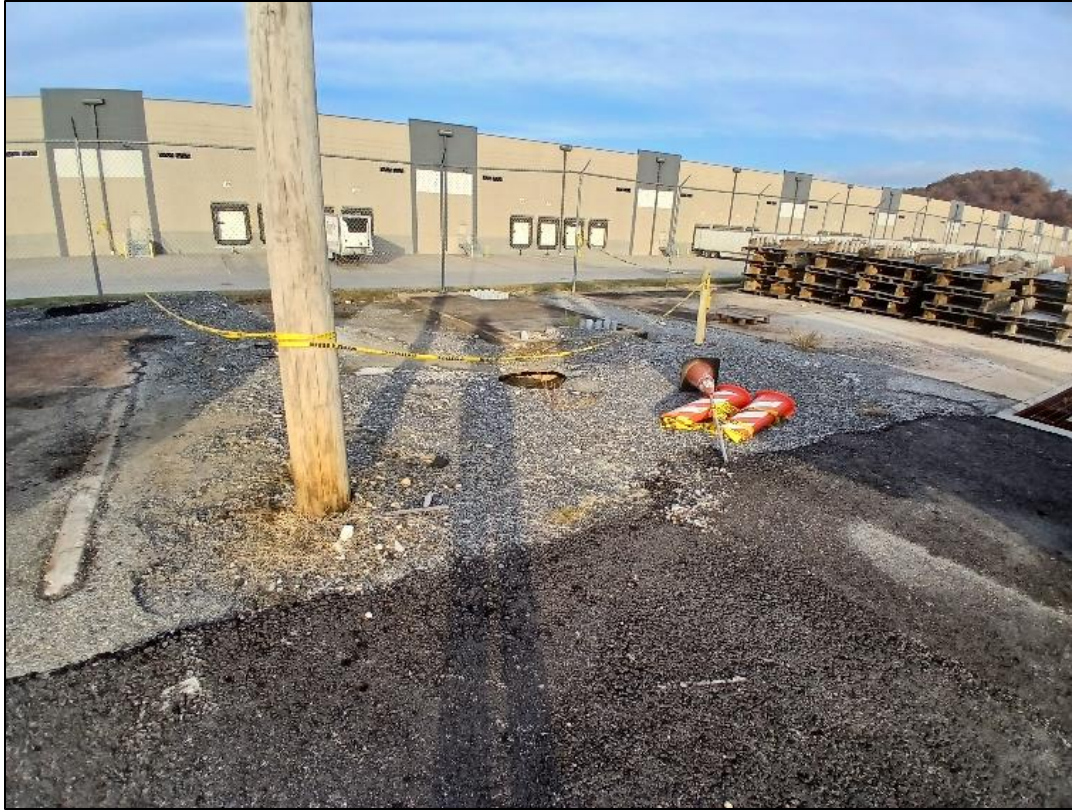
Photo 1: Sinkhole prior to repair work.

The contractor excavated an area approximately seven (7) feet deep and seven (7) feet long by five (5) feet wide in size. The repair work followed the sinkhole repair specification identified in the PRCP (**Appendix A**). Geotextile fabric was installed along the limits of the excavation. The excavation was backfilled with reversed grade rock starting at the bottom using R4 stone, R2 stone, gravel, and topped with four inches of asphalt. The asphalt cap that was replaced is an acceptable PRCP cap material meeting the minimum thickness and quality for direct contact prevention. Excavated soil was stockpiled near the repair work. Photos of the sinkhole repair work and asphalt installation are provided in **Appendix B**.

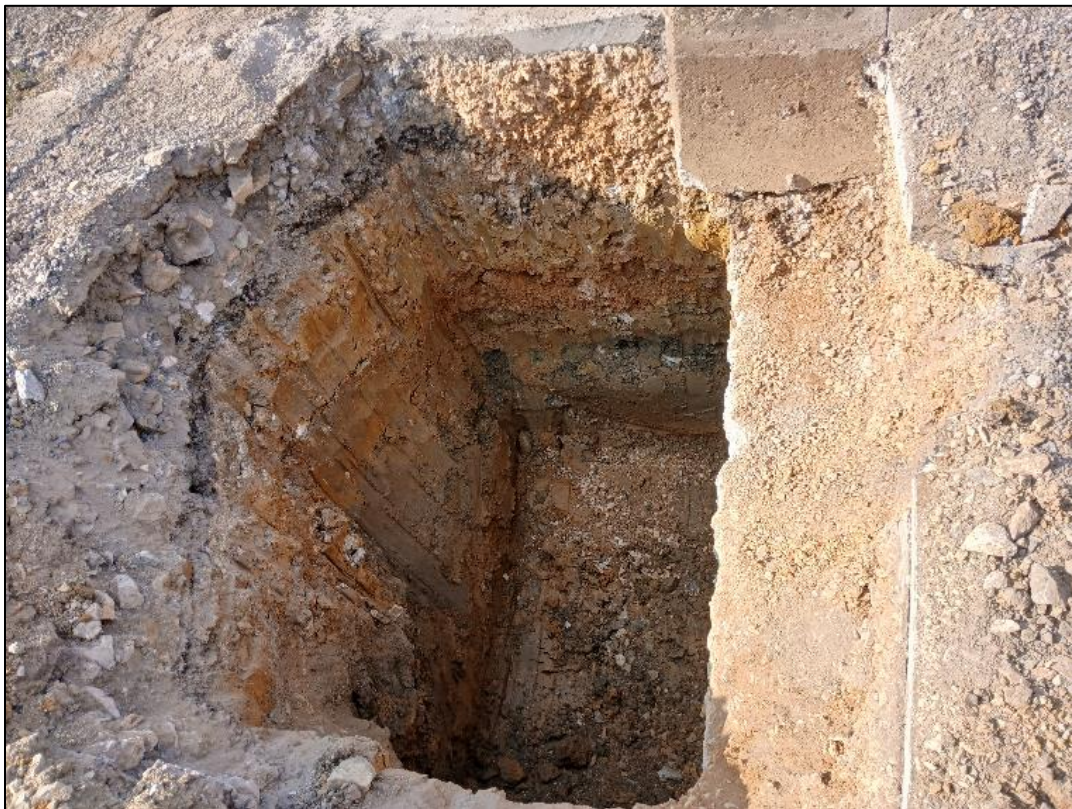
Photo 2: Sinkhole excavated to depth. Stable sidewalls and bottom.

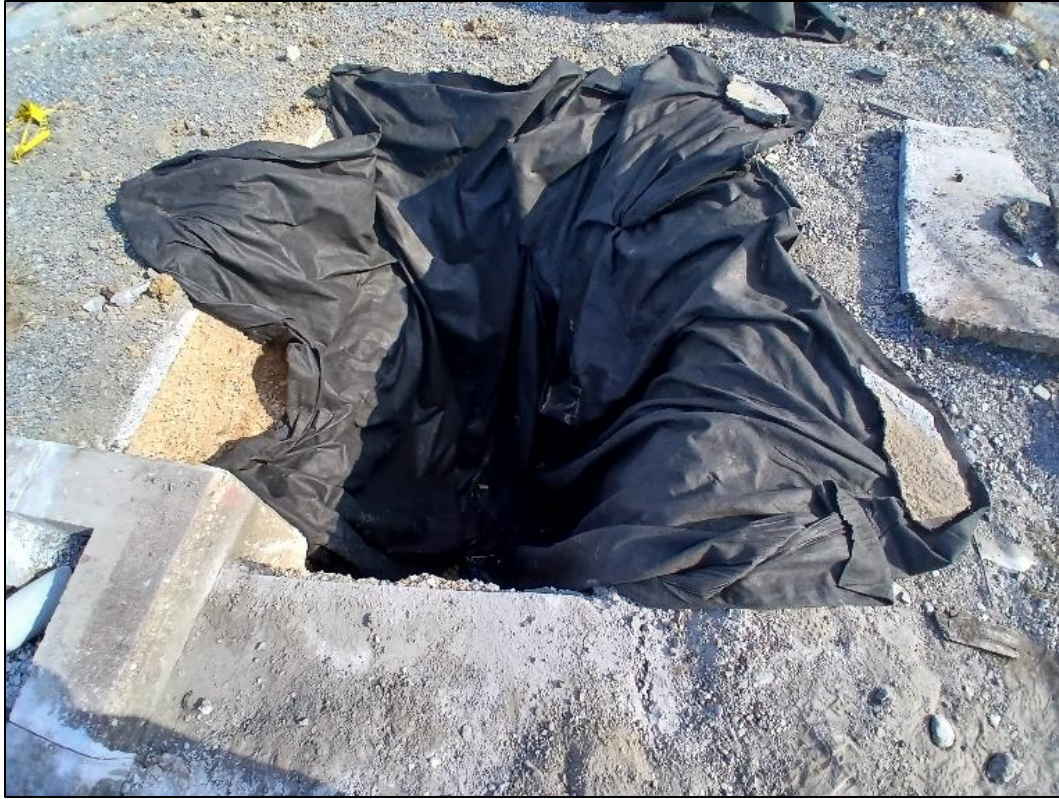
Photo 3: Geotextile fabric installed prior reverse grade stone backfill.

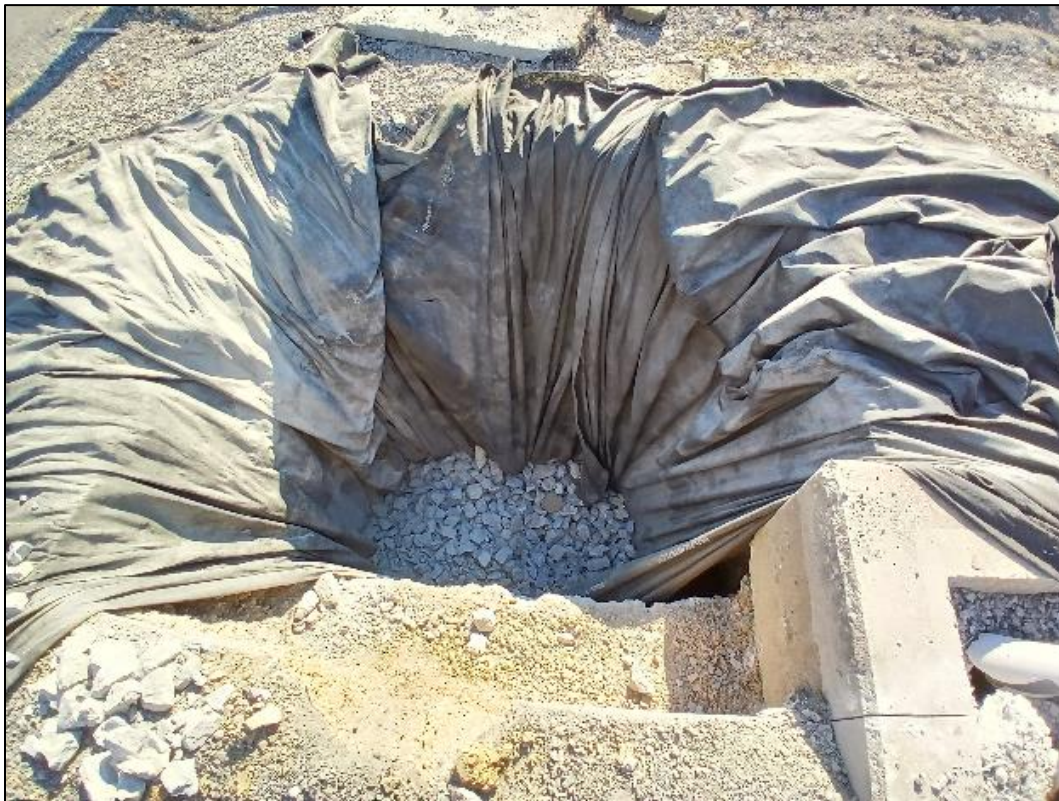
Photo 4: Begin backfill with R4 stone.

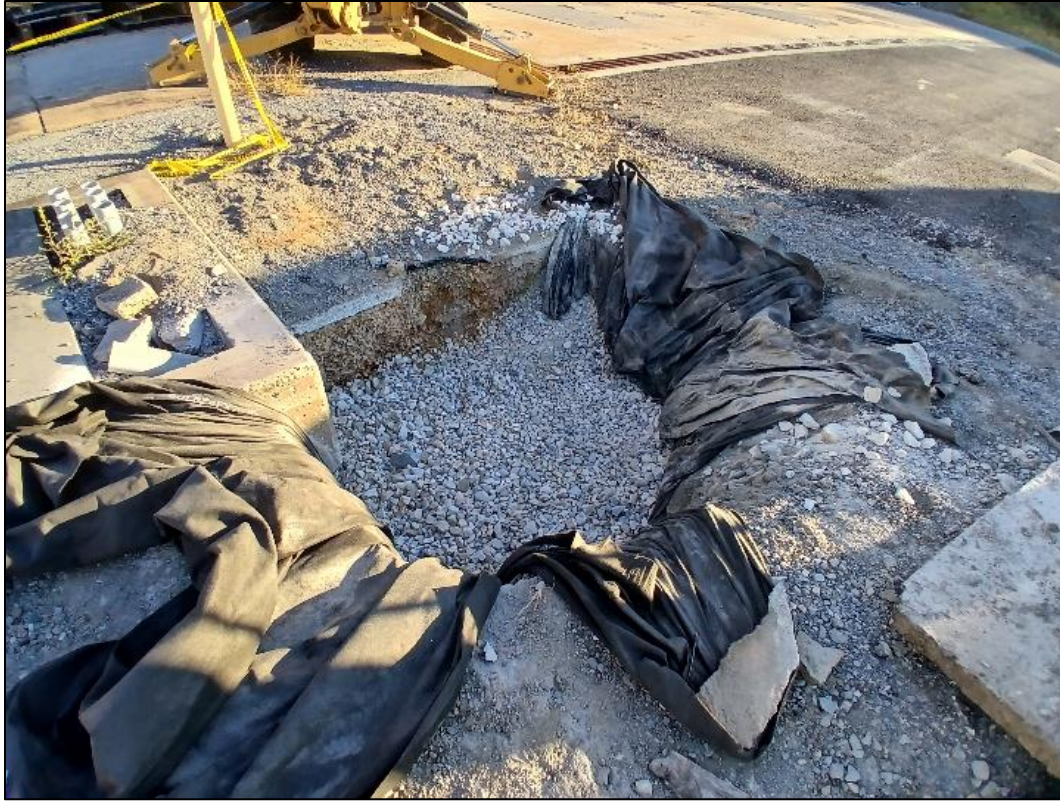
Photo 5: Gravel installed above the R2 stone. Geotextile fabric was folded on top of gravel.

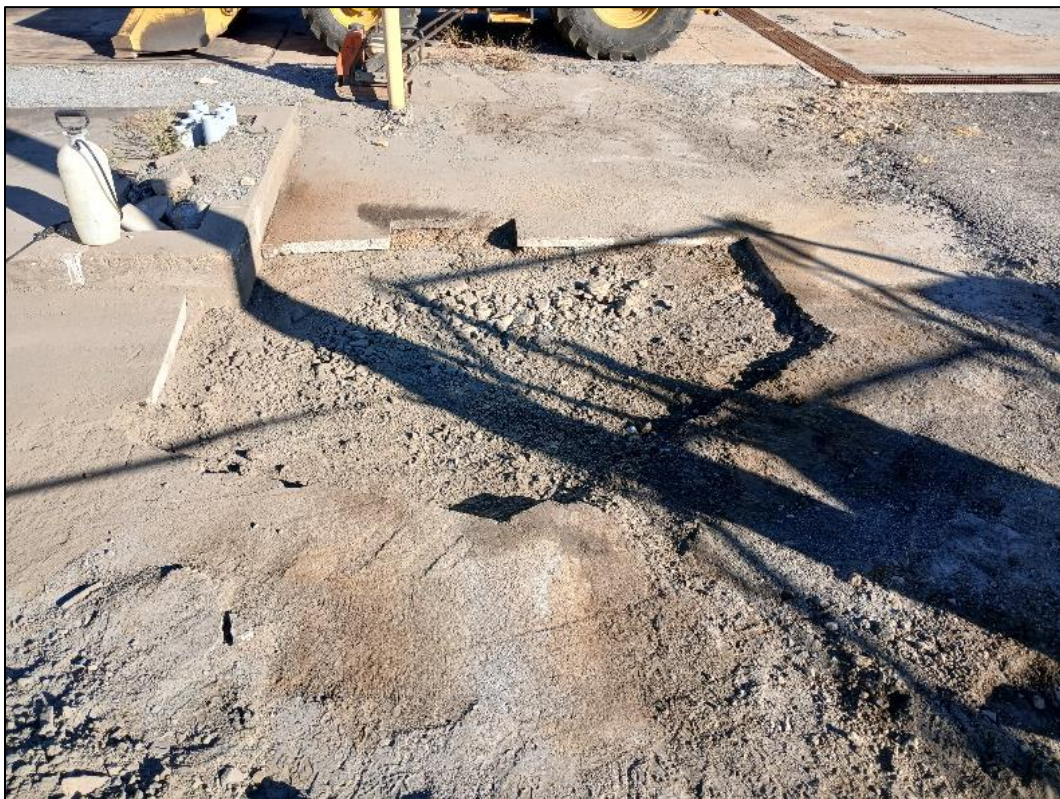
Photo 6: Photo prior installation of asphalt to replace cap.

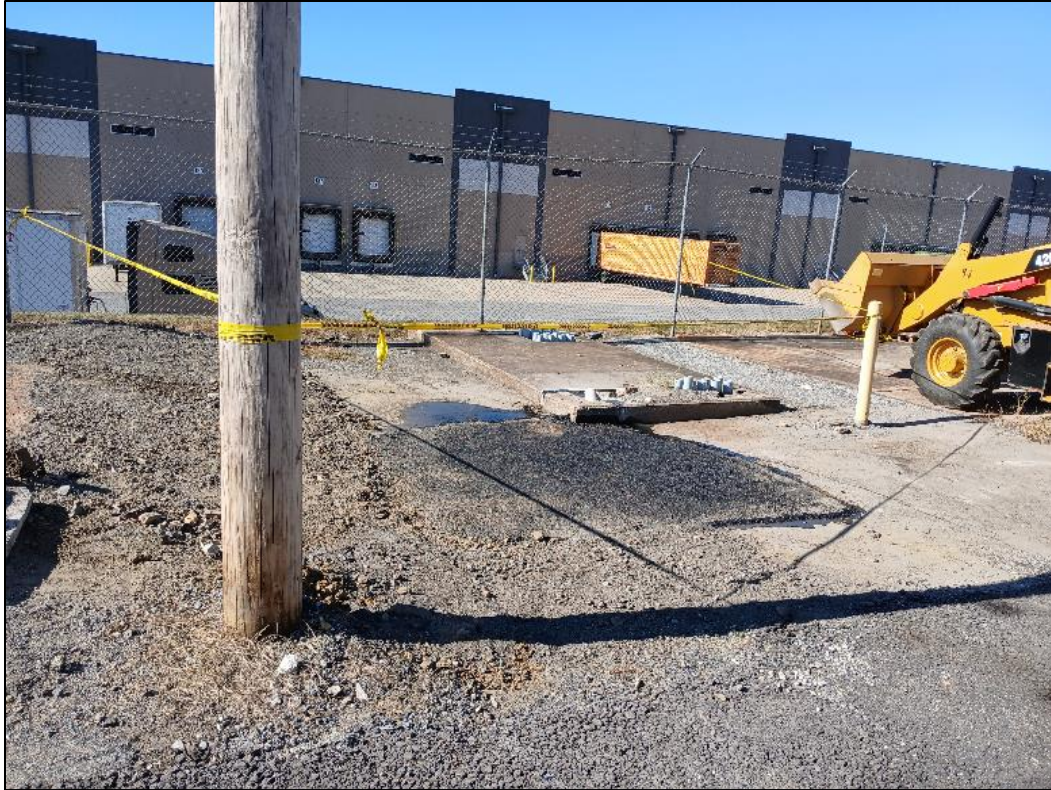
Photo 7: Asphalt cap installed over sinkhole repair area.

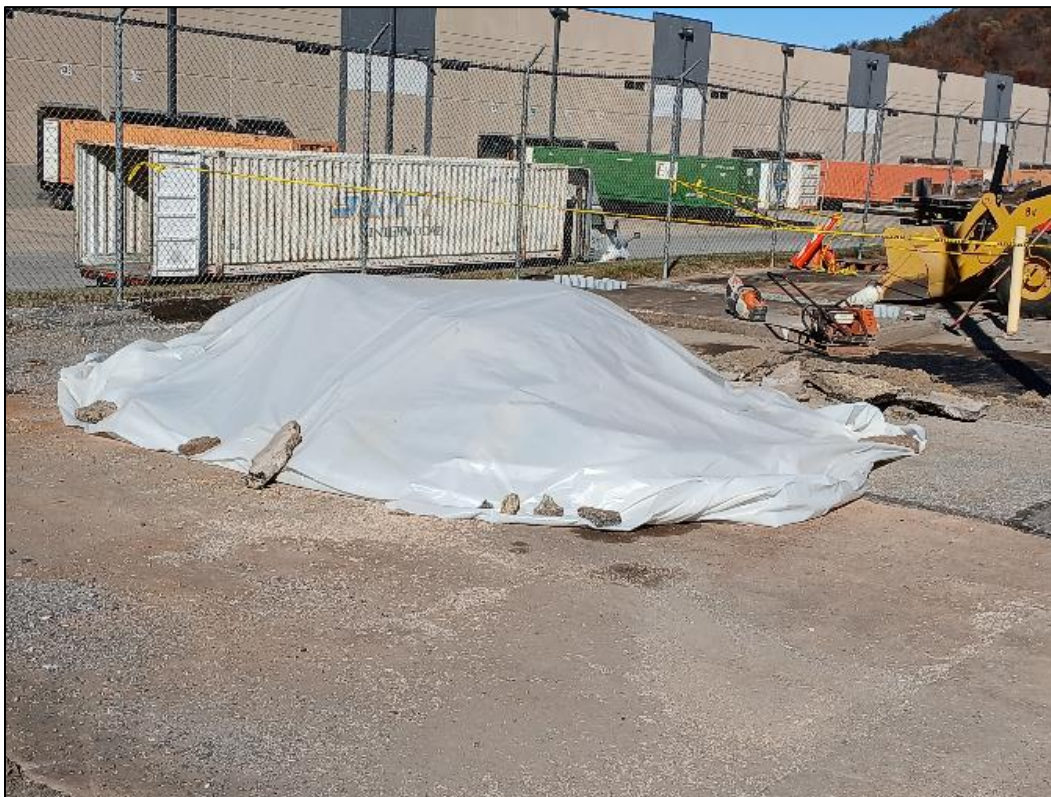
Photo 8: Excavated soil stockpiled south of sinkhole repair area.

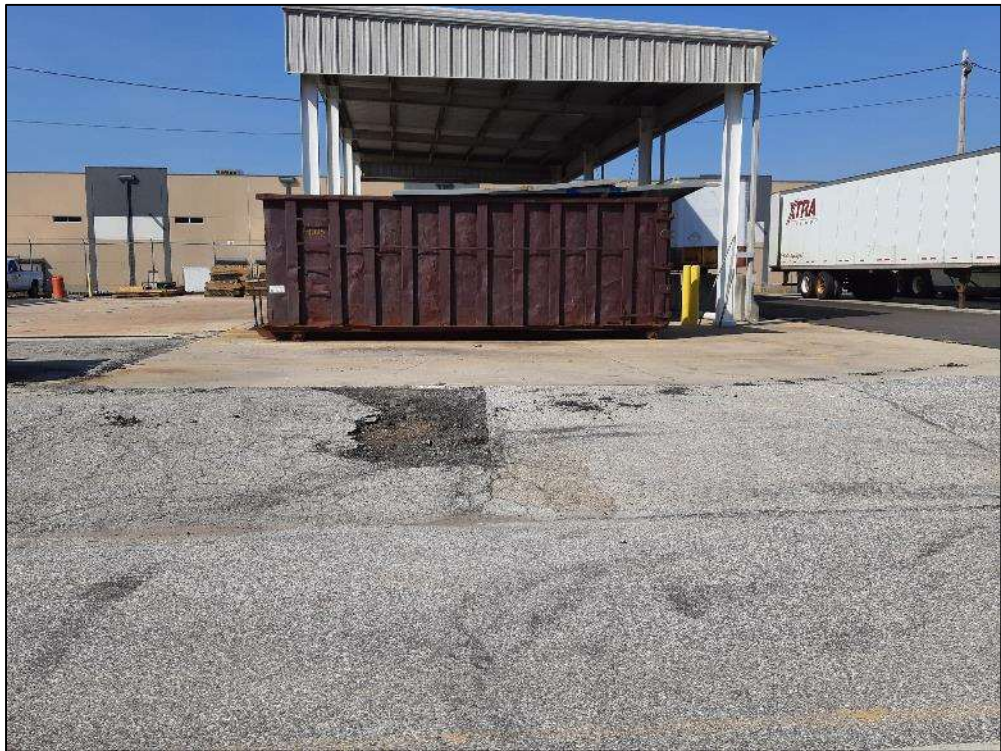
A small area of asphalt is beginning to break apart east of the roll off lean to structure, near Building 70. The cap is still intact and is in conformance, but this area should be monitored for additional damage.

Photo 2: Photo looking west at distressed asphalt located east of the roll box lean to structure.
Photo taken March 2024.
