FORM A
MONITORING AND MAINTANCE OF CAP AREAS FOR fYNOP ANNUAL
POST-REMEDATION CARE PLAN ACTIVITIES

This form is used to document the results of annual post-remediation care activities for engineering and institutional controls at the Former York Naval Ordnance Plant (fYNOP) in York, Pennsylvania. These activities are to be performed in accordance with the procedures in the approved Pennsylvania Land Recycling and Environmental Remediation Standards Act (Act 2) Final Report and Post-Remediation Care Plan (PRCP) contained in Appendix J of the Final Report.

Former York Naval Ordnance Plant
 1425 & 1445 Eden Road York, PA 17402

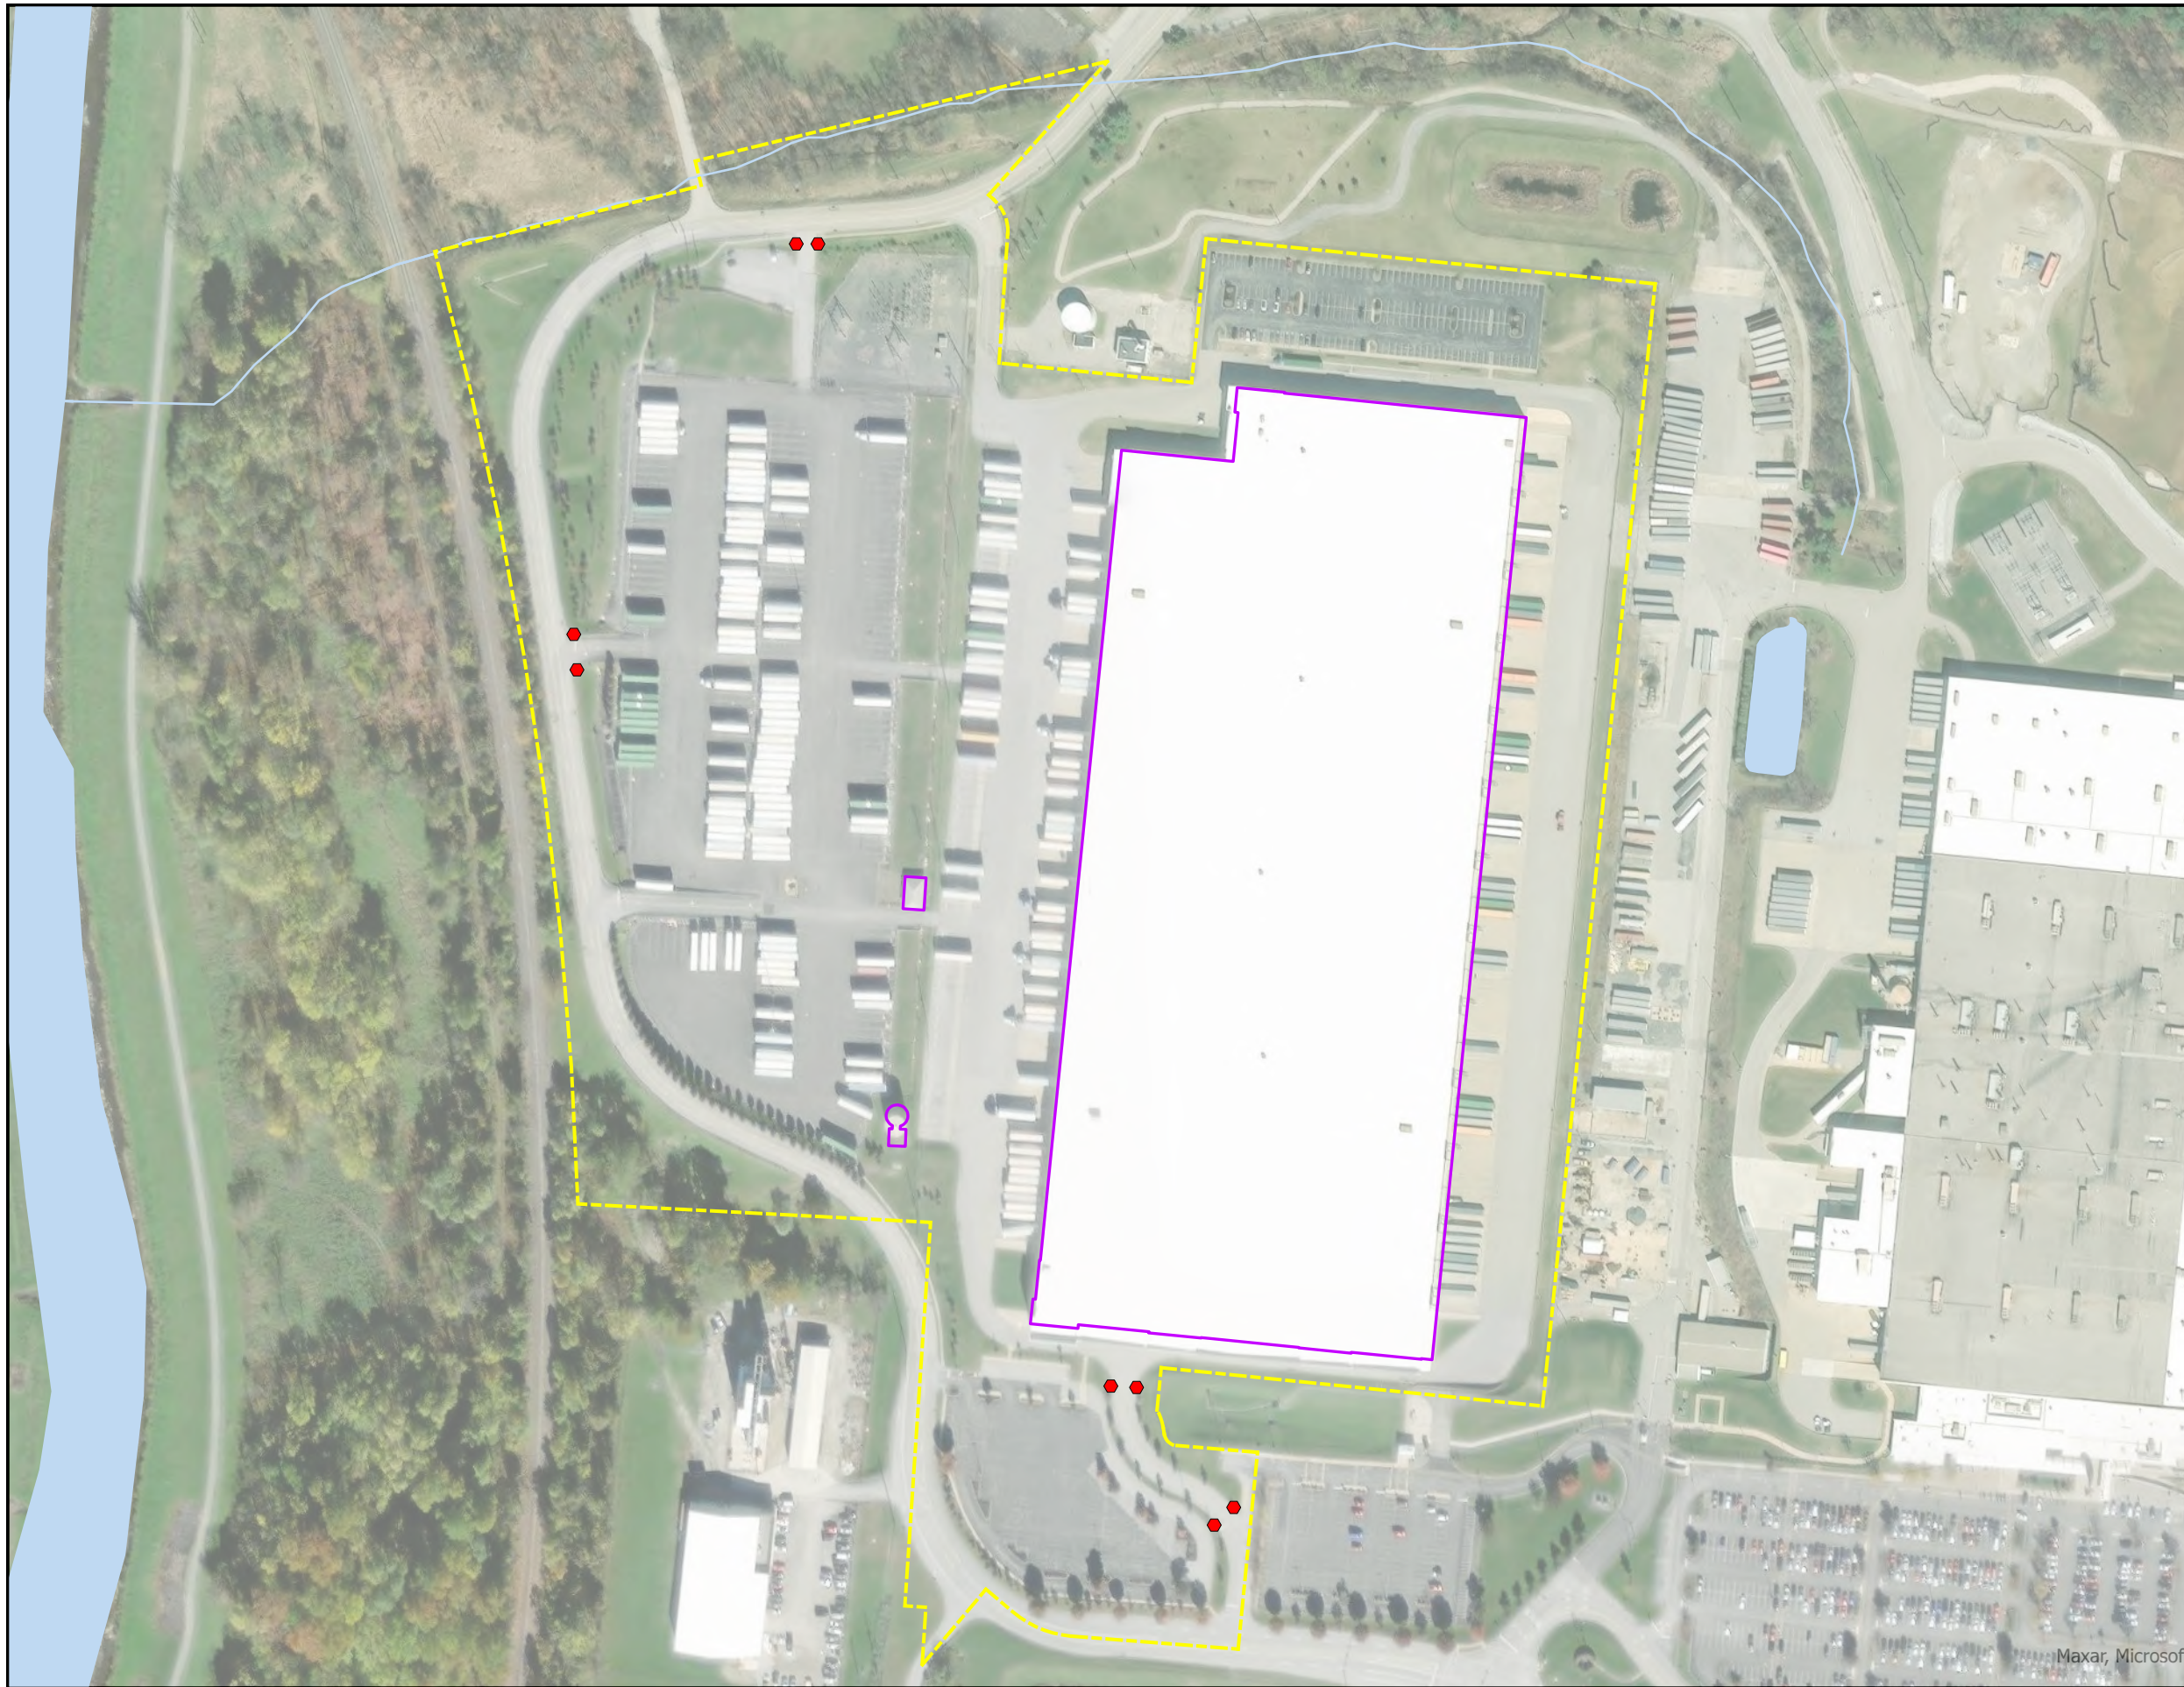
Gate Post Location Map

6-12-24 – Gate posts were installed at eight locations (four gates total) on the NP York 58 property by Long Fence, contracted by NorthPoint Development. The locations are at the northern entrance of the trailer parking area, the northern entrance on the west side of the trailer parking area, and two locations south of the warehouse (see attached figure). The construction consisted of hand excavating 12-inch diameter postholes within existing soil capped areas for installation of 4-inch diameter steel posts approximately 4 feet into the ground, secured with concrete. The new capped surface, including steel post with concrete collar, continues to eliminate direct contact exposure to underlying soil and reduces infiltration at a greater capacity than the pre-existing condition, and conforms with the PRCP.

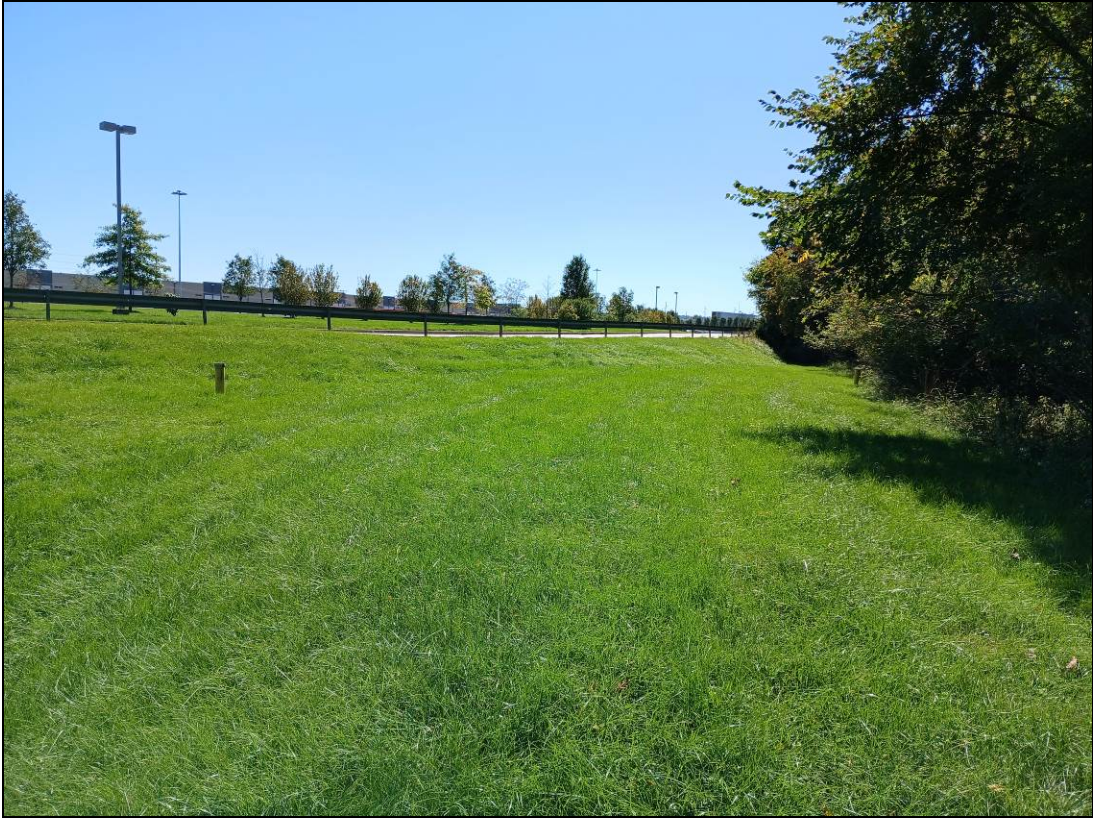
Photo 1: Photo looking south at Area B.

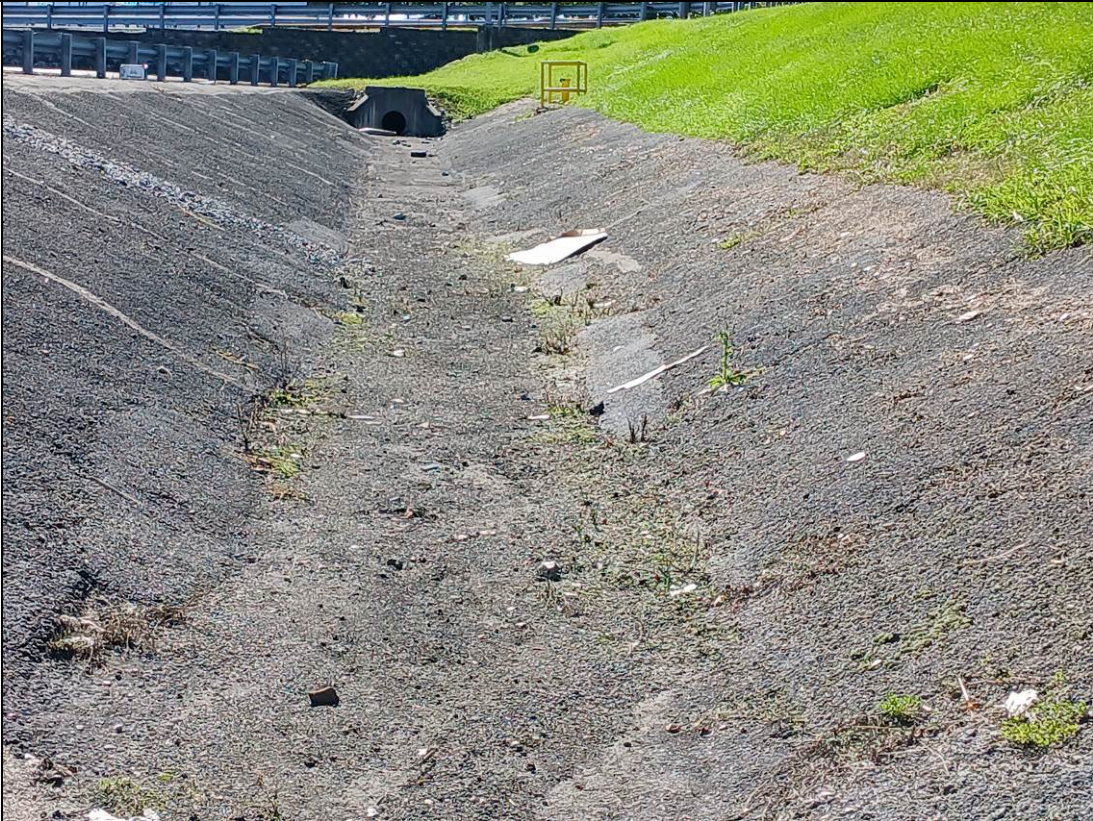
Photo 2: Photo looking south at vegetation growing the in paved swale. Trash was removed from the swale during the inspection.

West Parking Lot paved surfaces and the paved stormwater swale along Eden Road should be monitored for cracks and vegetation growth and repaired/maintained following regular inspections. Minor cracks were observed in the paved swale during 2024 quarterly inspections and were recommended for repair.

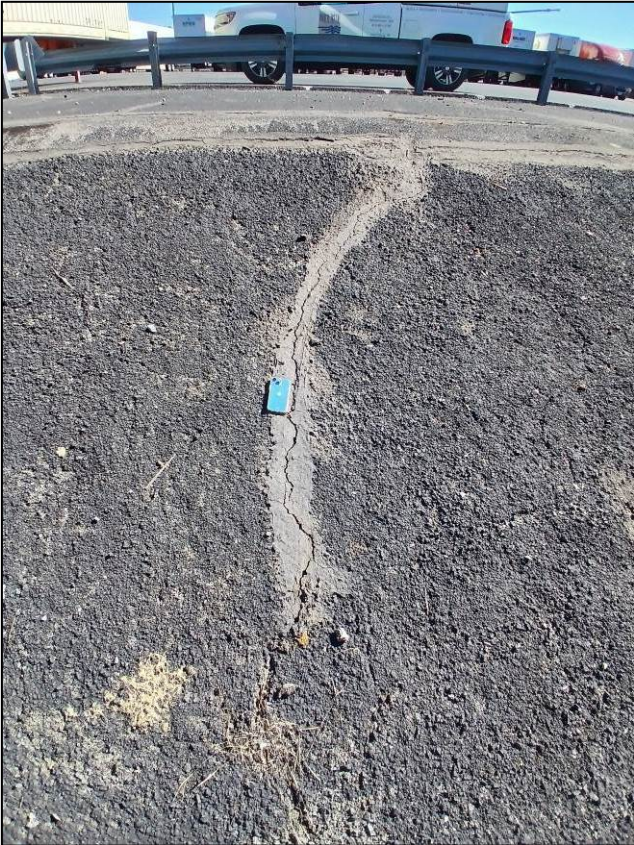
Photo 3: Photo looking east at a crack in eastern slope of the paved swale.

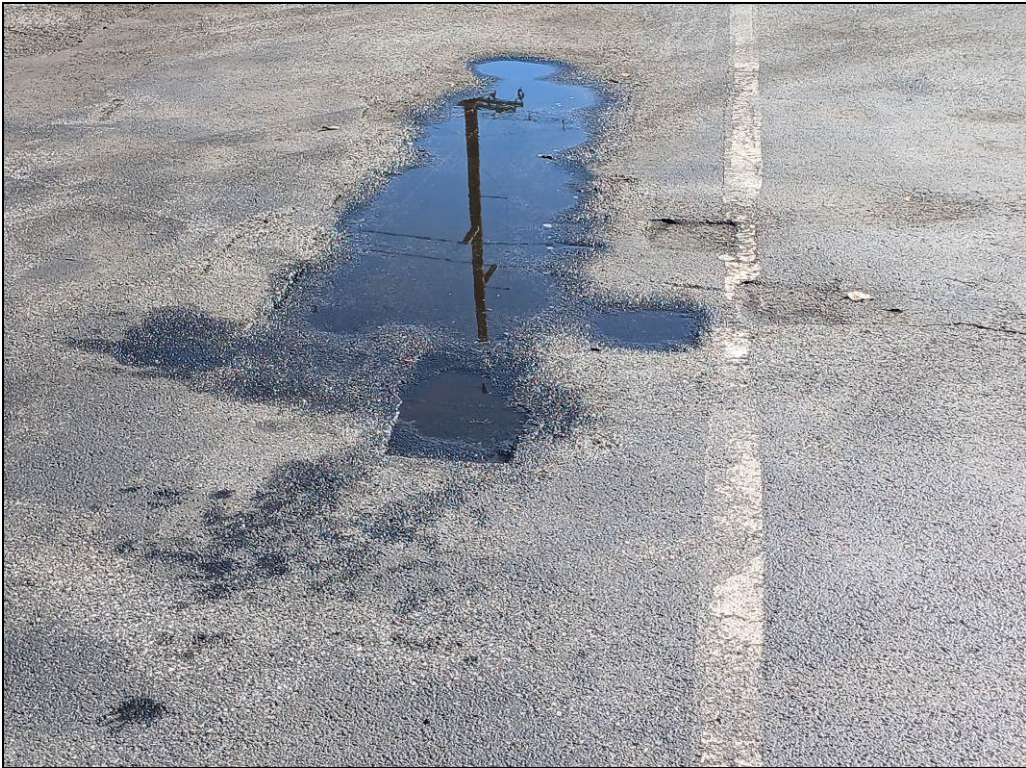
Photo 4: Photo looking east at impressions in the asphalt from the trailer feet. Cap is intact at impression locations.

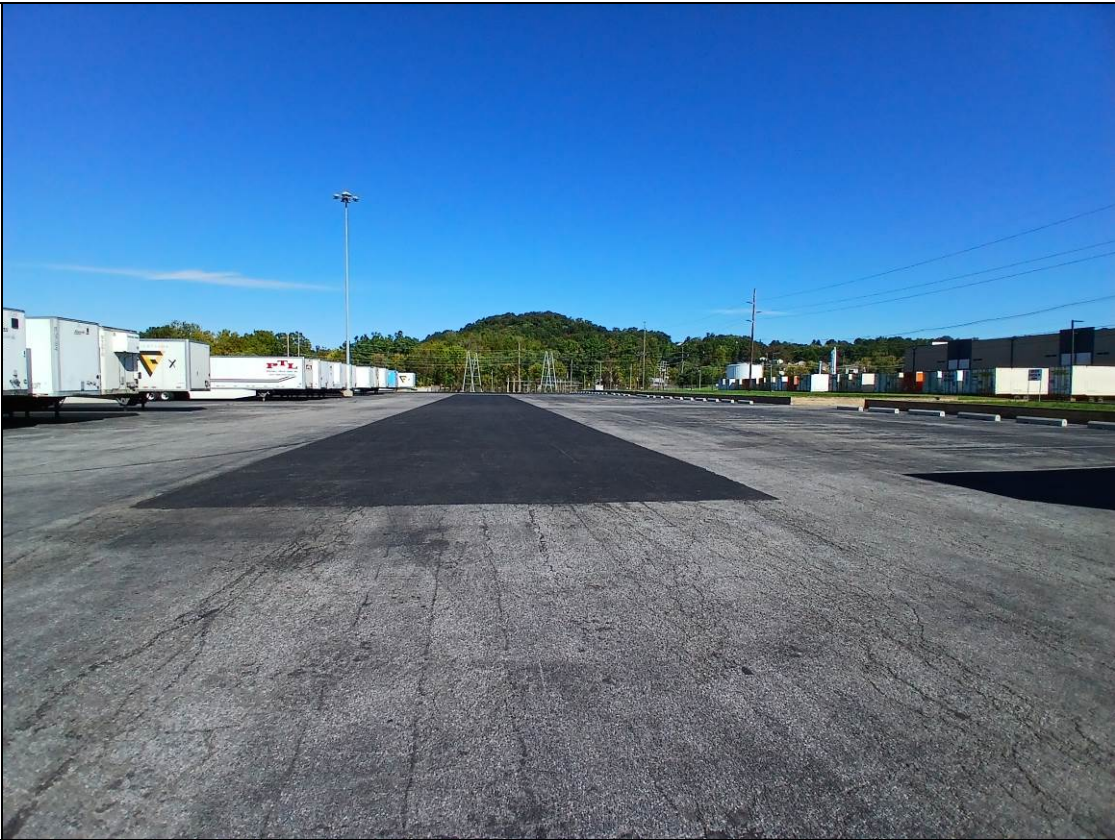
Photo 5: Photo looking north at area of asphalt repair in the central portion of the WPL.

Asphalt work was completed by All Out Paving on 9/13/24 and 10/5/24. Alligator repairs, crack filling, seal coating and line striping were conducted of selected West Parking Lot areas.

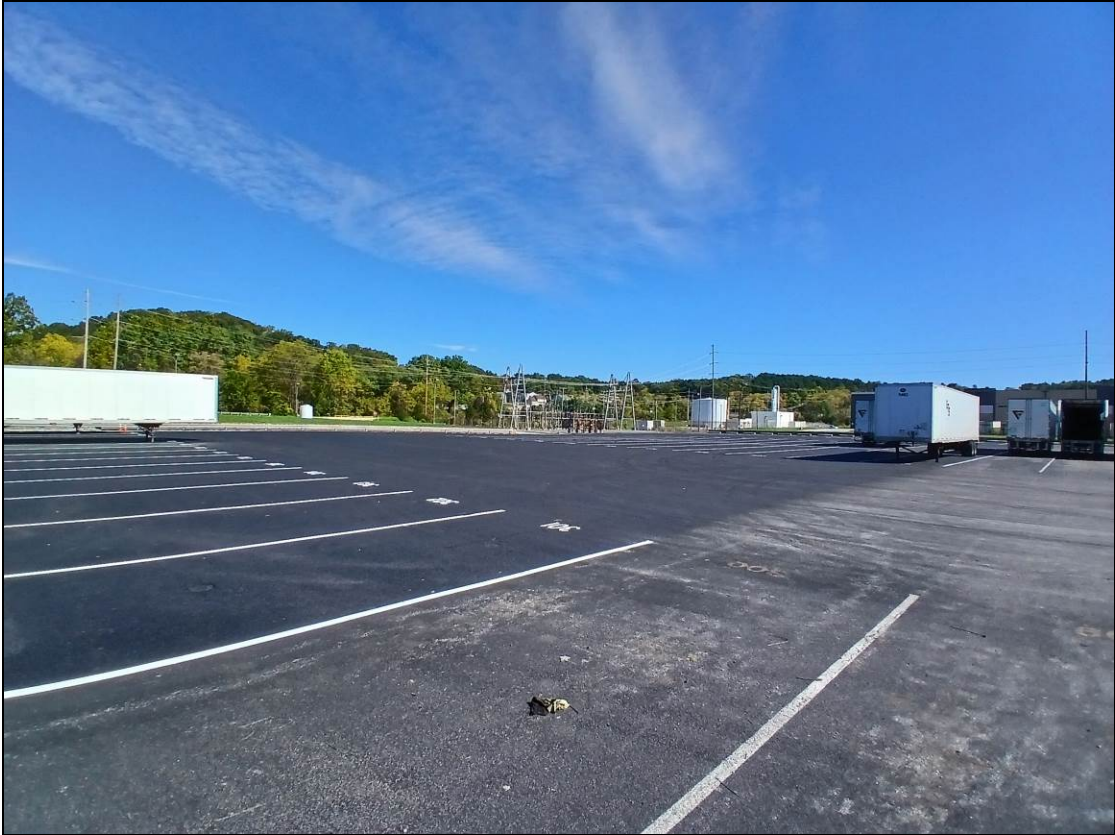
Photo 6: Photo looking northeast at northern fourth of WPL where asphalt seal coat was applied.
