FORM B
WEST CAMPUS WAREHOUSE VAPOR BARRIER ASSESSMENT FOR fYNOP
ANNUAL POST-REMEDATION CARE PLAN ACTIVITIES

The activity covered by this form includes verifying the integrity of the engineering control (vapor barrier) beneath the Eden Road Logistics Center (ERLC) warehouse building on the West Campus property in accordance with Section 4.3.2 in the PRCP. This form also documents maintenance of the vapor barrier, if performed, in accordance with Section 5.2 in the PRCP.

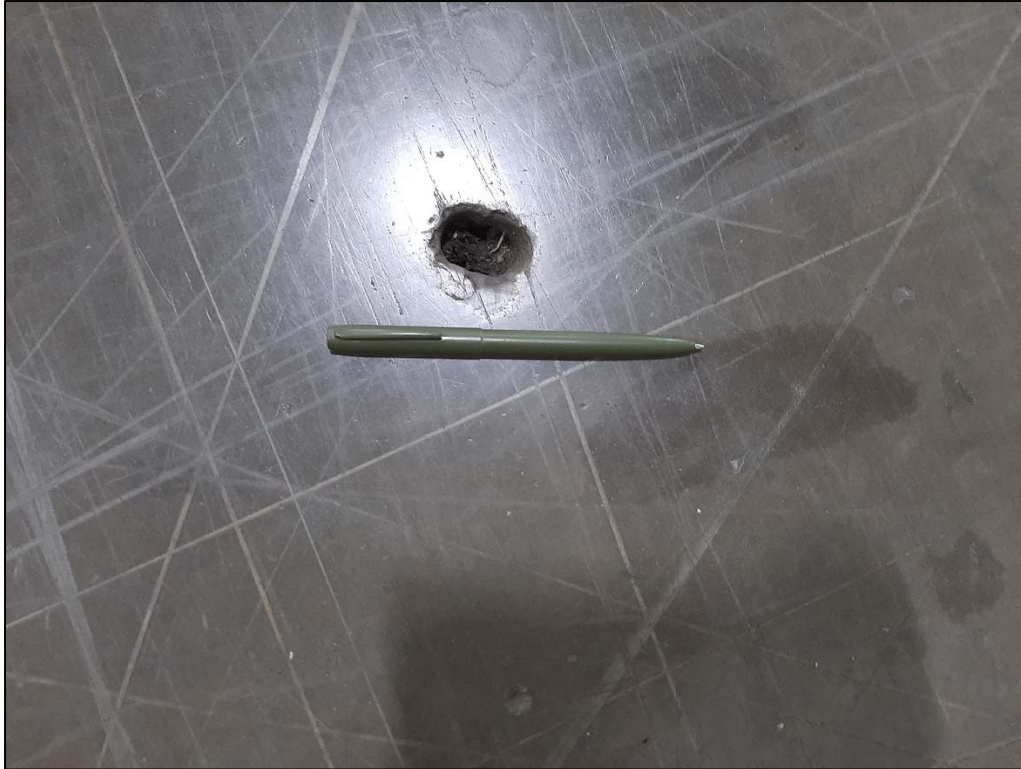
Several small holes were identified, and should be considered for repair to prevent further damage to the slab, but are not believed to compromise the underlying vapor barrier.

Photo 1: Photo of small hole in concrete floor near Door 1.

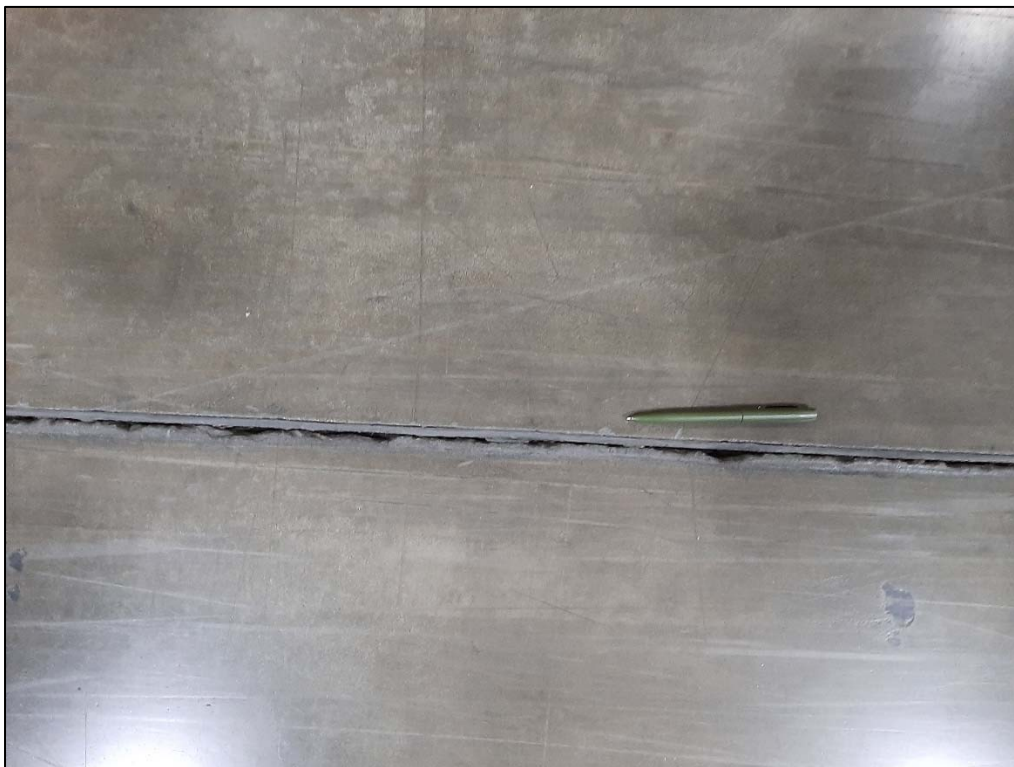
Photo 2: Photo of a gap in the caulk along a concrete seam near location A249.

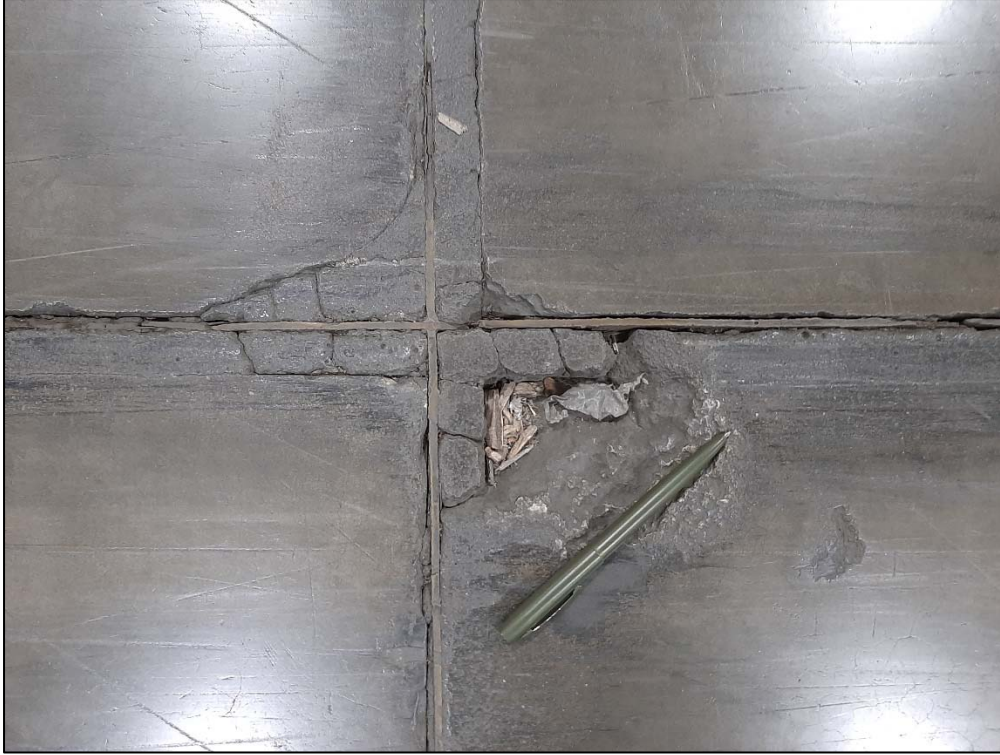
Photo 3: Photo of a crack along a concrete seam at A335.

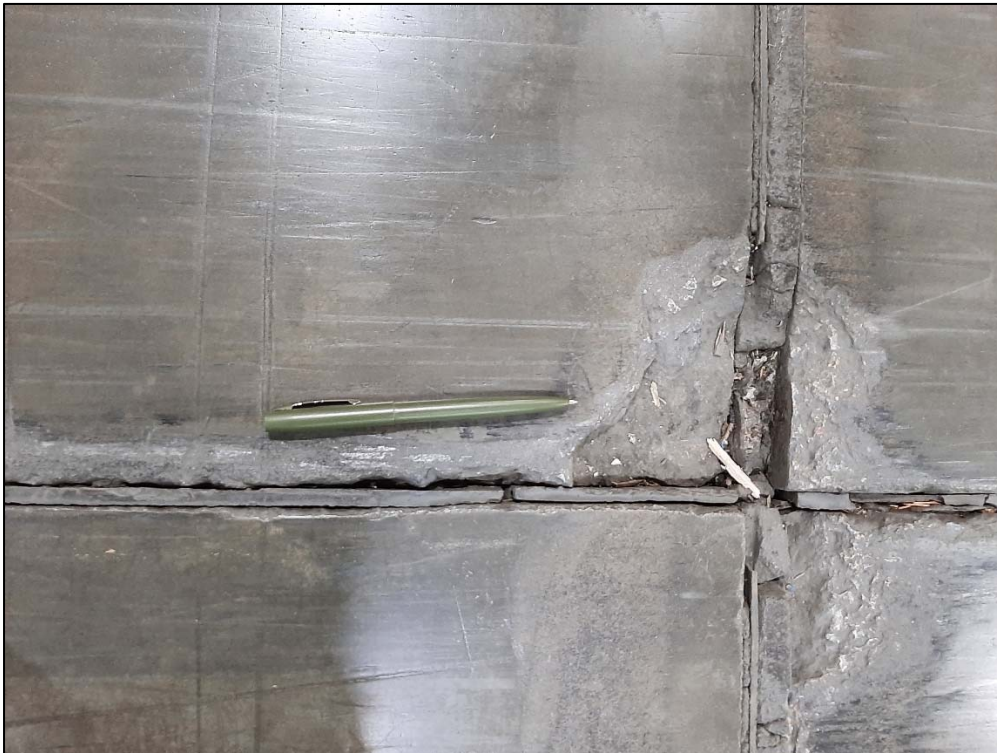
Photo 4: Photo of a crack along a concrete seam at A349.
