**FORM A**  
**MONITORING AND MAINTANCE OF CAP AREAS FOR fYNOP ANNUAL**  
**POST-REMEDATION CARE PLAN ACTIVITIES**

This form is used to document the results of annual post-remediation care activities for engineering and institutional controls at the Former York Naval Ordnance Plant (fYNOP) in York, Pennsylvania. These activities are to be performed in accordance with the procedures in the approved Pennsylvania Land Recycling and Environmental Remediation Standards Act (Act 2) Final Report and Post-Remediation Care Plan (PRCP) contained in Appendix J of the Final Report.

The activities covered by this form include reviewing low altitude aerial photographs using unmanned aircraft system (drone) technology and conducting a walk-over inspection to monitor integrity of cap areas in accordance with Section 4.3.1 in the PRCP. This form also includes interviewing property representatives to document maintenance of cap areas in accordance with Section 5.2 in the PRCP.

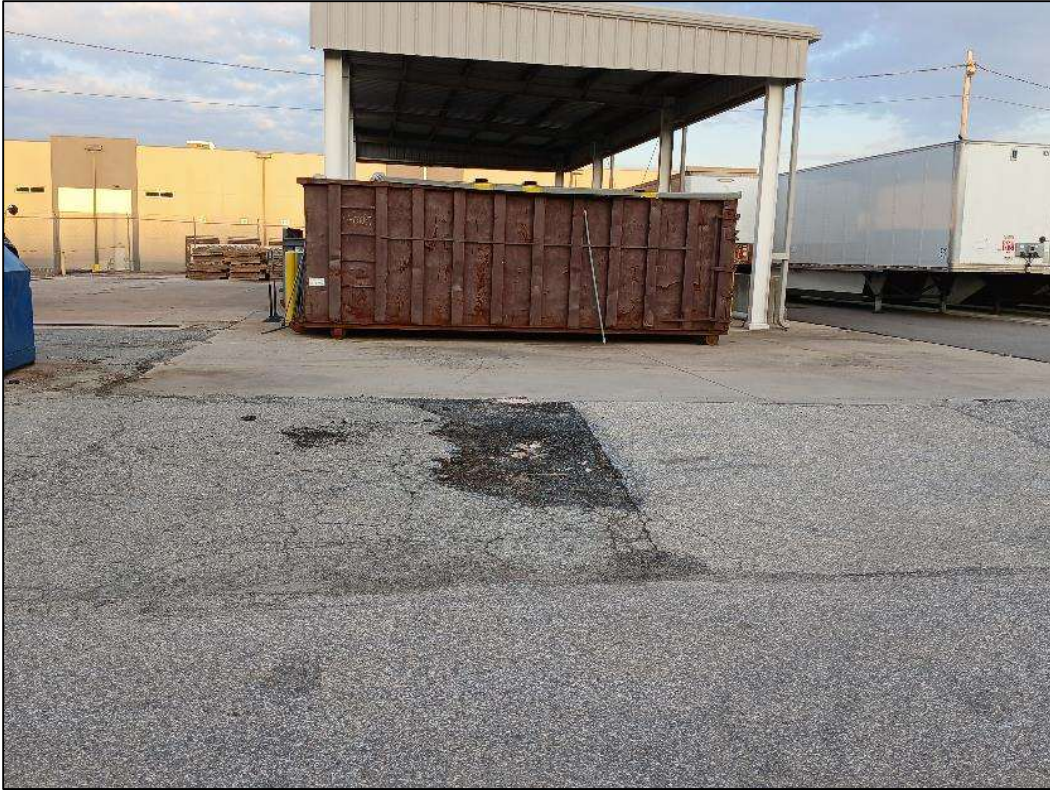
Photo looking west at distressed asphalt east of the roll off box lean-to structure.

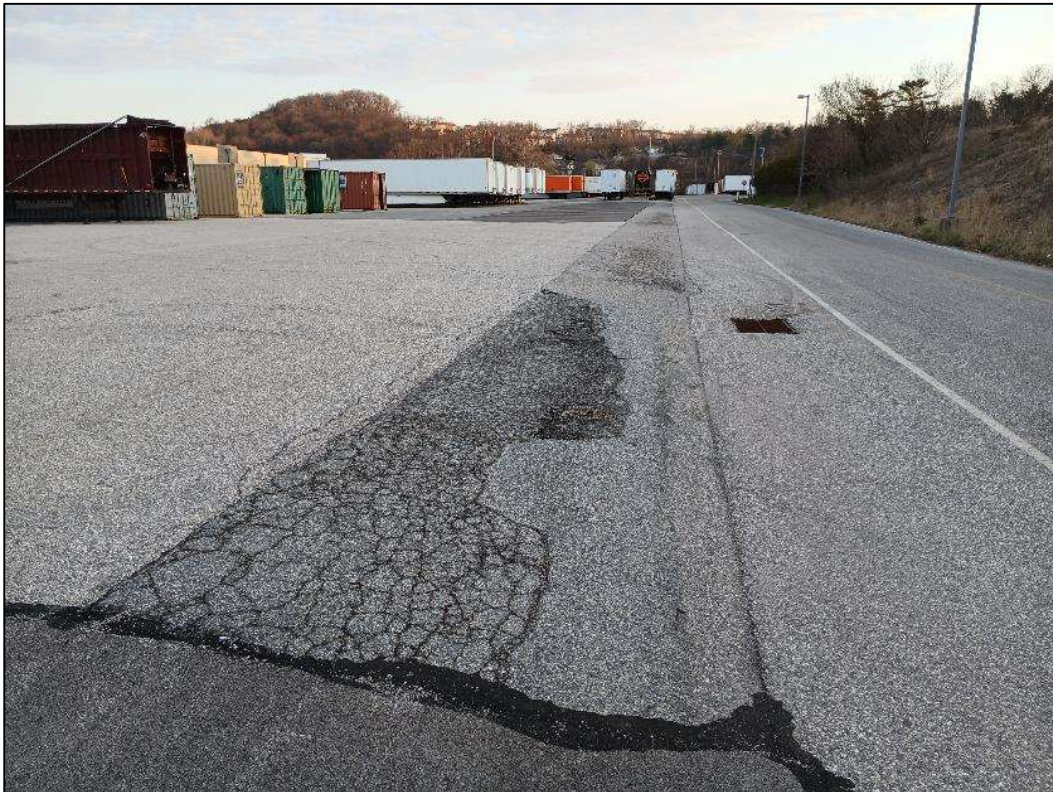
Photo looking north at distressed asphalt east of the safety shed.

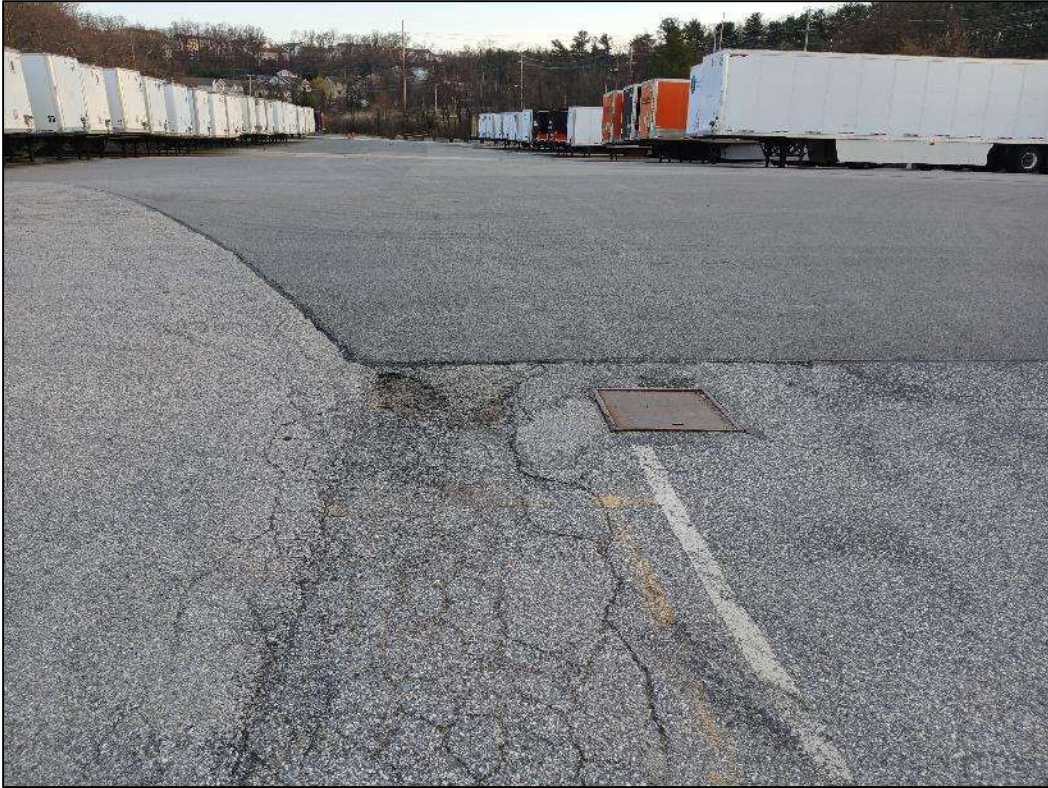
Photo looking north at distressed asphalt in the intersection near the fire pond.

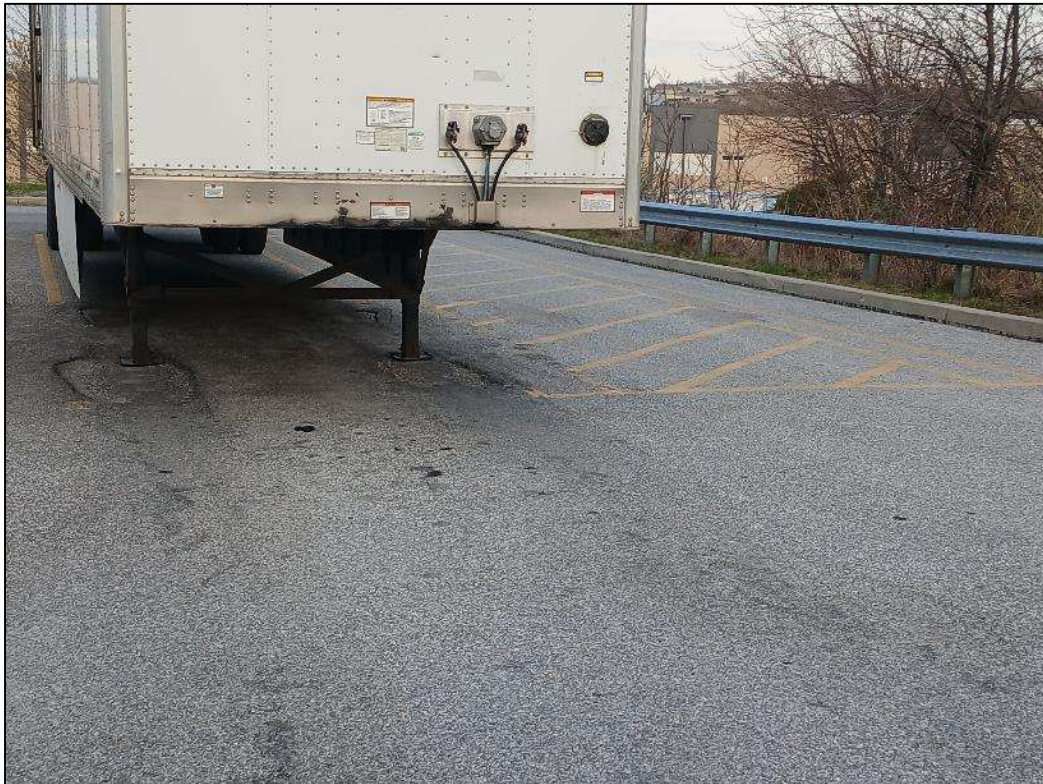
Photo looking west at distressed asphalt south of the fire water pond.

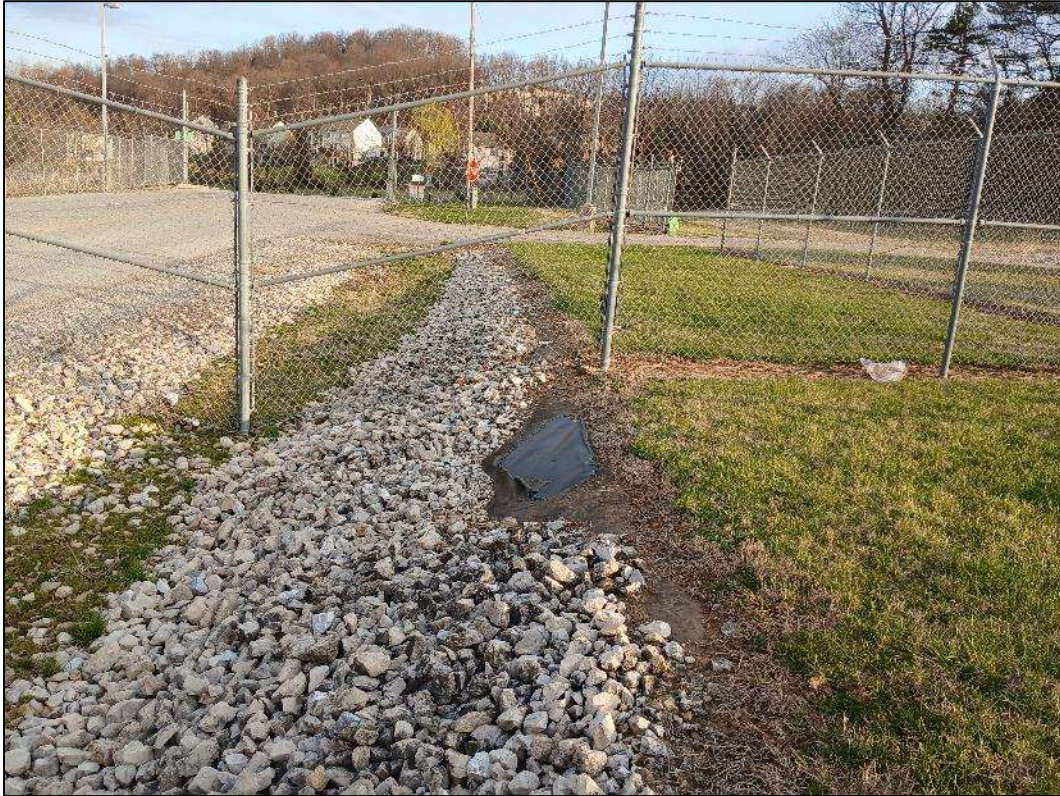
A small area of an HDPE Geomembrane liner along the Gate 5 driveway is exposed, and should be covered with rip rap cover or soil to avoid damage or deterioration.

Photo looking north at exposed HDPE liner on the east side of the GATE 5 access road.

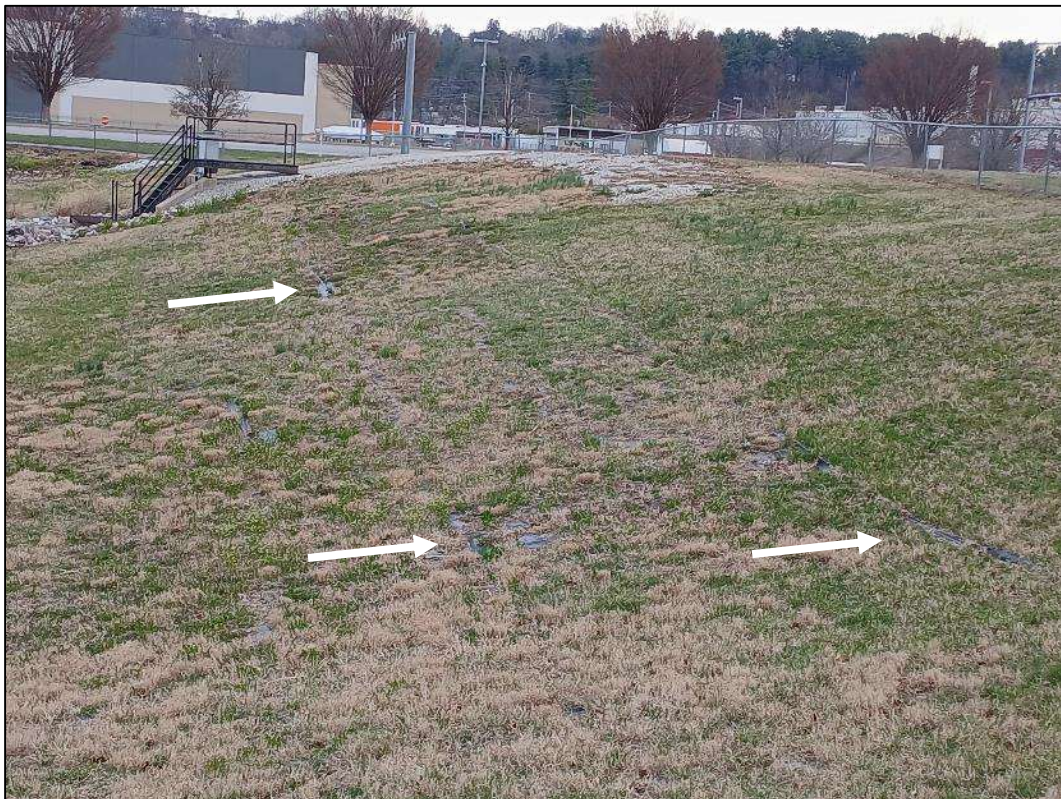
Photo looking north at exposed fabric on slope of stormwater retention pond.

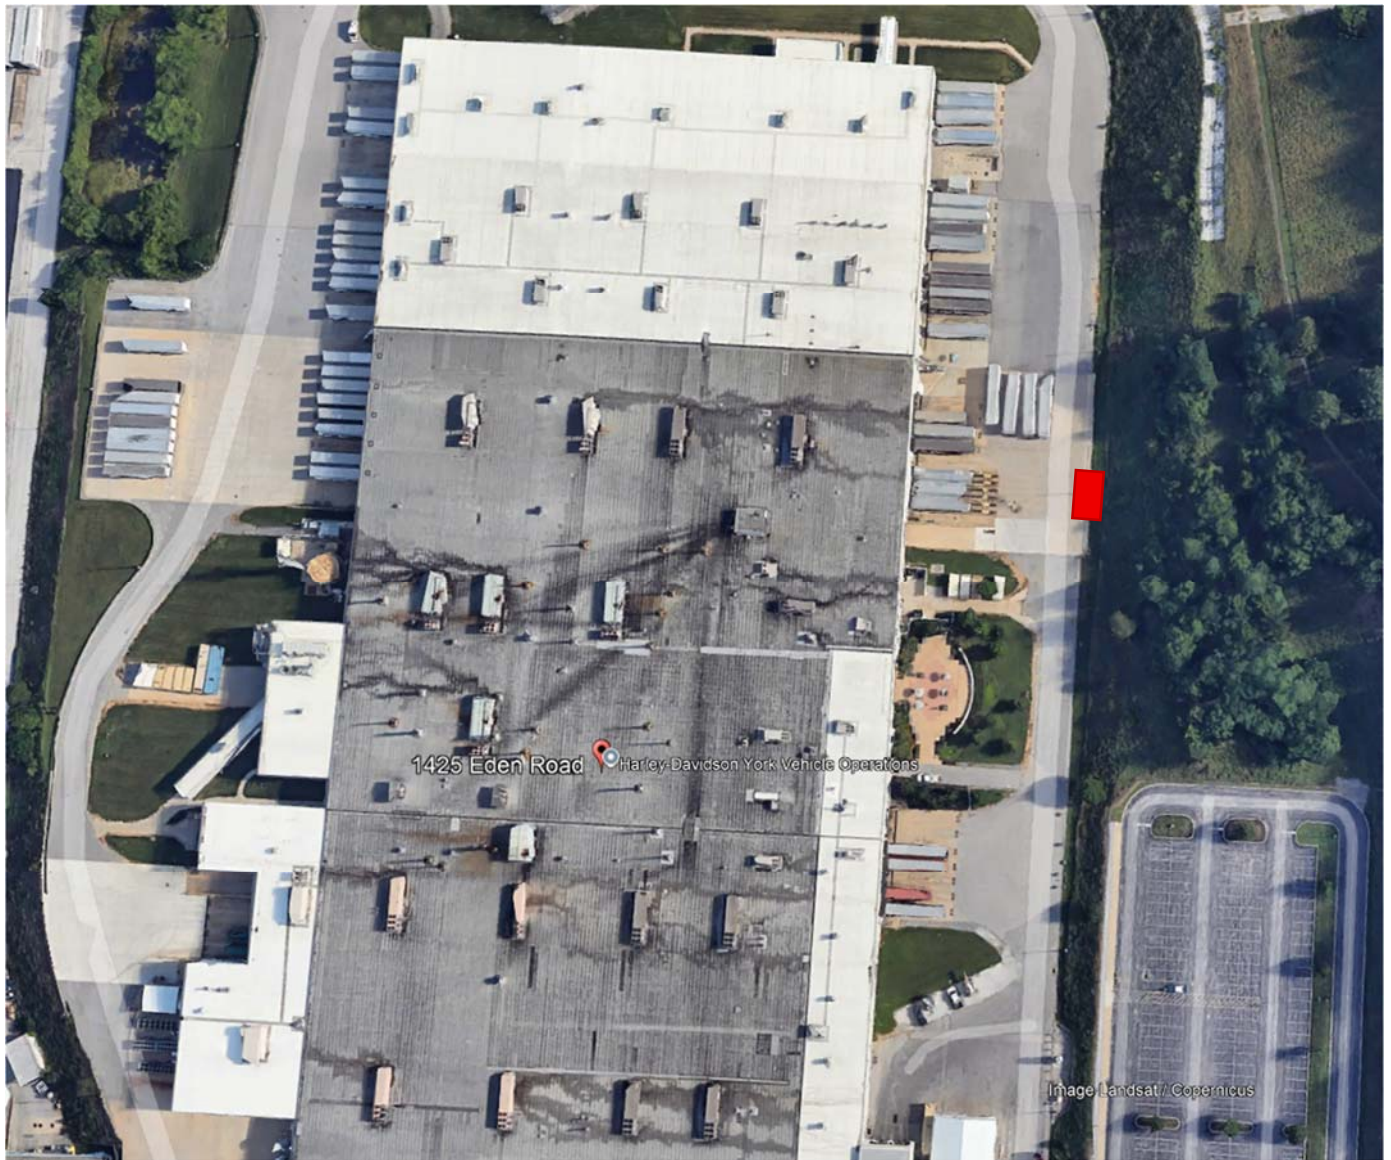
Figure 1 – East Dock Repair Location Map

Concrete loading dock area along the east side of Bldg 3 was removed, replaced and extended (same material).

1. The Building 3 east dock concrete replacement work was conducted during October 2025. The concrete and excavation work were completed by Kinsley. The work included removing a section of existing dock concrete that was 57 feet by 23 feet, replacing the concrete, and adding an additional five (5) feet of concrete dock area along the eastern edge. The concrete in the dock area that was removed varied in thickness from four to six inches but was replaced with eight (8) inches of concrete, including the extended dock area.

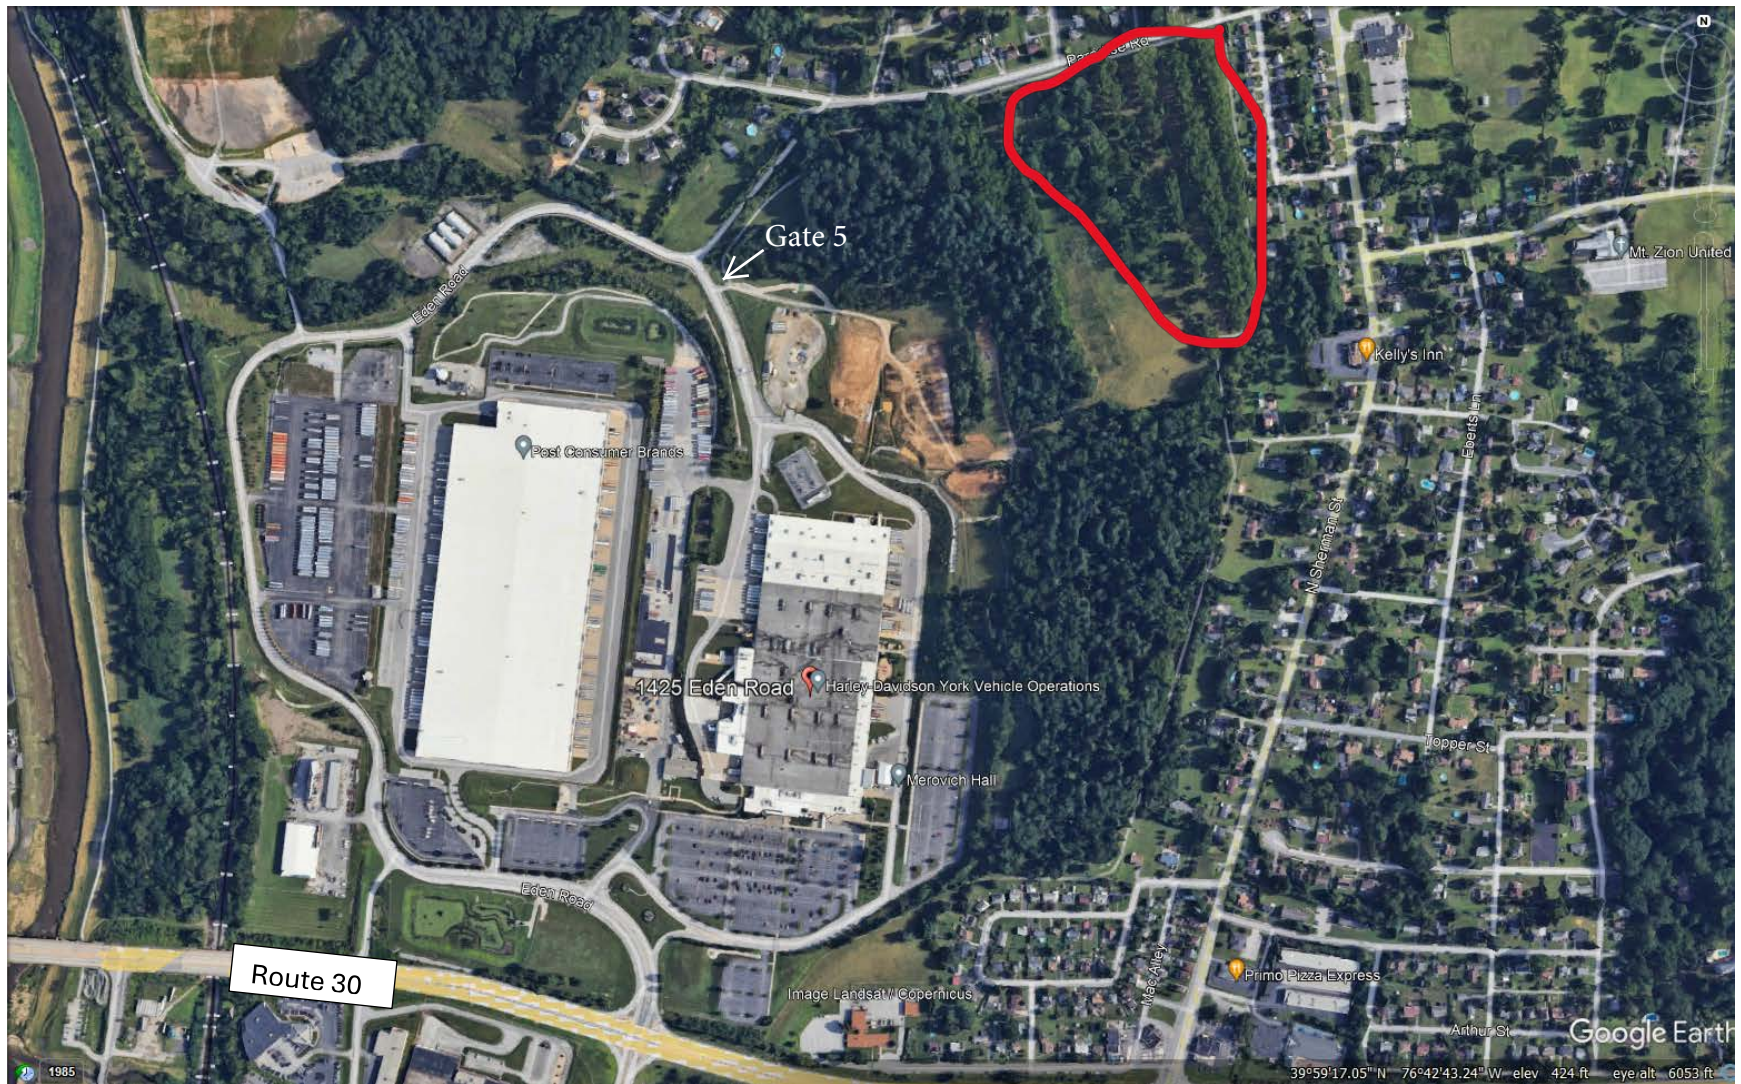
In early 2025 Harley-Davidson completed harvest of an old stand of black walnut trees located within approximately 15-16 acres of the northeast corner of the Harley-Davidson property (LUA 2).

Walnut tree harvest boundry circled in red in NE corner of the property. Site Address 1425 Eden Road, York, PA 17402.

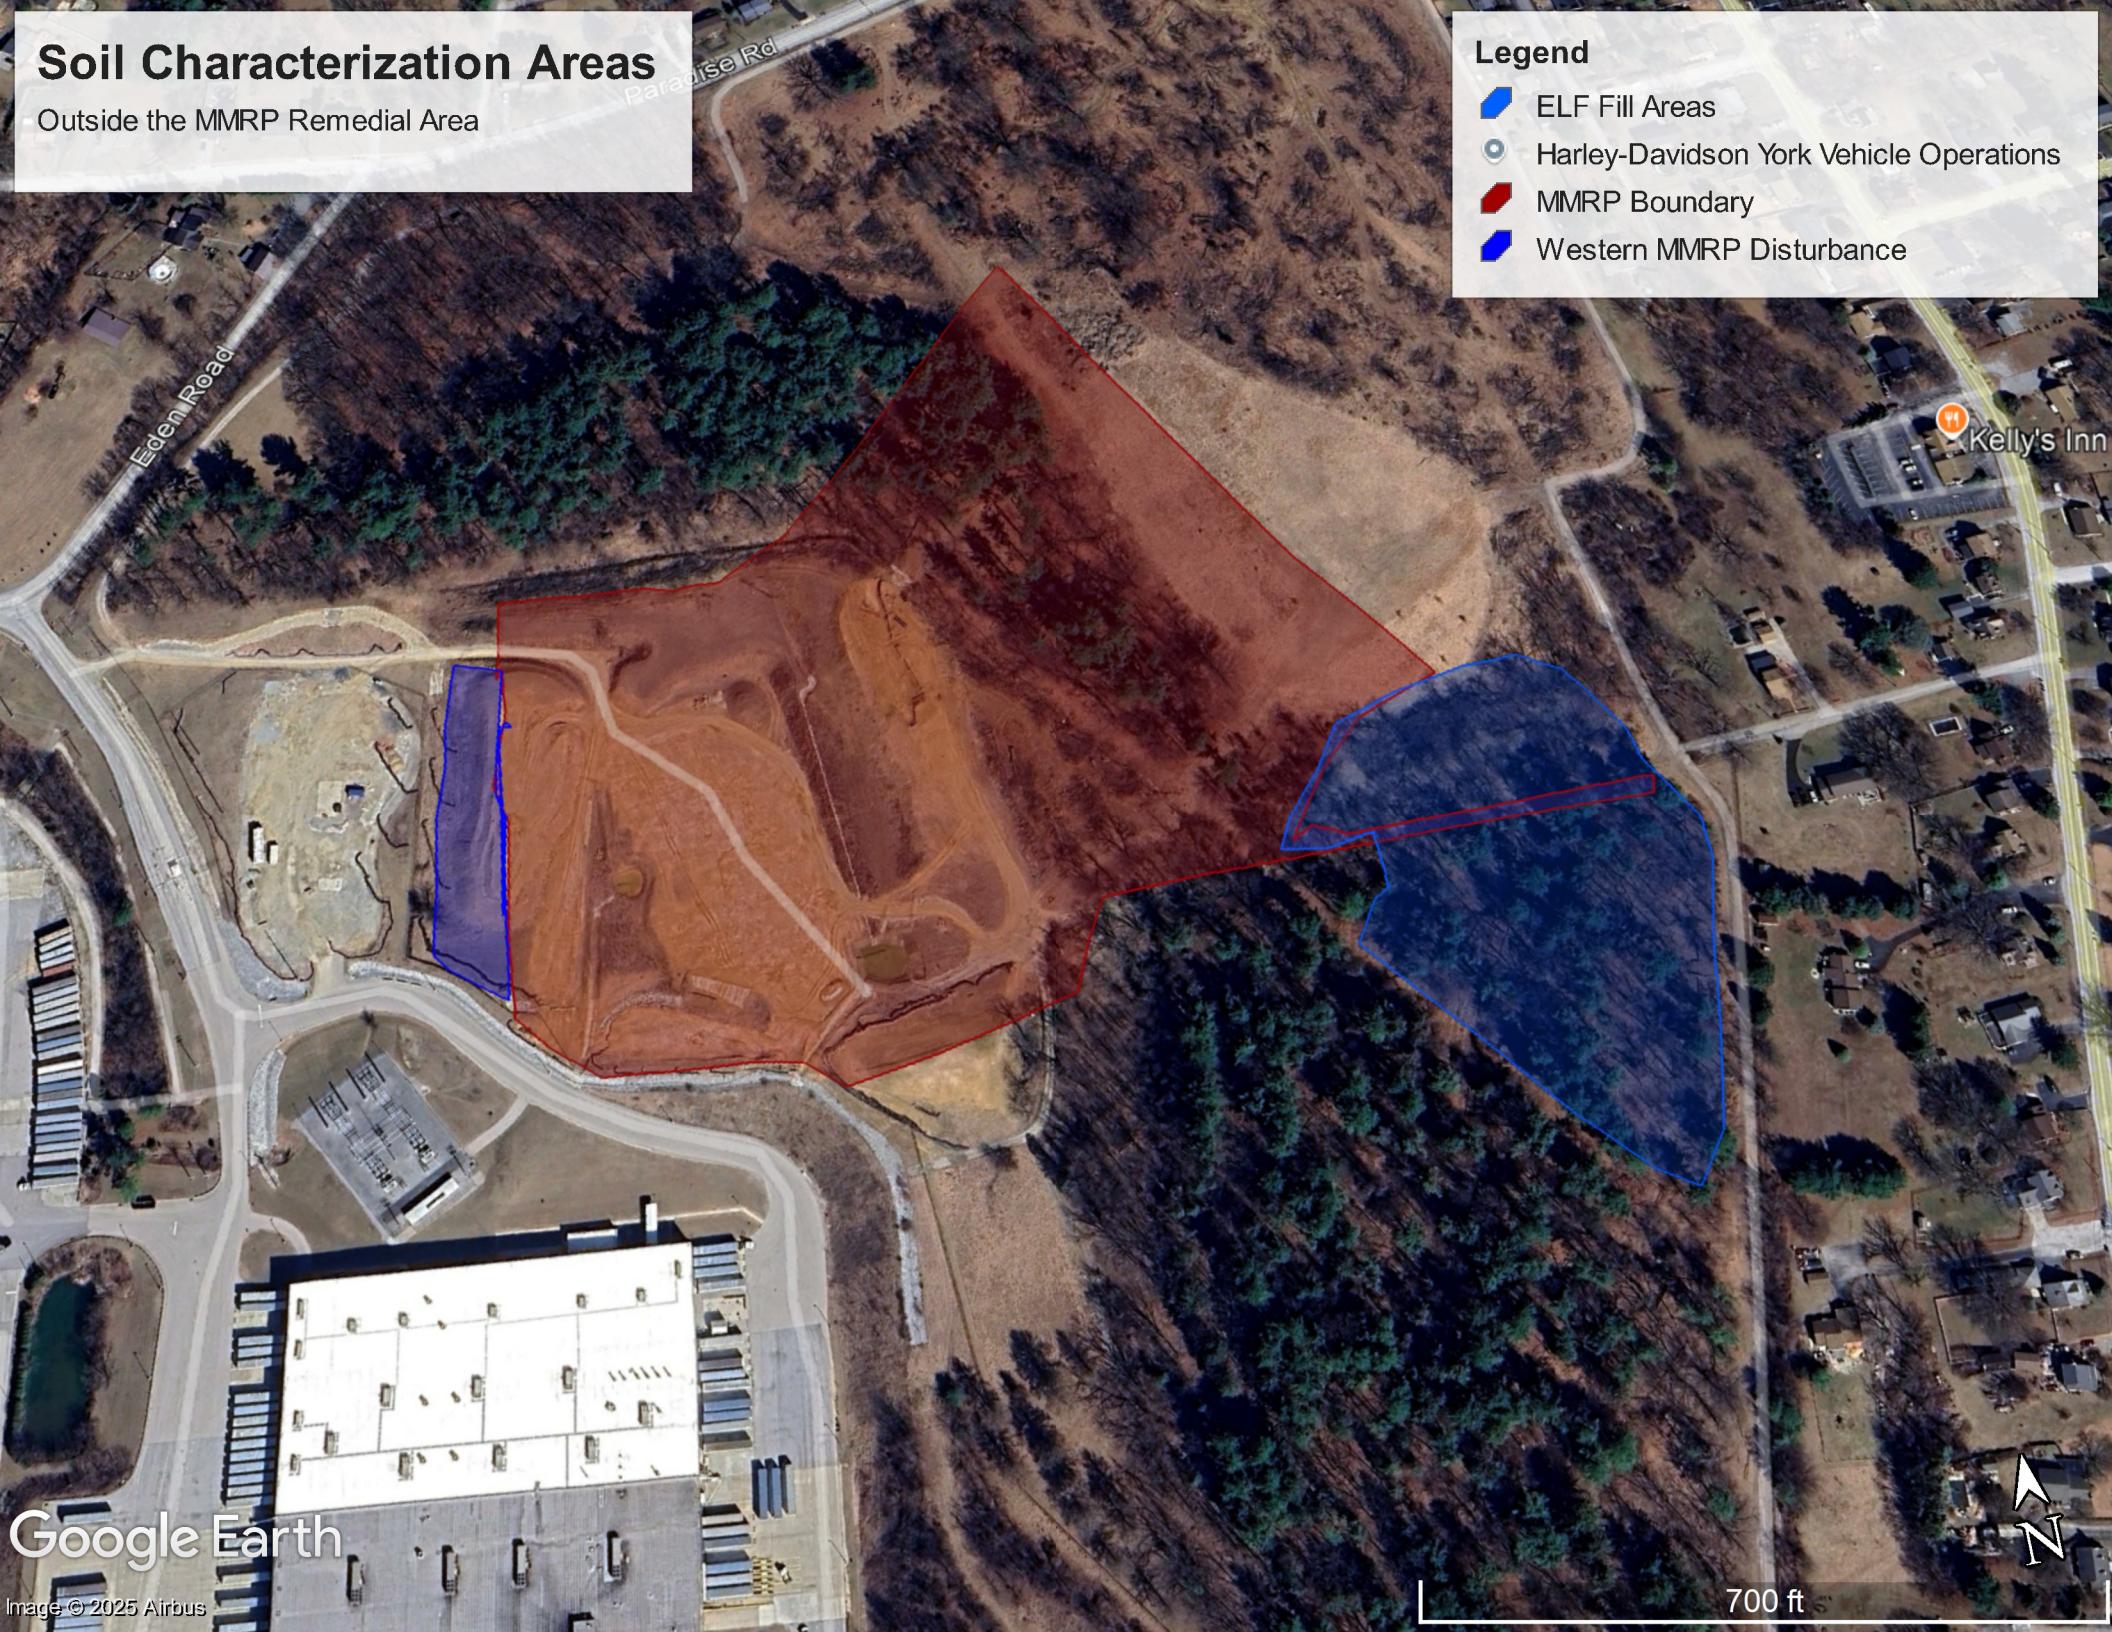
# Soil Characterization Areas

MMRP remediation is ongoing to address the cleanup of residual munitions and explosives of concern, munitions debris, and munitions constituents by EA and their contractor, Clean Harbors Environmental Services, Inc. Disturbances and excavation work is visible within the MMRP area of the site, with three areas extending beyond that border. Additional areas of fill were created around the Eastern Landfill Area of LUA 2 in late 2025 as part of this project.
