**FORM A**  
**MONITORING AND MAINTANCE OF CAP AREAS FOR fYNOP ANNUAL**  
**POST-REMEDATION CARE PLAN ACTIVITIES**

This form is used to document the results of annual post-remediation care activities for engineering and institutional controls at the Former York Naval Ordnance Plant (fYNOP) in York, Pennsylvania. These activities are to be performed in accordance with the procedures in the approved Pennsylvania Land Recycling and Environmental Remediation Standards Act (Act 2) Final Report and Post-Remediation Care Plan (PRCP) contained in Appendix J of the Final Report.

Former York Naval Ordnance Plant  
1425 & 1445 Eden Road York, PA 17402

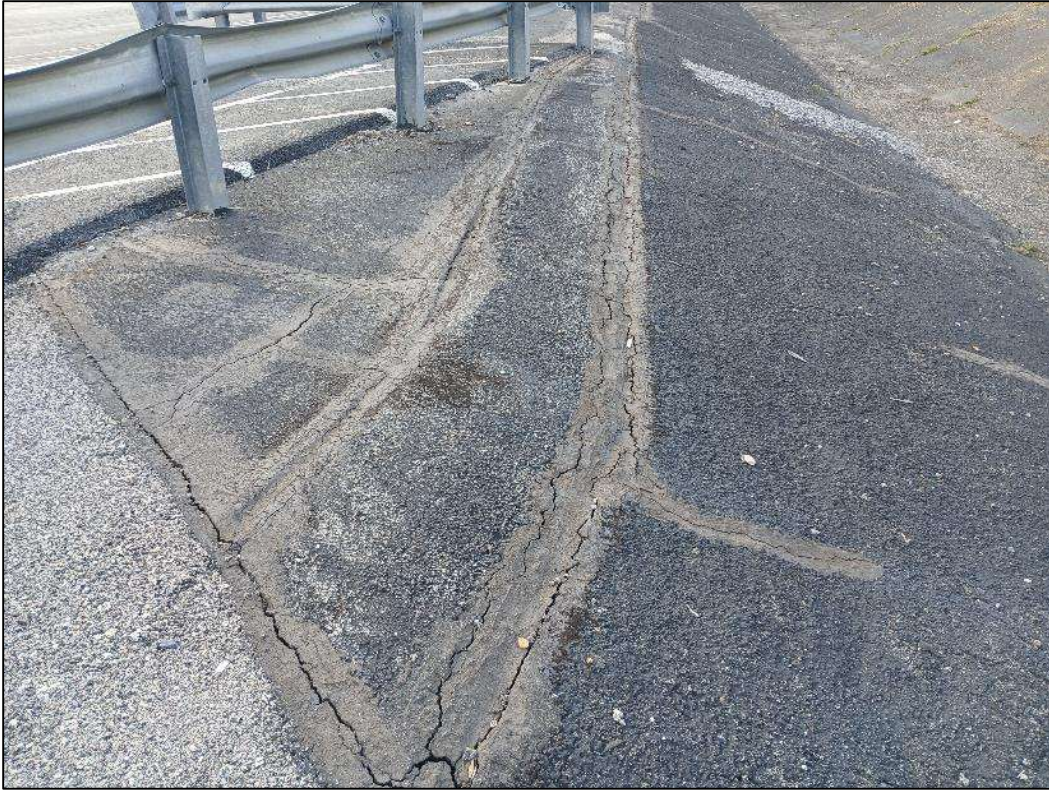
West Parking Lot asphalt paved stormwater swale along Eden Road is monitored for cracks and vegetation growth. Minor cracks were observed along approximately 100 feet of the paved swale during 2025 quarterly inspections and were recommended for repair.

Photo looking south at cracks in the asphalt in the paved swale.

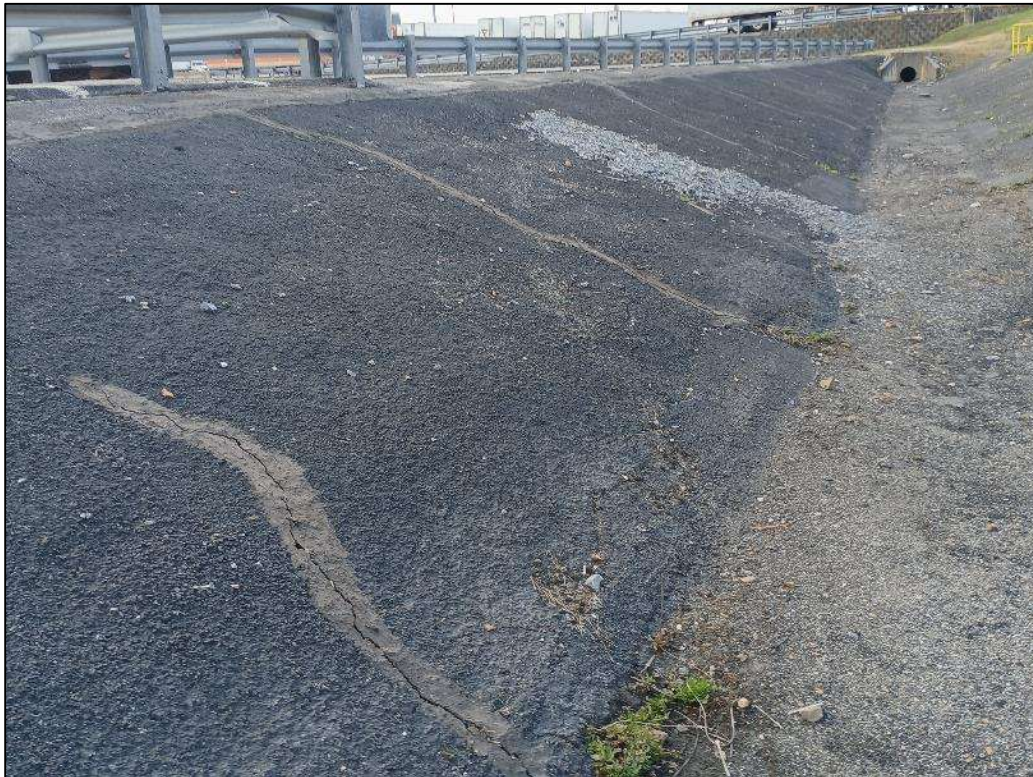
Photo looking south at cracks in the asphalt in the paved swale.

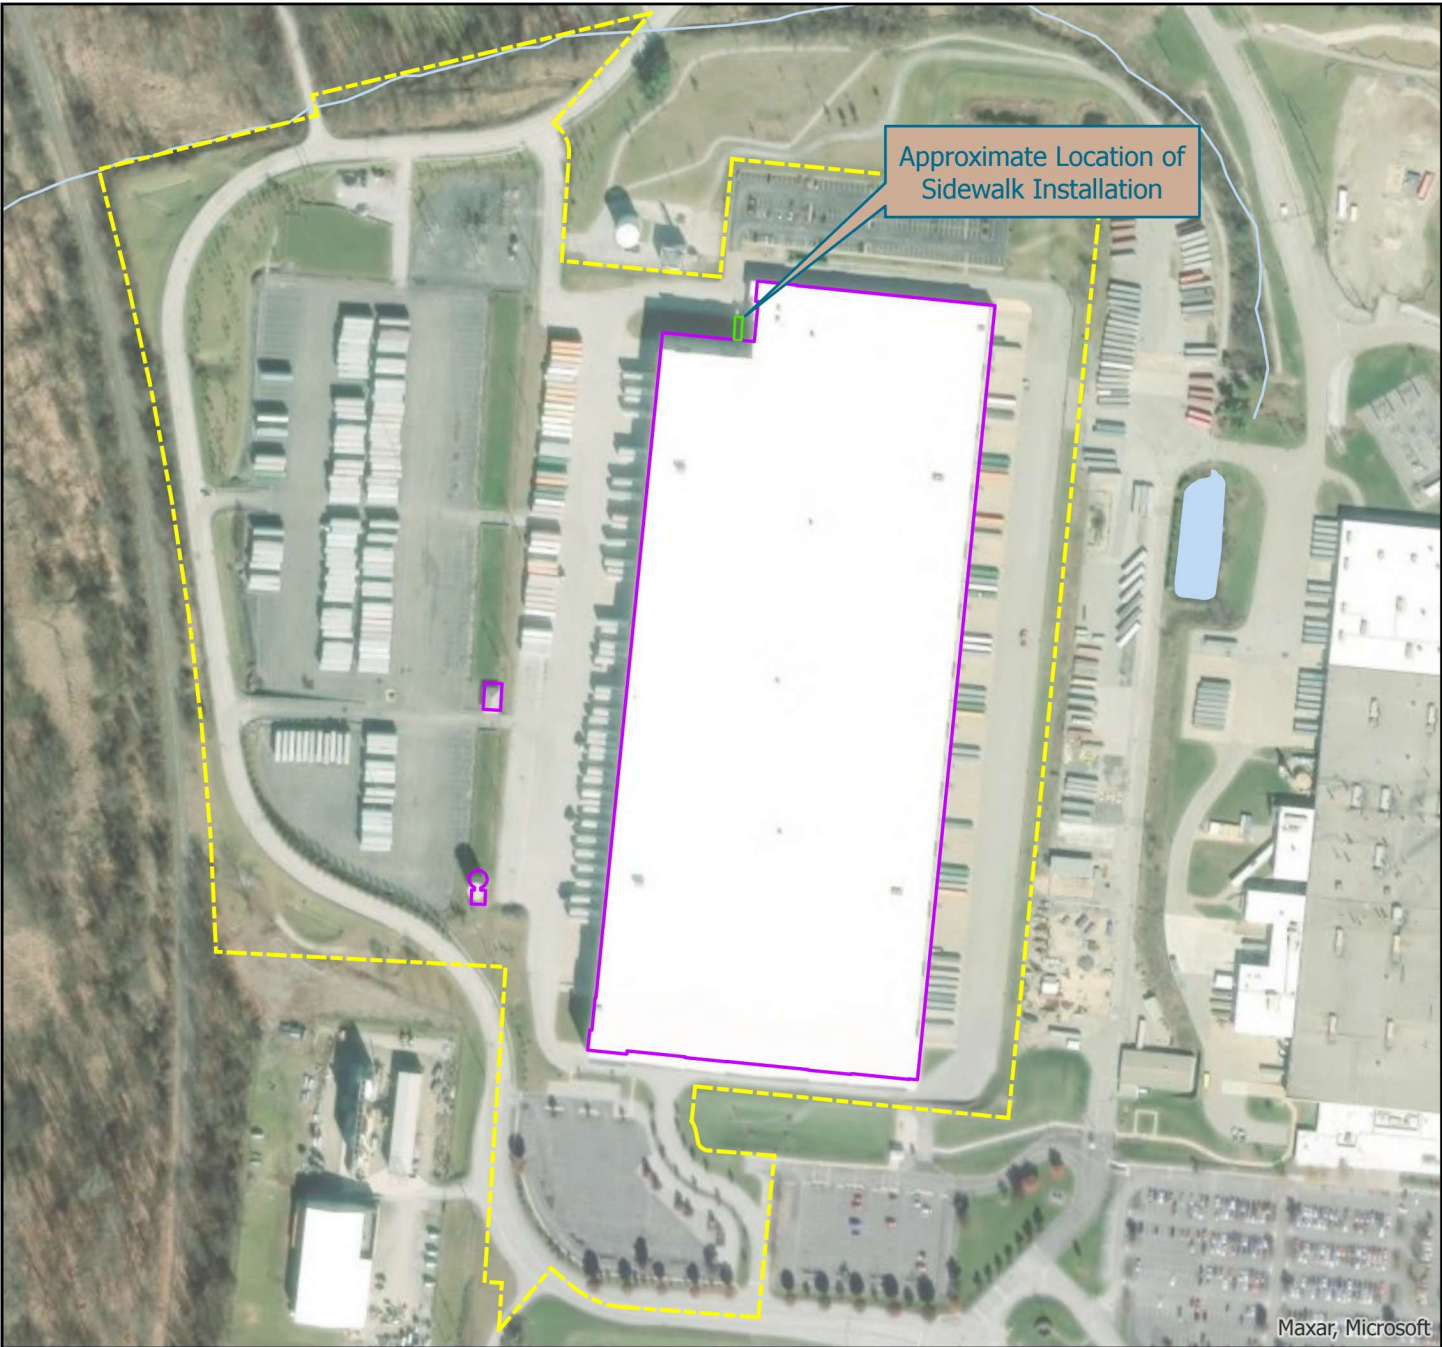
Sidewalk Installation Location

1- New pedestrian sidewalk was installed within existing soil cap area along the northwest corner of the warehouse in June 2025. The new sidewalk measured 4' by 40', and was constructed with 4" of stone subbase and 4" of concrete following removal of 8" of soil; and

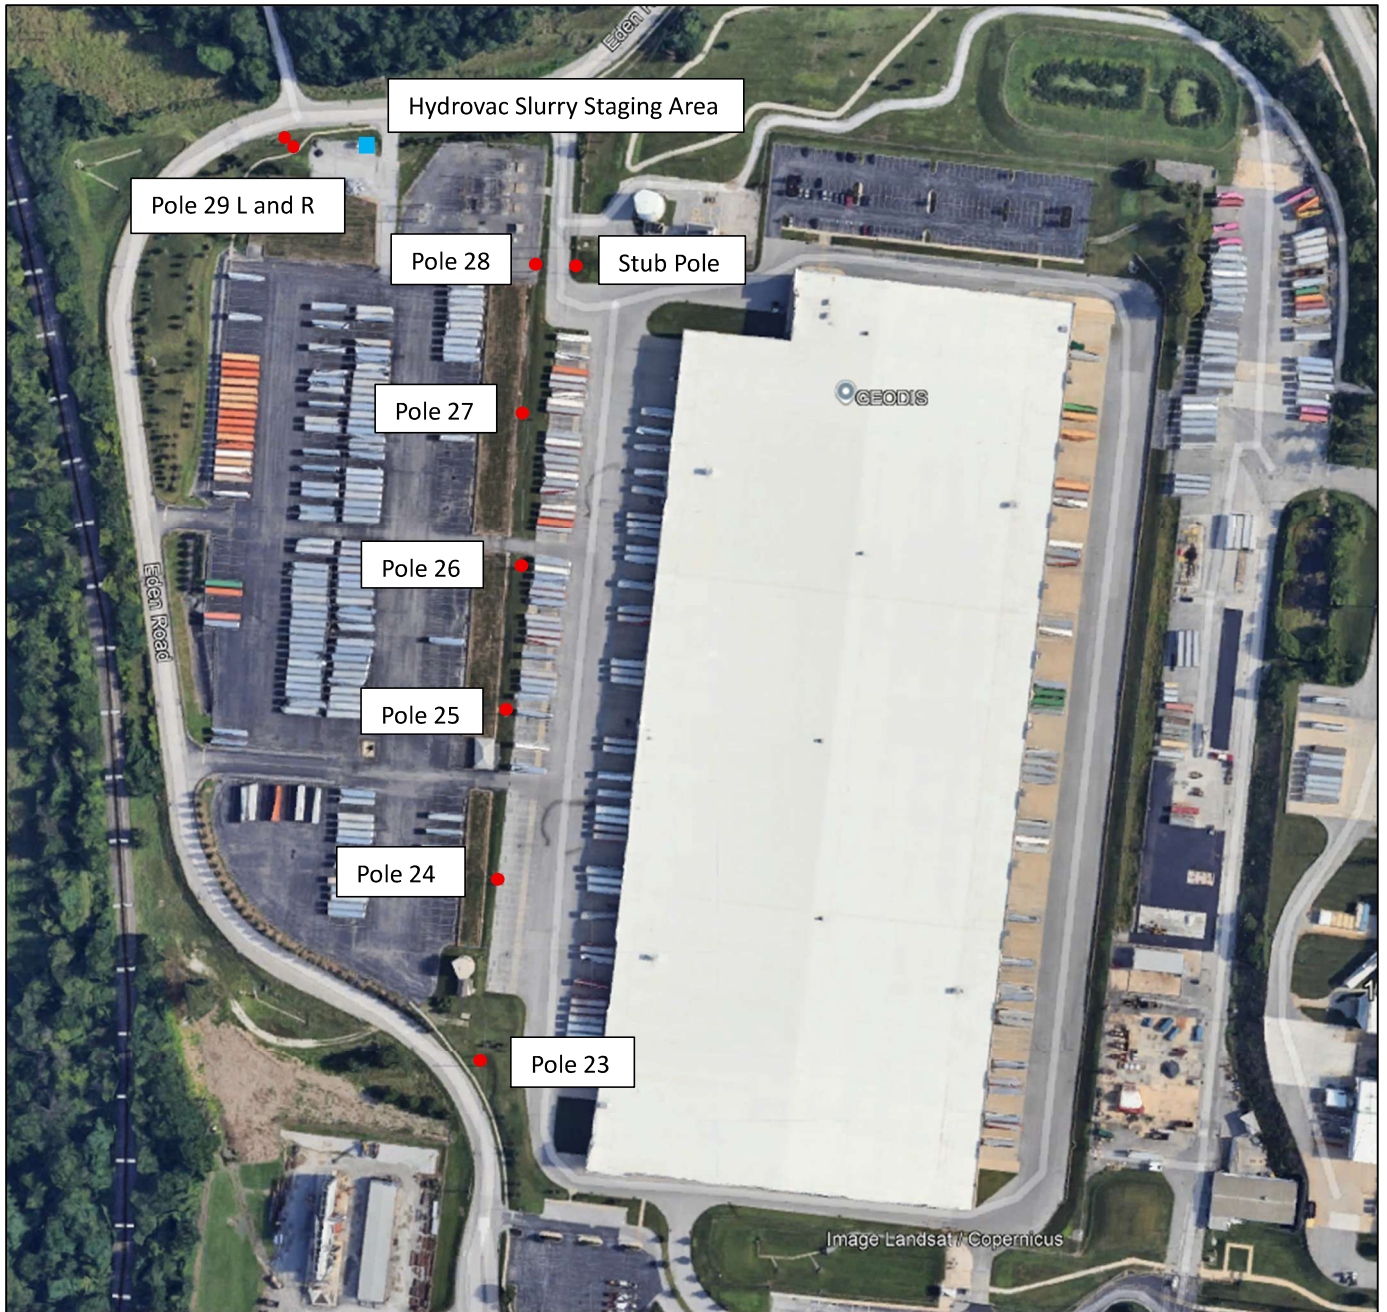
**Figure 2 – Utility Pole Installation Location Map, NP York 58, LLC facility, York PA**

2- Met-Ed updated their electrical infrastructure across the site which entailed removing and replacing nine (9) electrical poles in September and October 2025. New poles were placed next to the existing ones within soil cap areas across the West Parking Lot. Thirty-six inch (36") diameter holes were created for each new pole, and each hole was filled with a new wooden pole, gravel and compacted soil that was removed. The old pole location was cut flush, or removed and filled with compacted soil that was removed for the new pole.

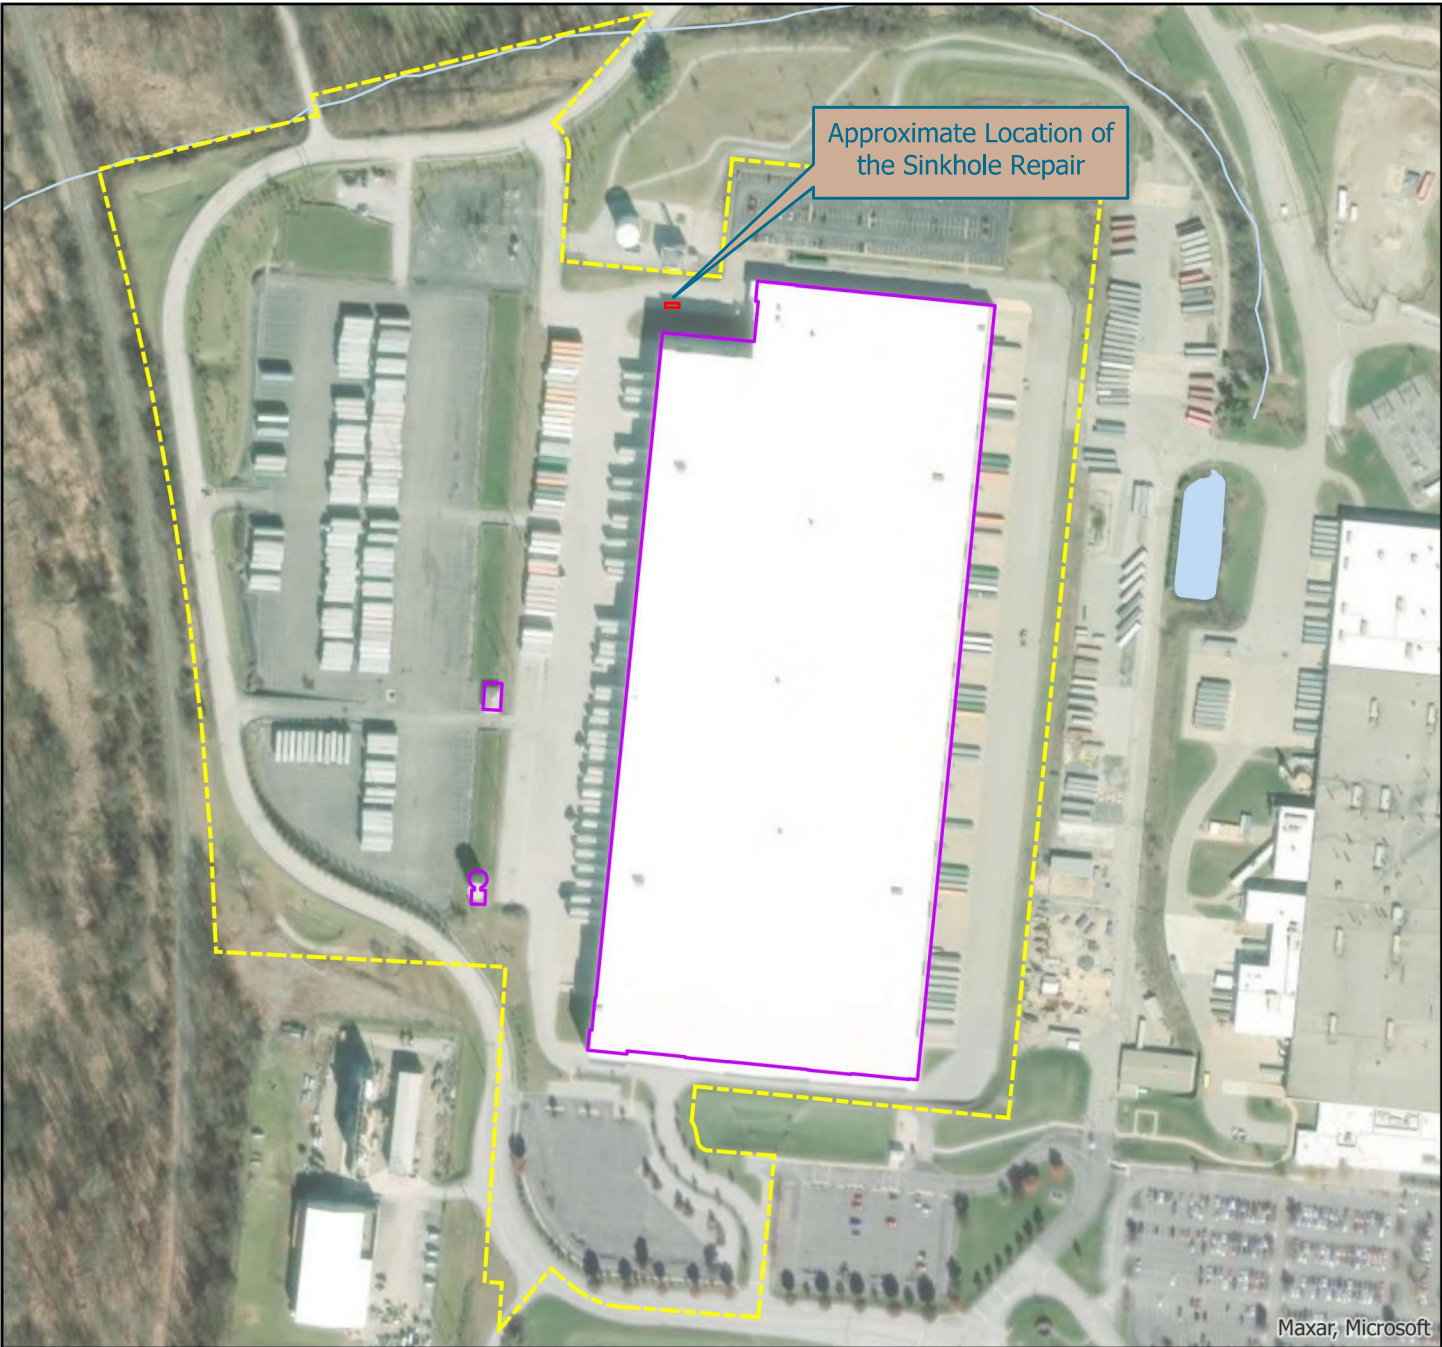
| | Sinkhole Repair Location | |

3- Repairs to asphalt following small sinkhole repair: A small sinkhole was repaired within the asphalt roadway along the north side of the warehouse in August 2025. Following repair of the sinkhole, a 21" by 29" cut-out patch was replaced over the repair area with new asphalt (same thickness).
