**FORM B**  
**WEST CAMPUS WAREHOUSE VAPOR BARRIER ASSESSMENT FOR fYNOP**  
**ANNUAL POST-REMEDATION CARE PLAN ACTIVITIES**

The activity covered by this form includes verifying the integrity of the engineering control (vapor barrier) beneath the Eden Road Logistics Center (ERLC) warehouse building on the West Campus property in accordance with Section 4.3.2 in the PRCP. This form also documents maintenance of the vapor barrier, if performed, in accordance with Section 5.2 in the PRCP.

Date of assessment: 3/28/2025

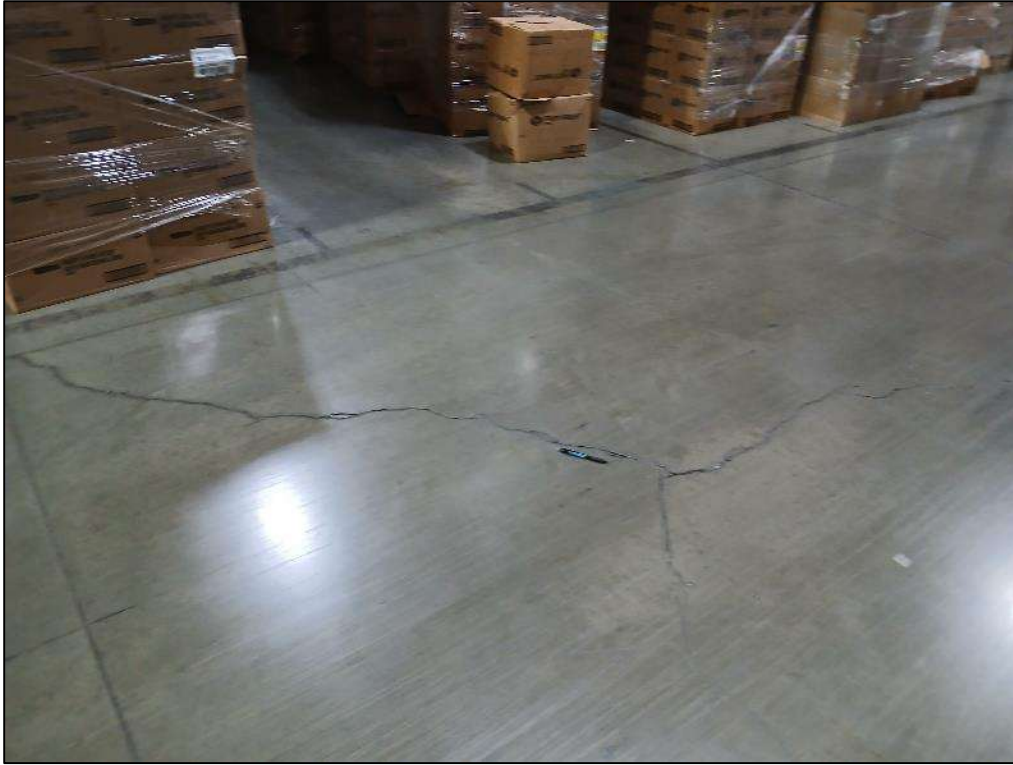
Photo 1: Photo of cracks in the concrete near location G227.

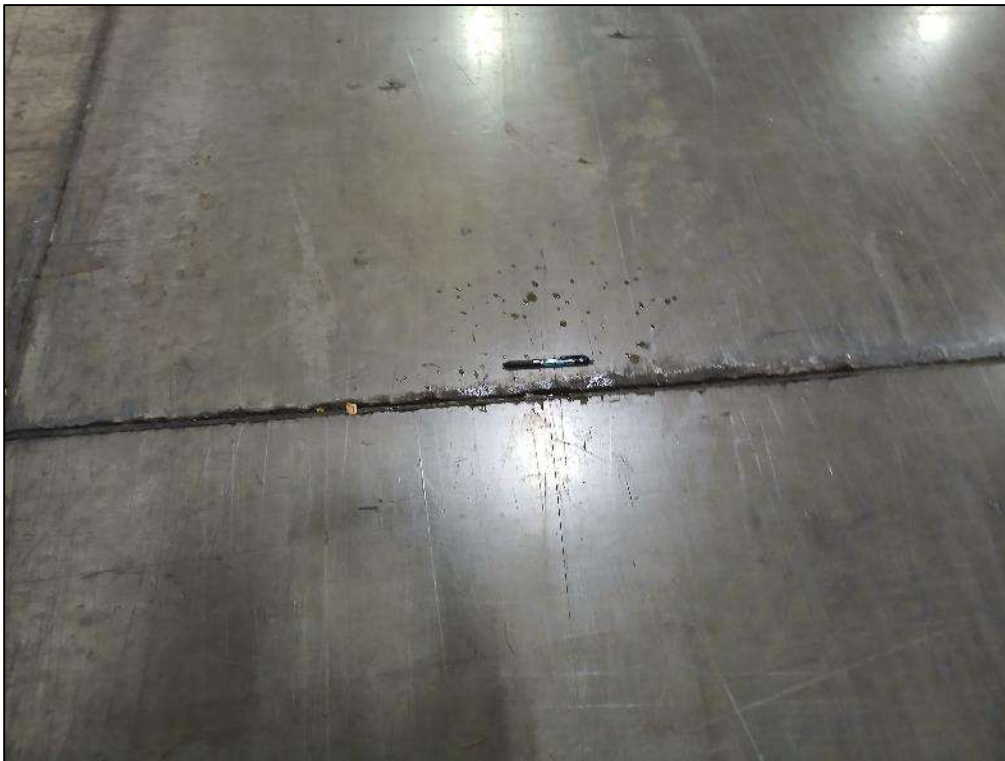
Photo 2: Photo of a gap in the caulk along a concrete seam near location A133.

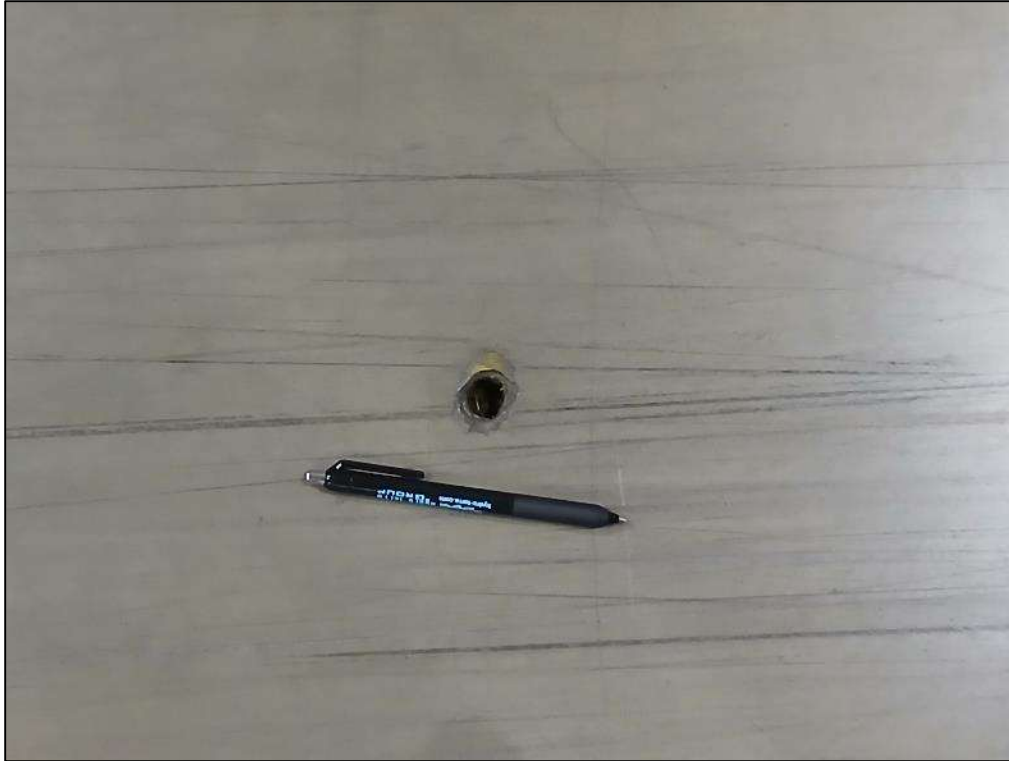
Photo 3: Photo of a small hole in the concrete near AD238.

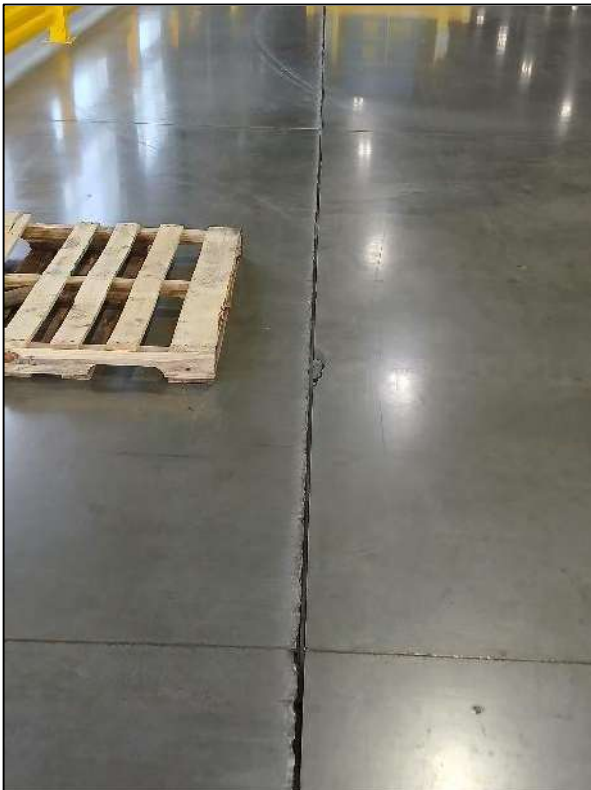
Photo 4: Photo of a gap in caulk along concrete seam in the southwest corner of the warehouse.
