From: Warren, Jeffrey J. [mailto:JEFFREY.J.WARREN@saic.com]
Sent: Monday, July 16, 2012 1:40 PM
To: Jennifer Reese
Cc: Stephen M. Snyder; Alan Miller; Rodney.Myers@harley-davidson.com
Subject: RE: Harley-Davidson - Building 58 GPR

Below is a quick summary of the GPR efforts conducted at Building 58 on Friday. No information was known about the approximate location or size of the suspect pit. Four anomalous areas were identified and ranked in order.

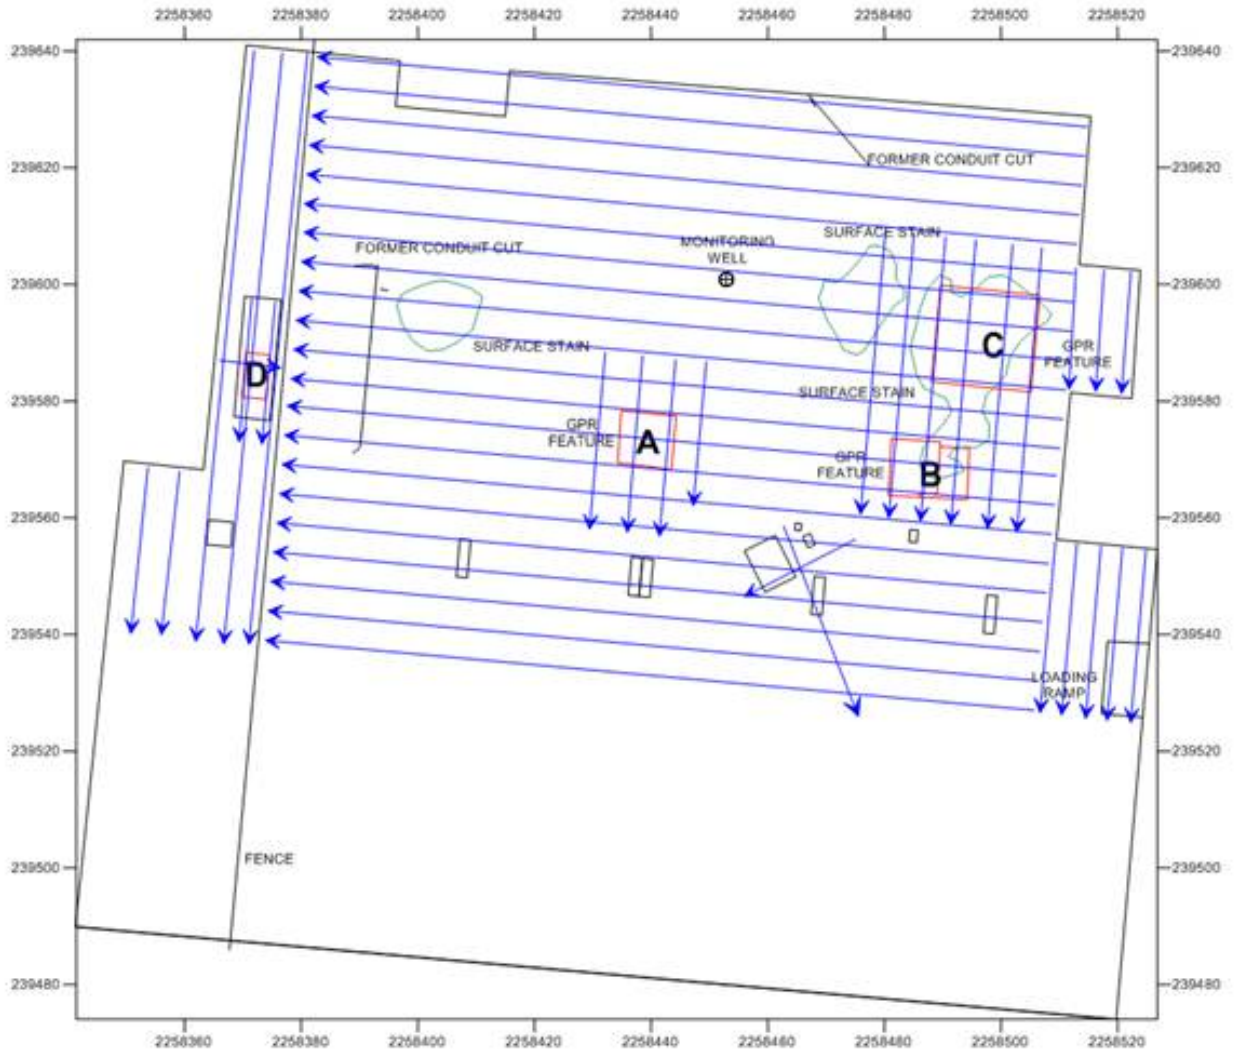
Anomalous Area A

- **Anomalous Area A** Revealed a transitional reinforcement and attenuated GPR signal at depth. Initially, no surface expression was obvious. However, after close inspection, this area appeared to coincide with the limits of minor cracks in the slab
- **Anomalous Area B** Revealed a transitional reinforcement and attenuated GPR signal at depth. This area also coincided with newer concrete slab.
- **Anomalous Area C** Revealed a transitional reinforcement and attenuated GPR signal at depth. This area also coincided with newer concrete slab.
- **Anomalous Area D** Revealed a high amplitude reflection at depth. This feature may be a result of a utility or other historic subsurface structure.
