MEMORANDUM

To: File - Harley-Davidson Motor Company Operations, Inc. (Harley-Davidson)
York Facility Remediation Trust Fund

Re: Demolition of the Thermal Fume Oxidizer (TFO), Groundwater Treatment System

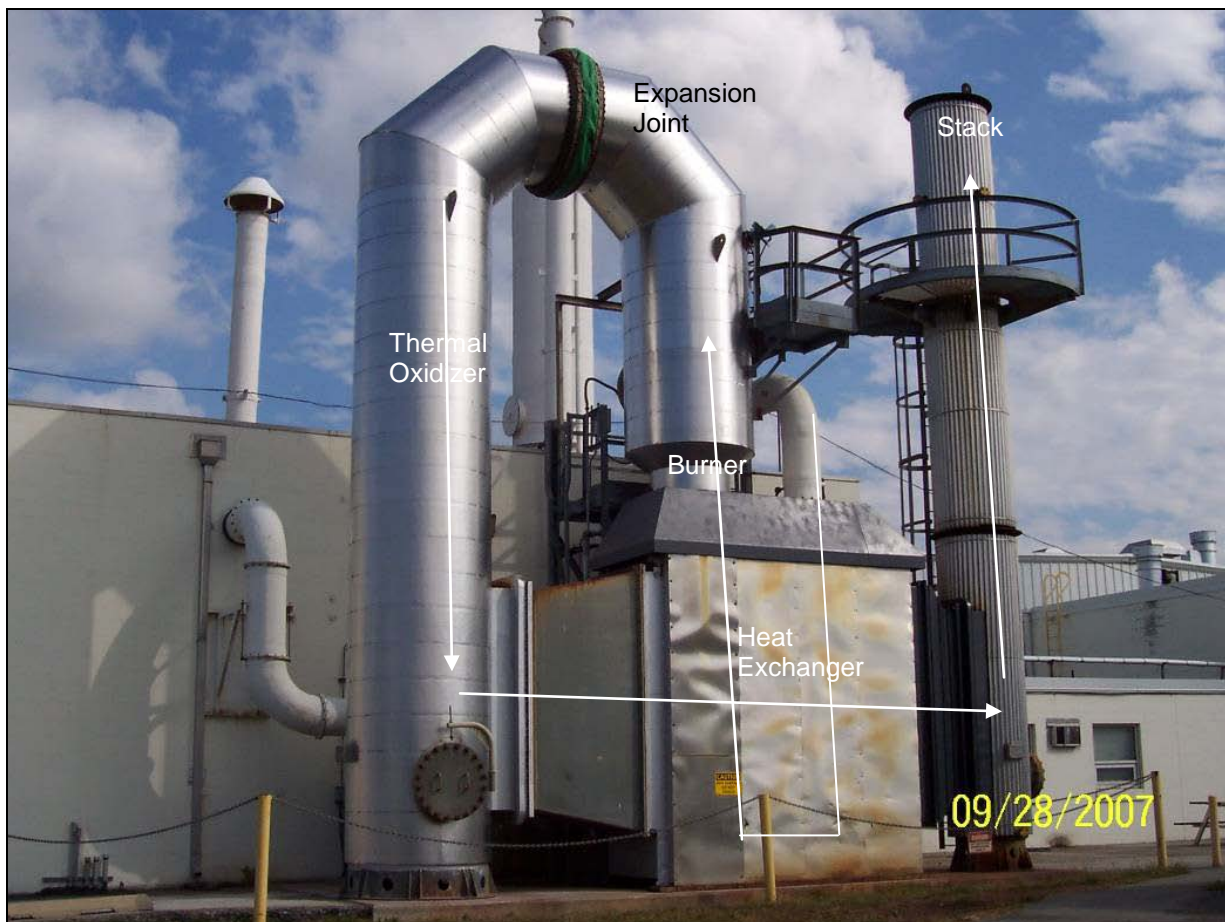
Figure 1. Photo of Thermal Fume Oxidizer before demolition (arrows show direction of off-gas flow).

Abandonment and removal/salvage of the TFO (and associated Lower Flammability Limit (LFL) monitoring equipment) was recommended, due to deterioration and resultant airflow restriction found in the heat exchanger unit; uncertainty regarding the long term reliability of other TFO components; and the high cost of heat exchanger replacement. The TFO was in operation since 1994 (for over 15 years) and has exceeded its life expectancy. Replacement was not recommended, due to availability of the existing granular-activated carbon (GAC) for off-gas VOC treatment.

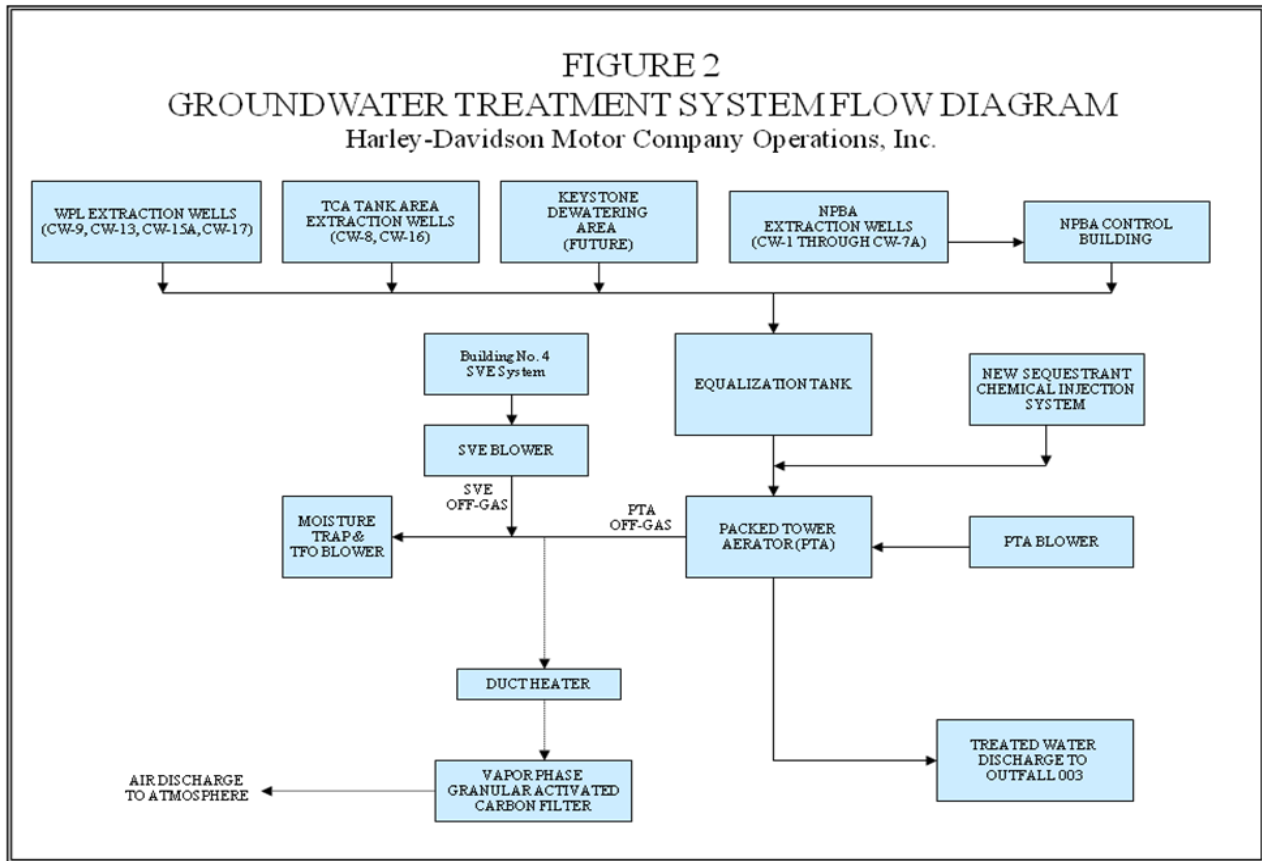
FIGURE 2
GROUNDWATER TREATMENT SYSTEM FLOW DIAGRAM
 Harley-Davidson Motor Company Operations, Inc.

All off-gas treatment for the groundwater treatment system (GWTS) is now facilitated solely via the GAC unit for VOC treatment. A chemical sequestering agent injection system was added to address scale buildup on the PTA packing, and should help to eliminate the need for any future acid washing of the PTA. Figure 2 illustrates the current groundwater treatment system flow diagram and schematic.

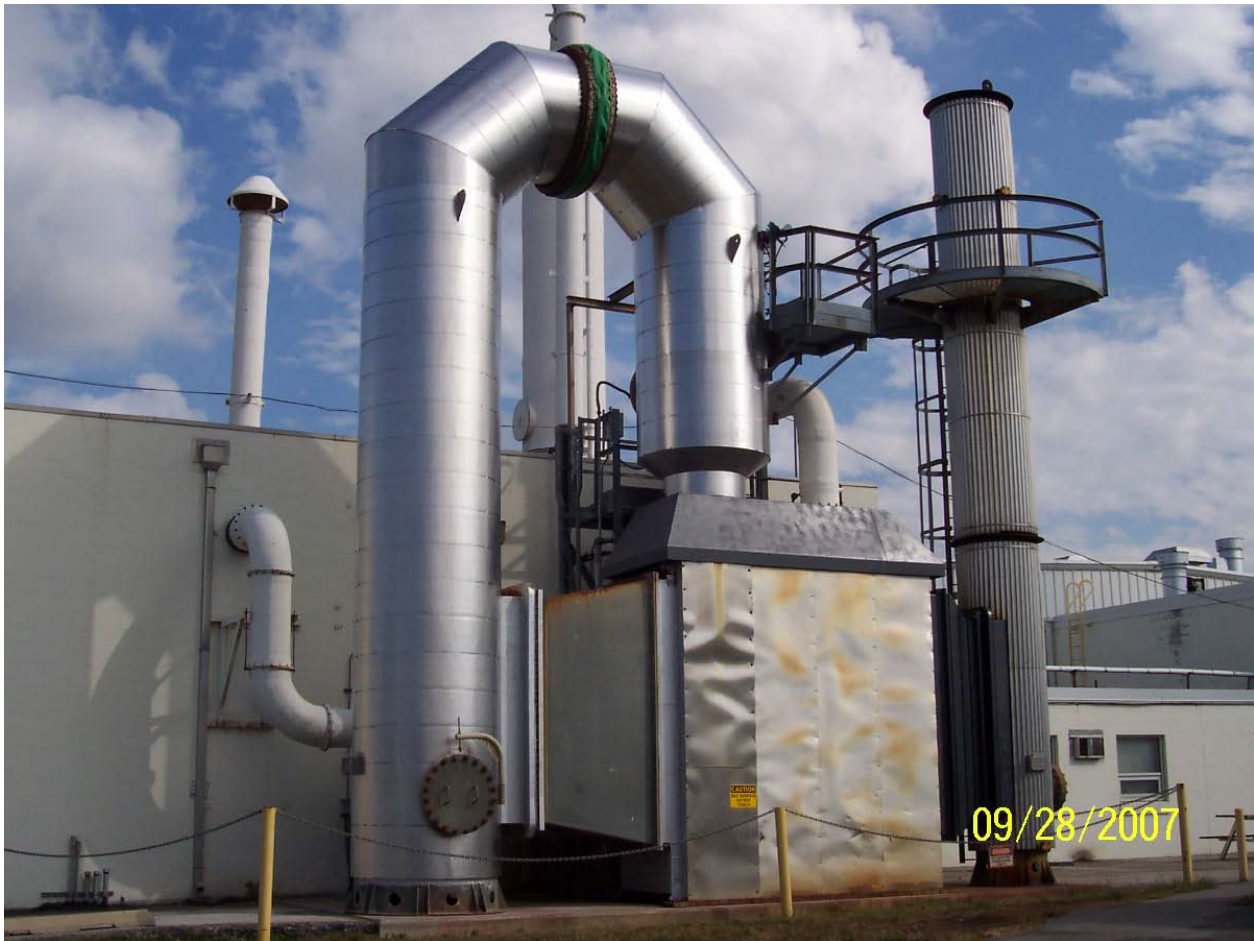
TFO before demolition.

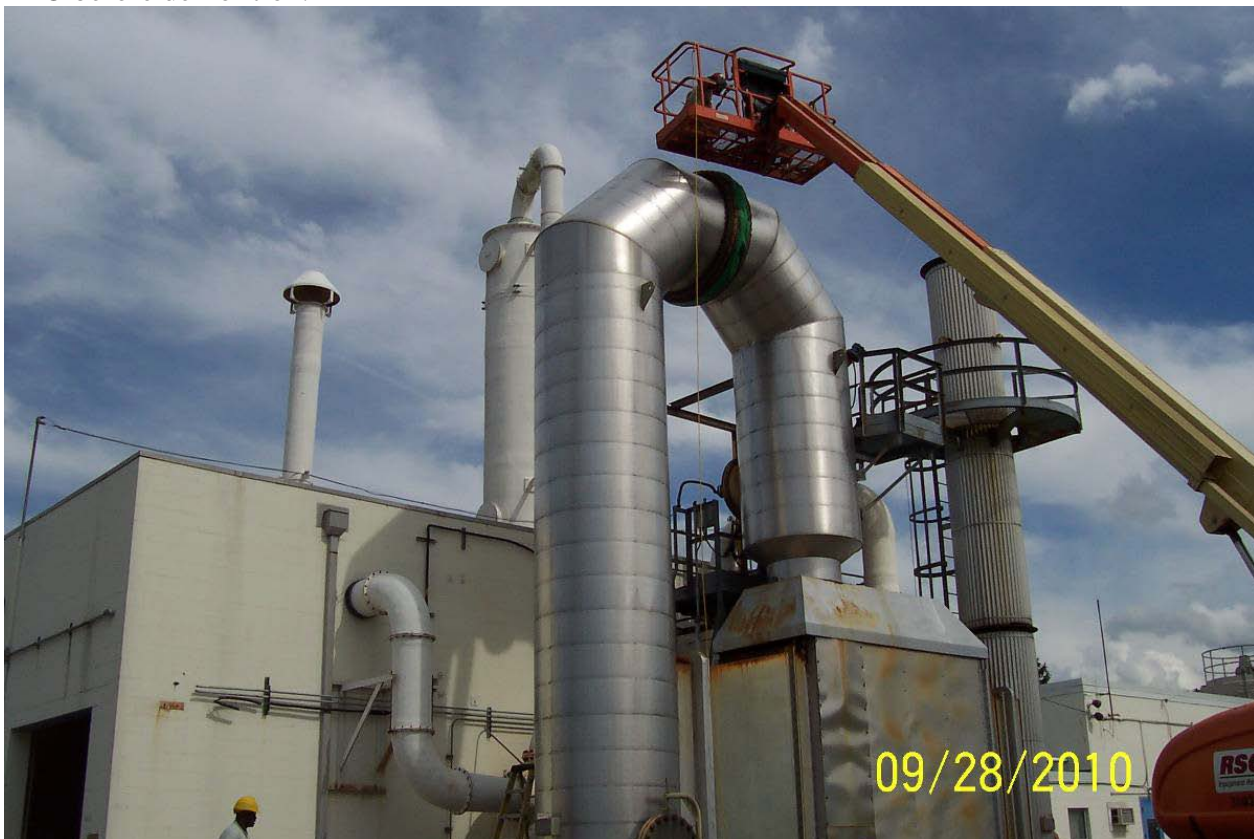
S&T removing the bolts in the flexible joint.

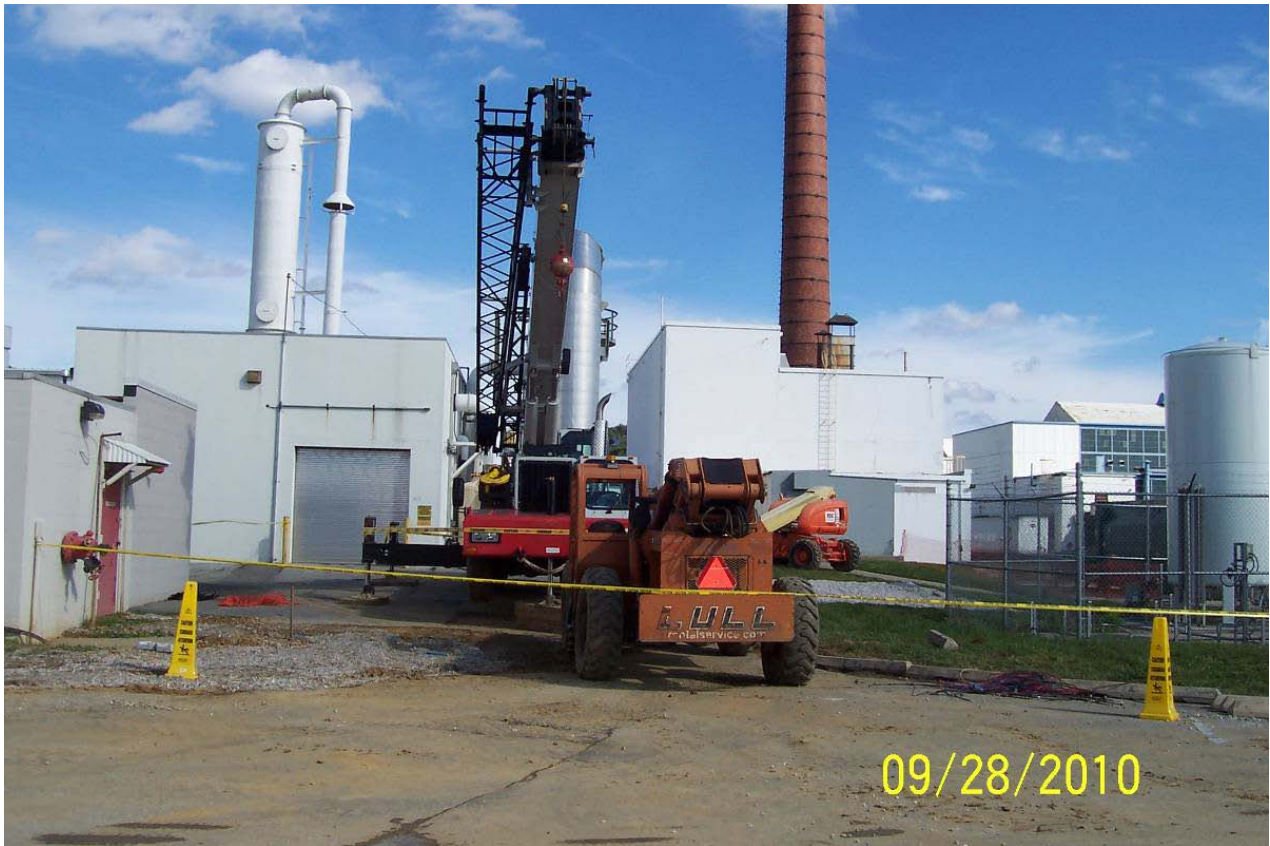
Crane used to lift stacks.

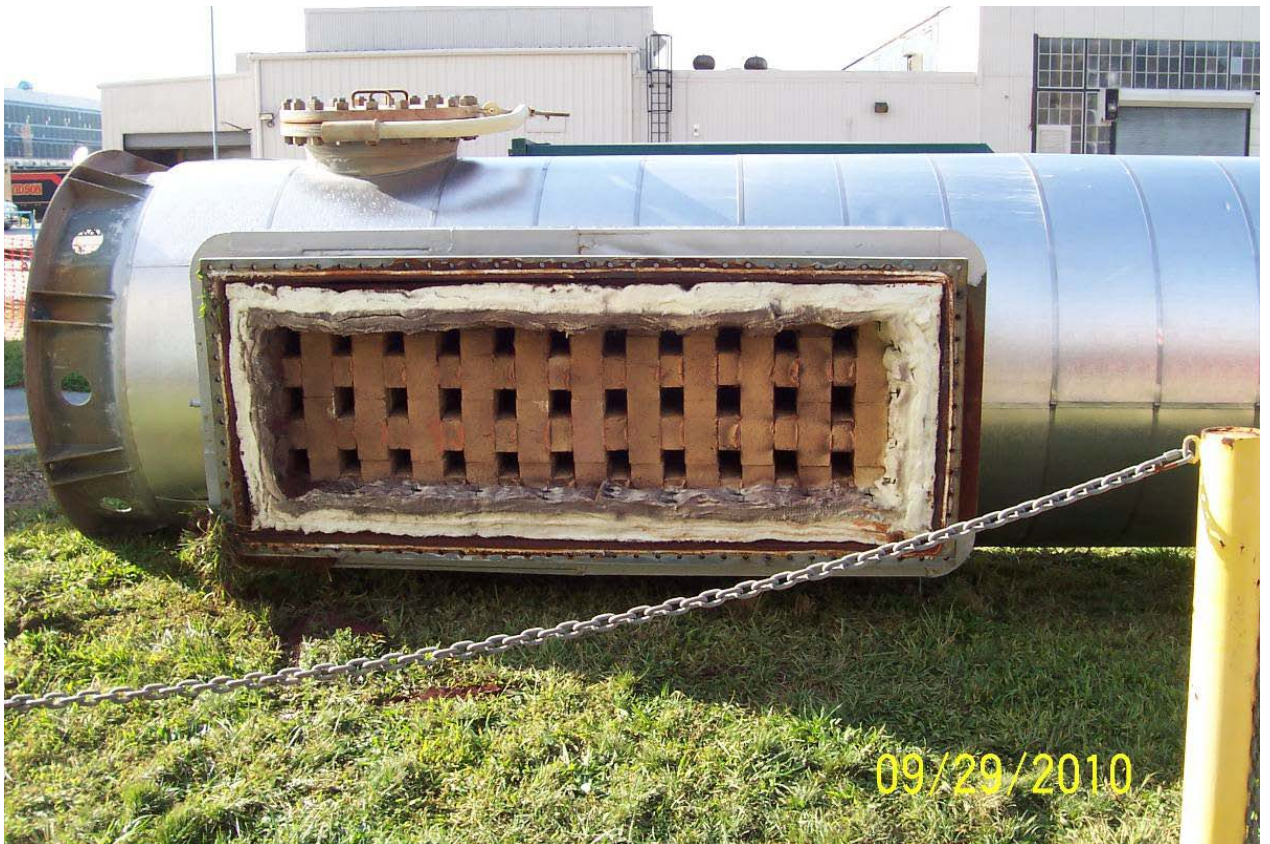
TFO western stack lying on the ground looking at the refractory bricks.

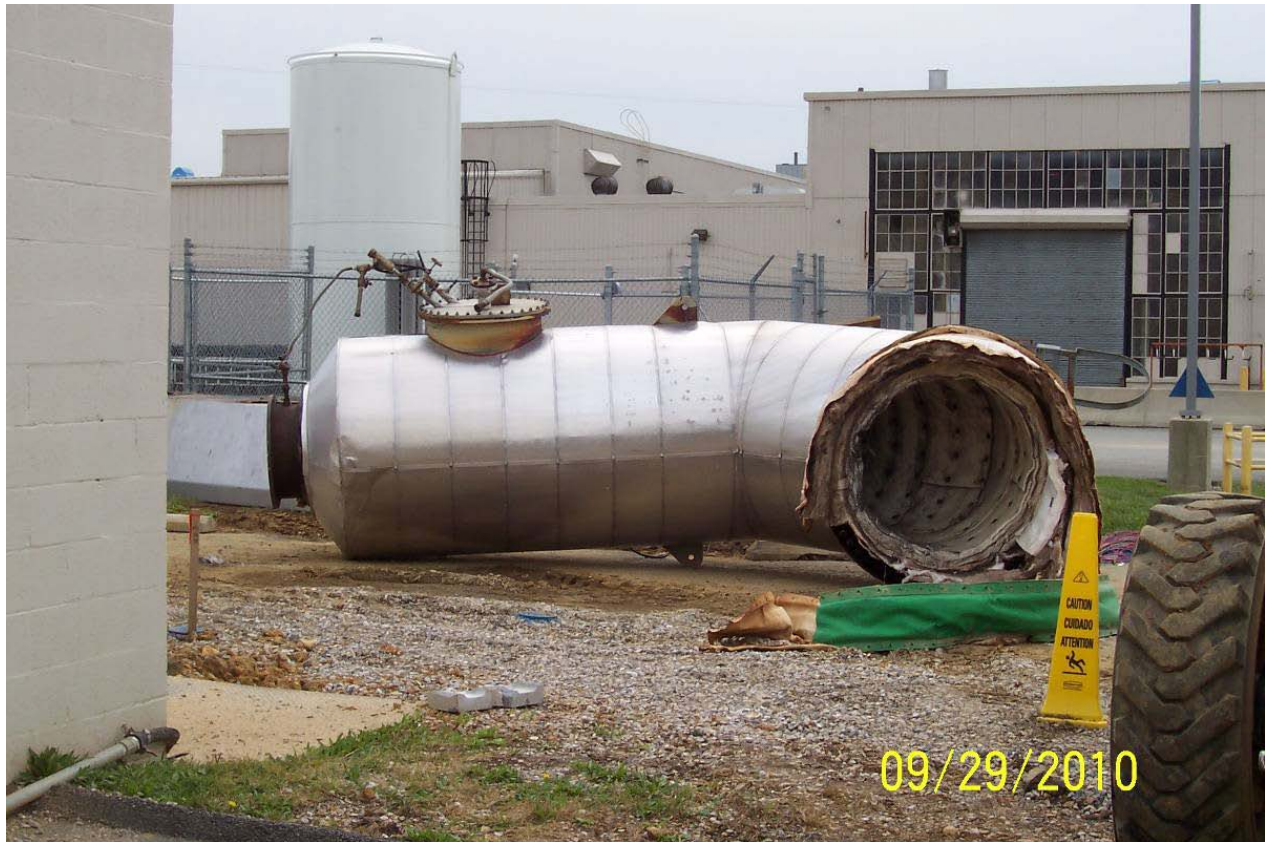
TFO burner on left side of stack and insulation can be seen on the right side of the stack.

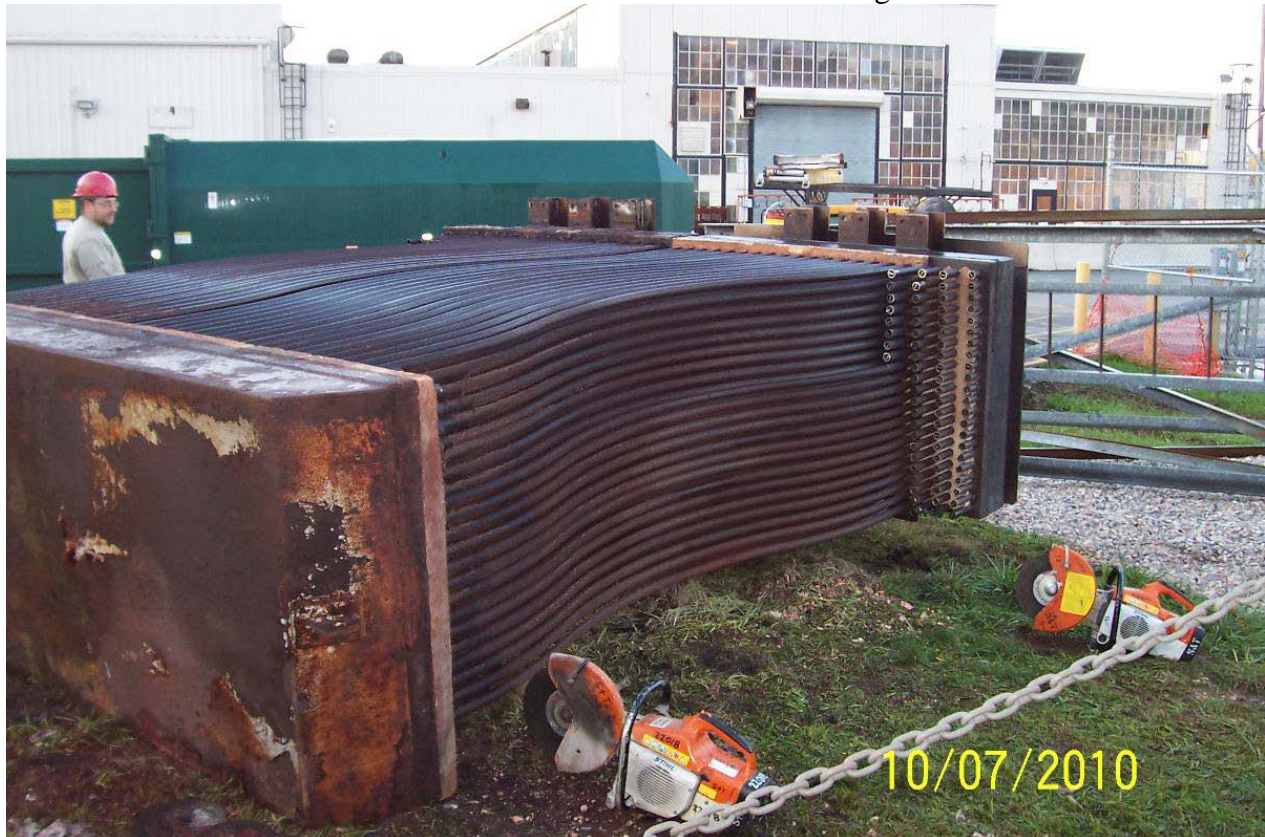
TFO recuperator rods are being removed for scrap. The near side is carbon steel and the far side is stainless steel. These corroded rods restricted air flow through the TFO.

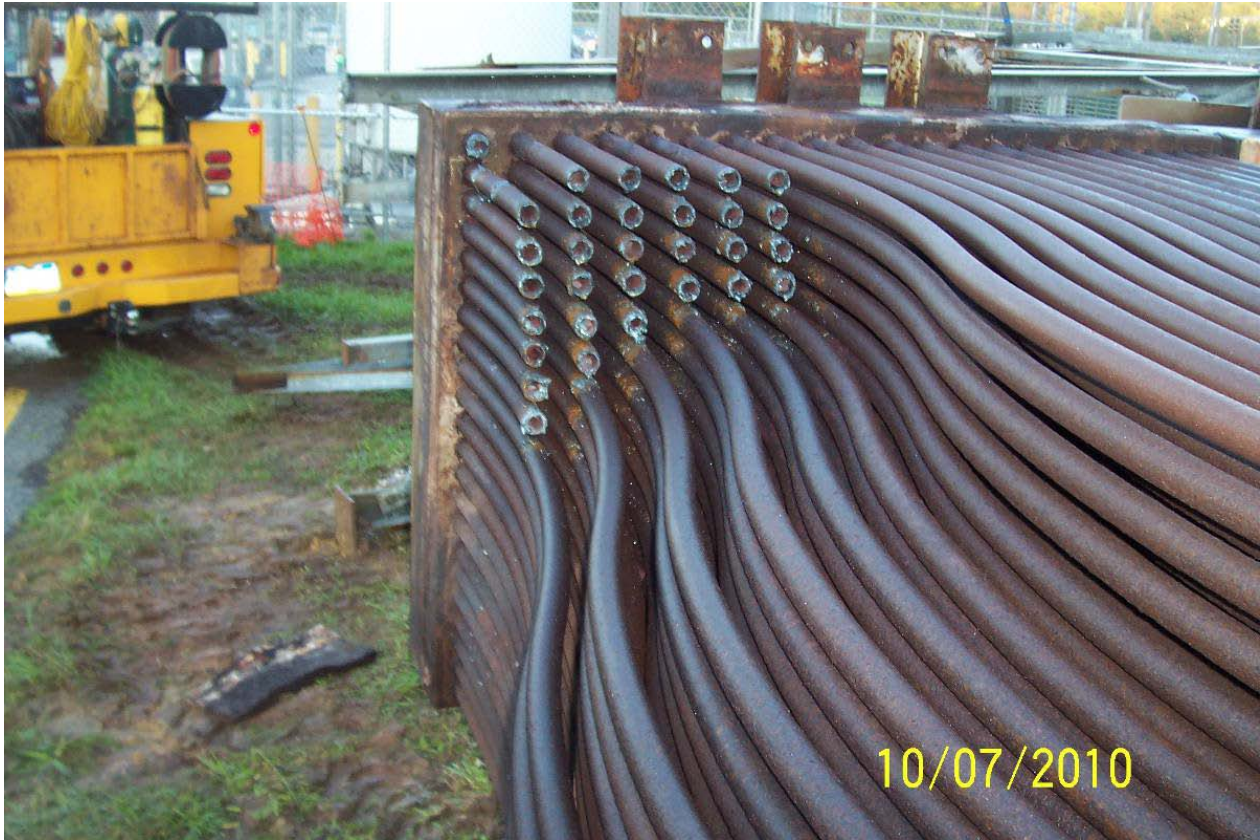
Stainless steel recuperator rods.

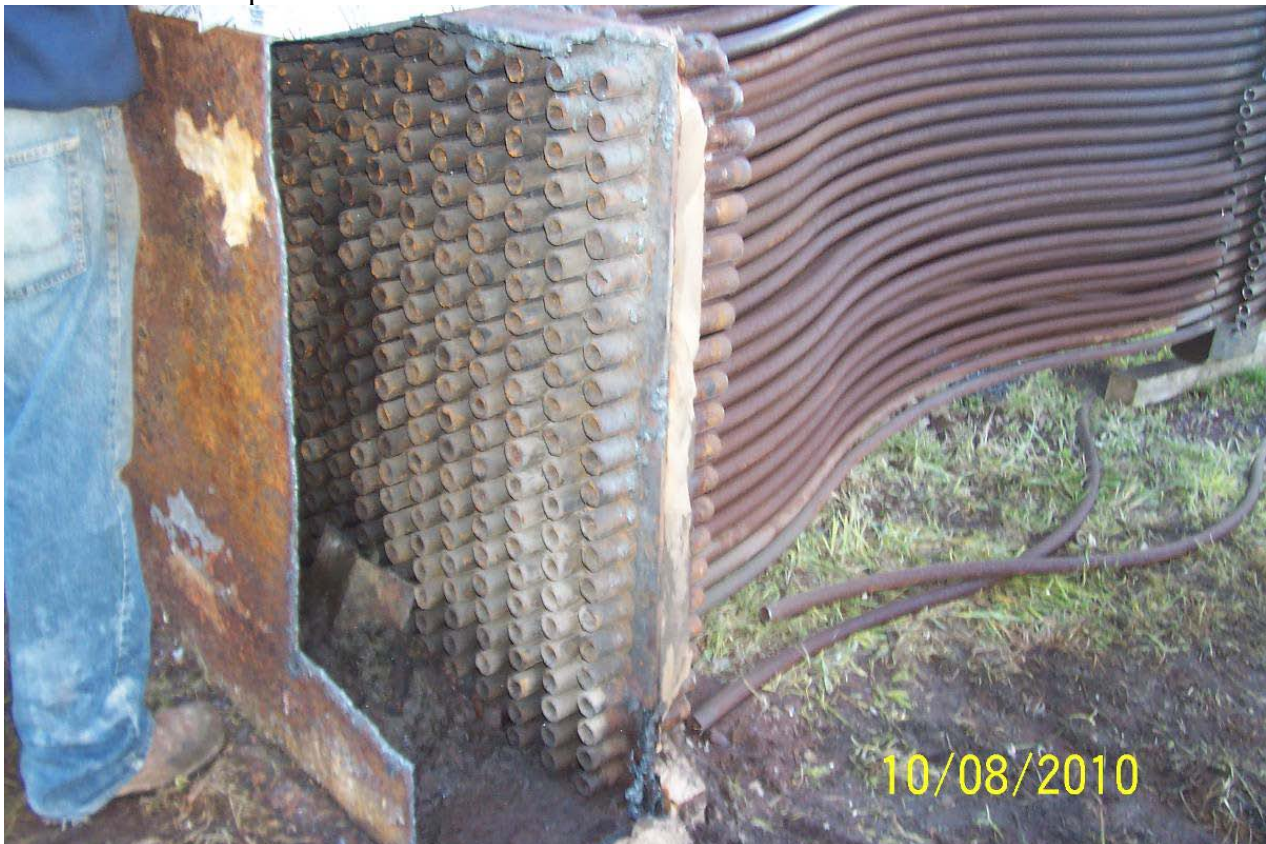
The bottom of the recuperator where the air passed from the carbon steel to the stainless steel rods.

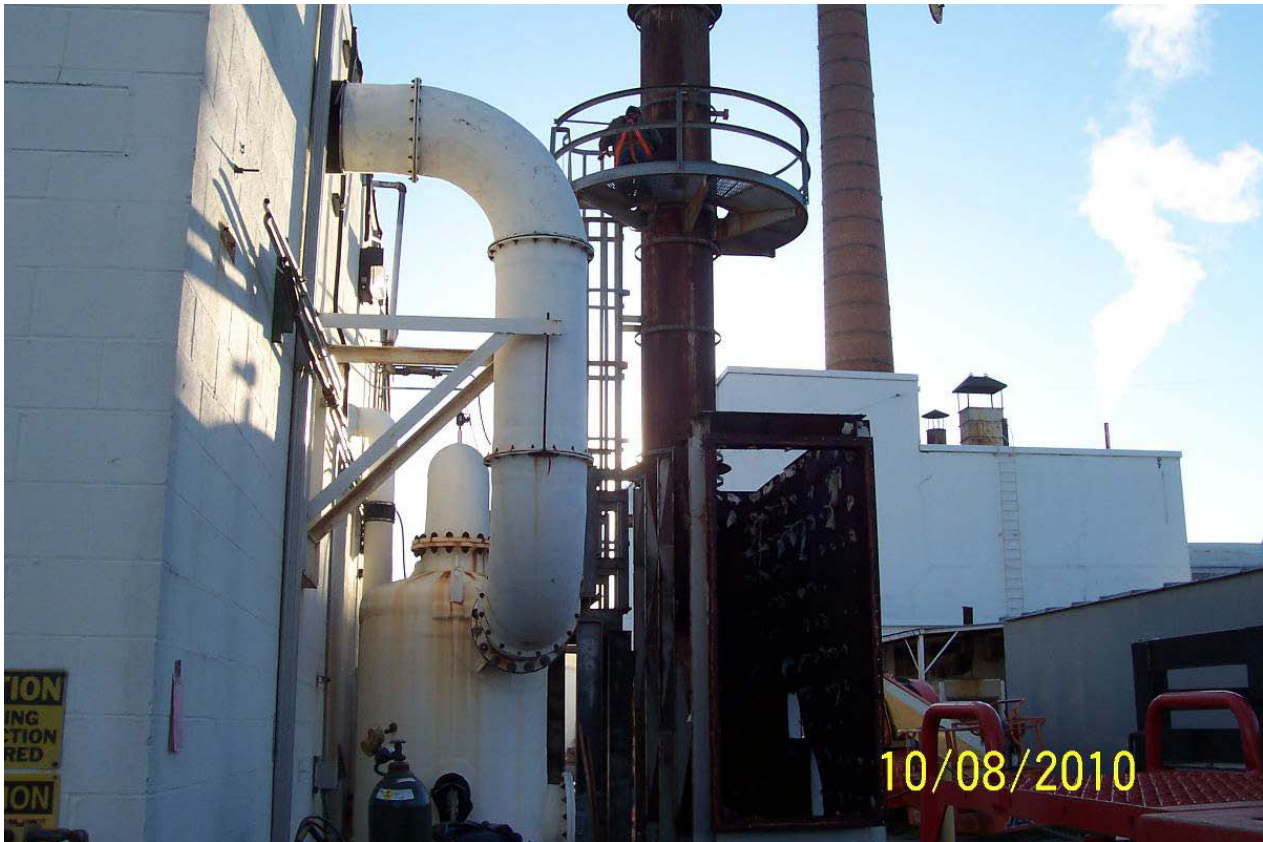
Looking east inside the recuperator once the rods were removed.

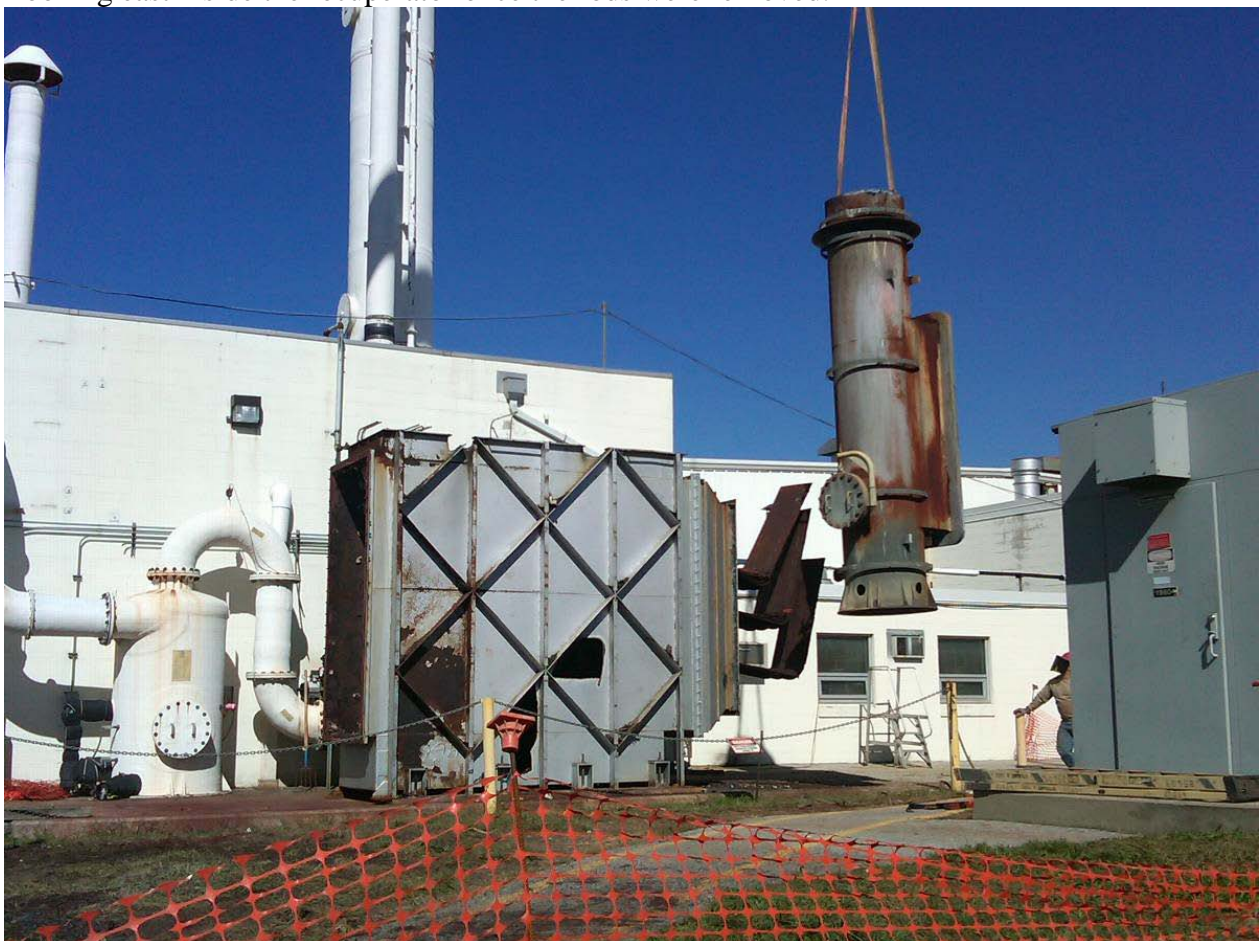
View of the east stack of the TFO (effluent side) being lifted off.

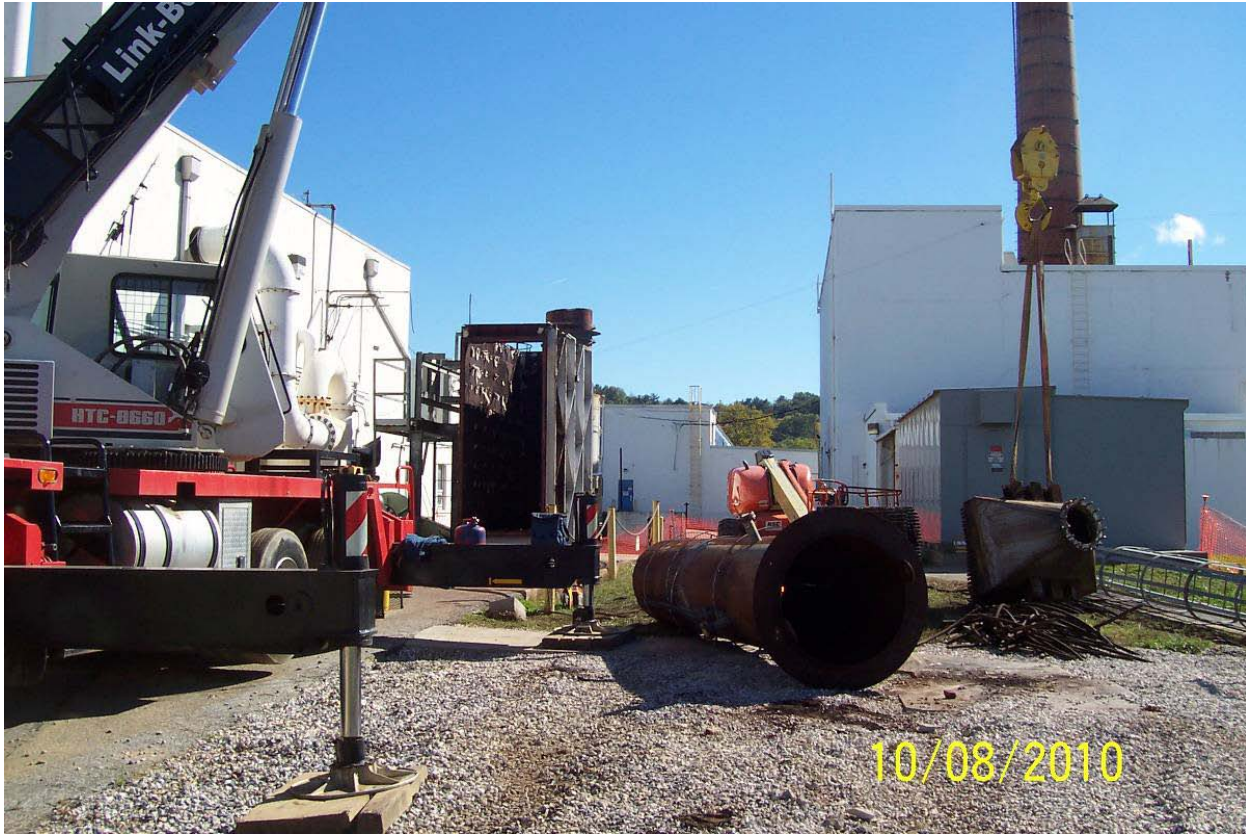
TFO looking east. Both stacks, the recuperator, and the platform was removed.

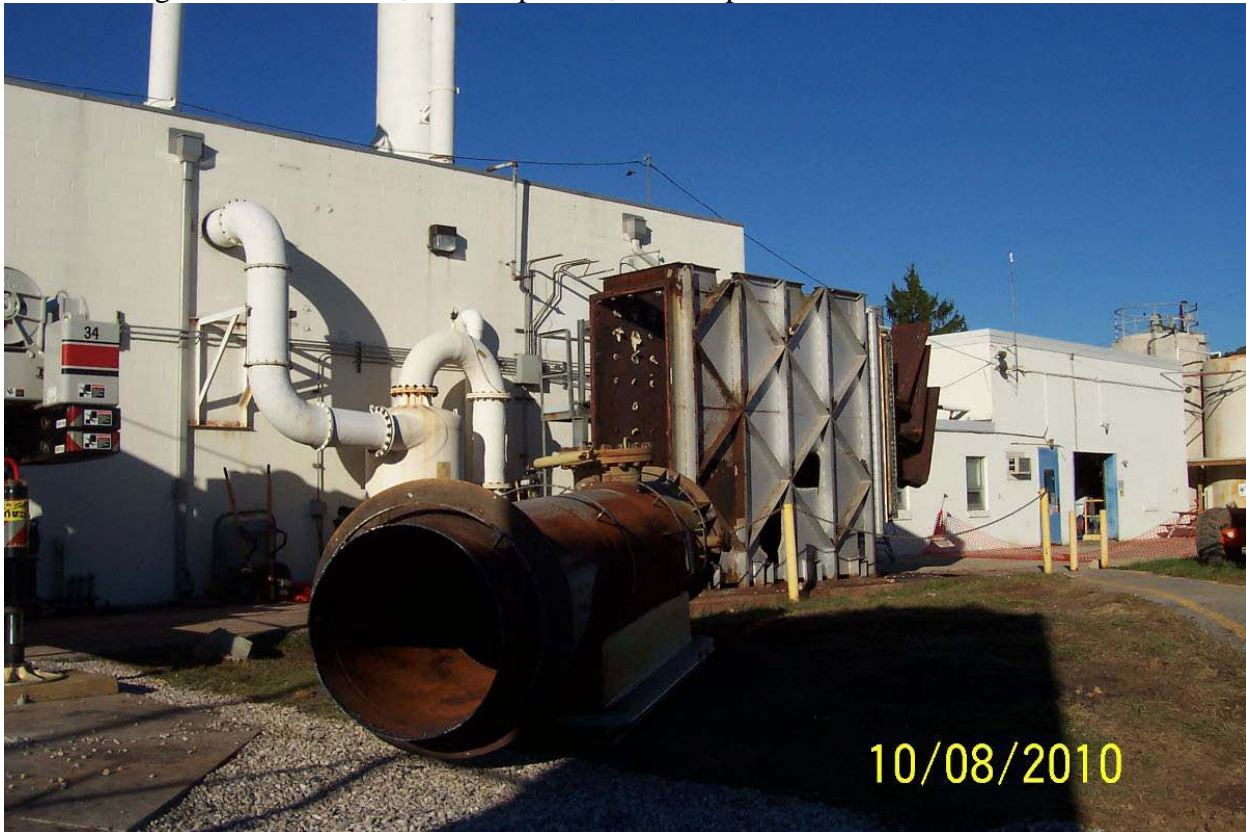
The eastern stack is on the ground for demolition.

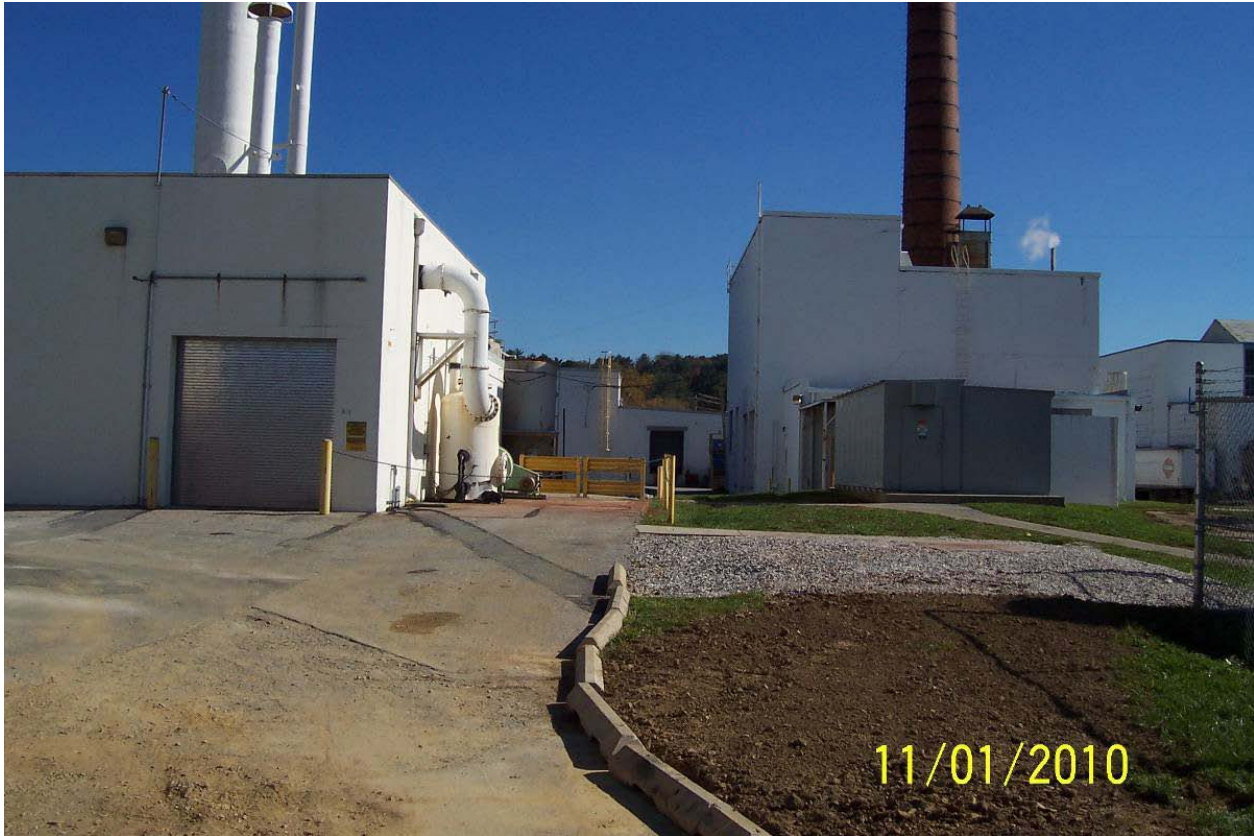
Looking east at the TFO pad after the TFO and hydrogen storage area were removed.

Following demolition, Stewart & Tate restored the surrounding area and installed a guardrail along the east side of the former TFO pad. All wall penetrations were sealed. SAIC completed the removal and securing of the electrical control panel components, and exterior conduit connections. Wiring and control capacity was retained for the moisture knock-out tank pump and monitoring sensor; and for the

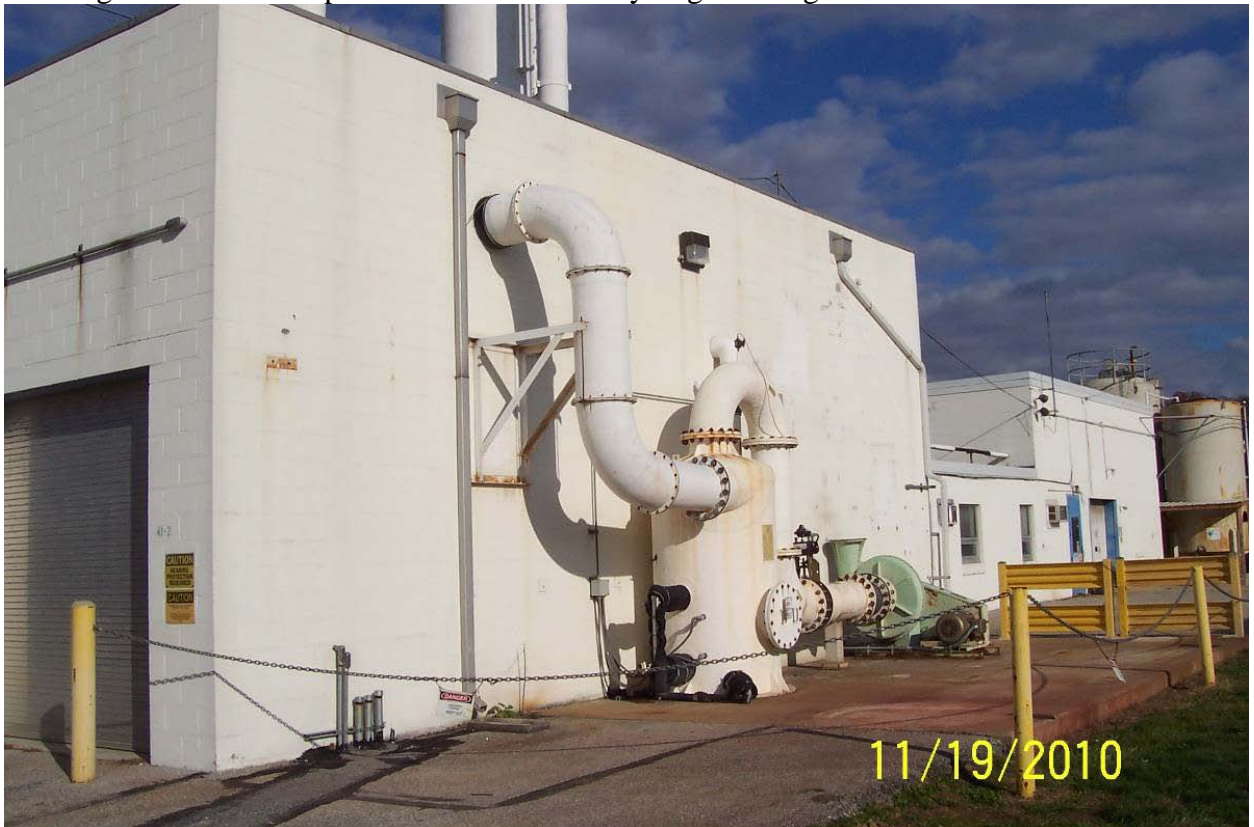
Looking northeast at the TFO pad after the TFO was removed.
