**2017 ANNUAL MONITORING PROGRESS REPORT FOR THE
NPBA EXTRACTION SYSTEM SHUTDOWN
Former York Naval Ordnance Plant
1425 Eden Road, Springettsbury Township
York, Pennsylvania**

April 2018

Groundwater Sciences Corporation

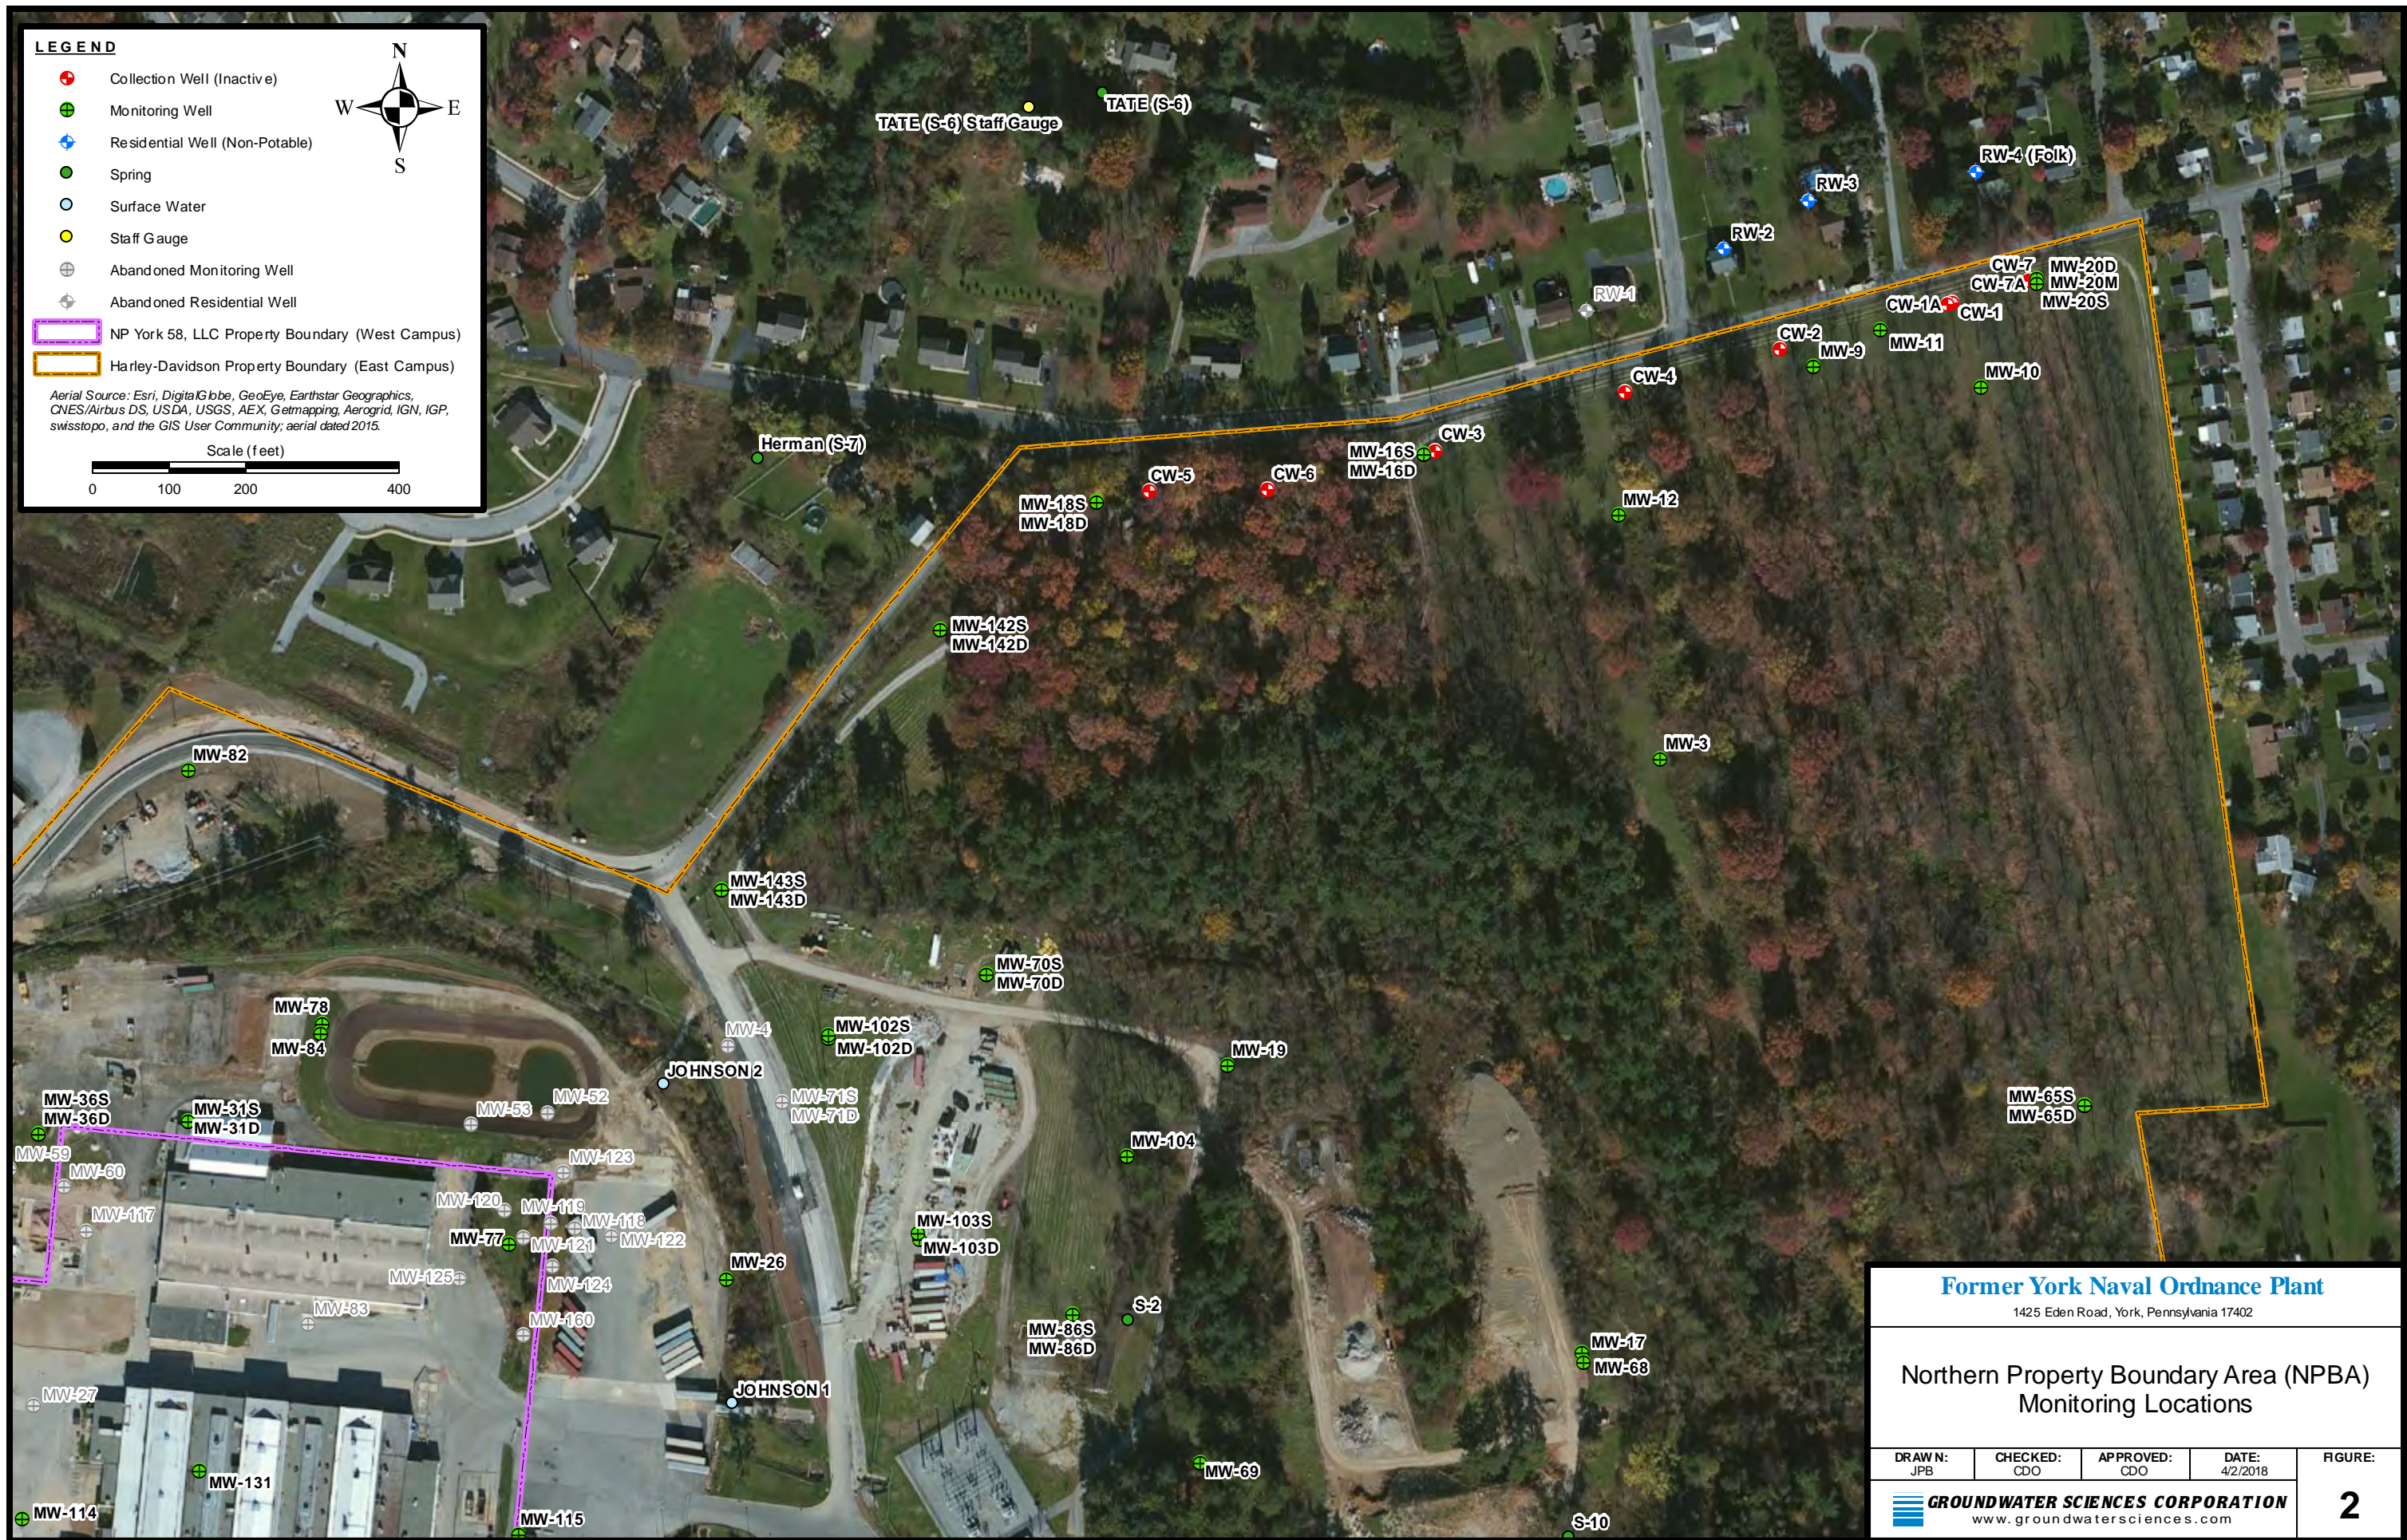
**Northern Property Boundary Area (NPBA)
Monitoring Locations**

Fourth year (2017) monitoring results are discussed in this section, followed by a discussion of the potential for off-Site migration of Site-related COCs. Groundwater locations monitored in 2017 are shown on **Figure 2** and are summarized below:

Wells MW-16D and MW-18S&D exhibit artesian conditions and contain packers to seal the flow of groundwater to the surface. Wells MW-20M&D do not contain packers, but the water elevations are high in these wells indicating that the groundwater is under pressure at those locations. Note that the water level in private non-potable well RW-4 (Folk) was measured on October 14, 2017 when the homeowner allowed access (2 days prior to the comprehensive round of water levels). In addition, RW-1 no longer exists, RW-3 is not accessible for monitoring and the property owners have denied access to spring Herman (S-7) (**Figure 2**).

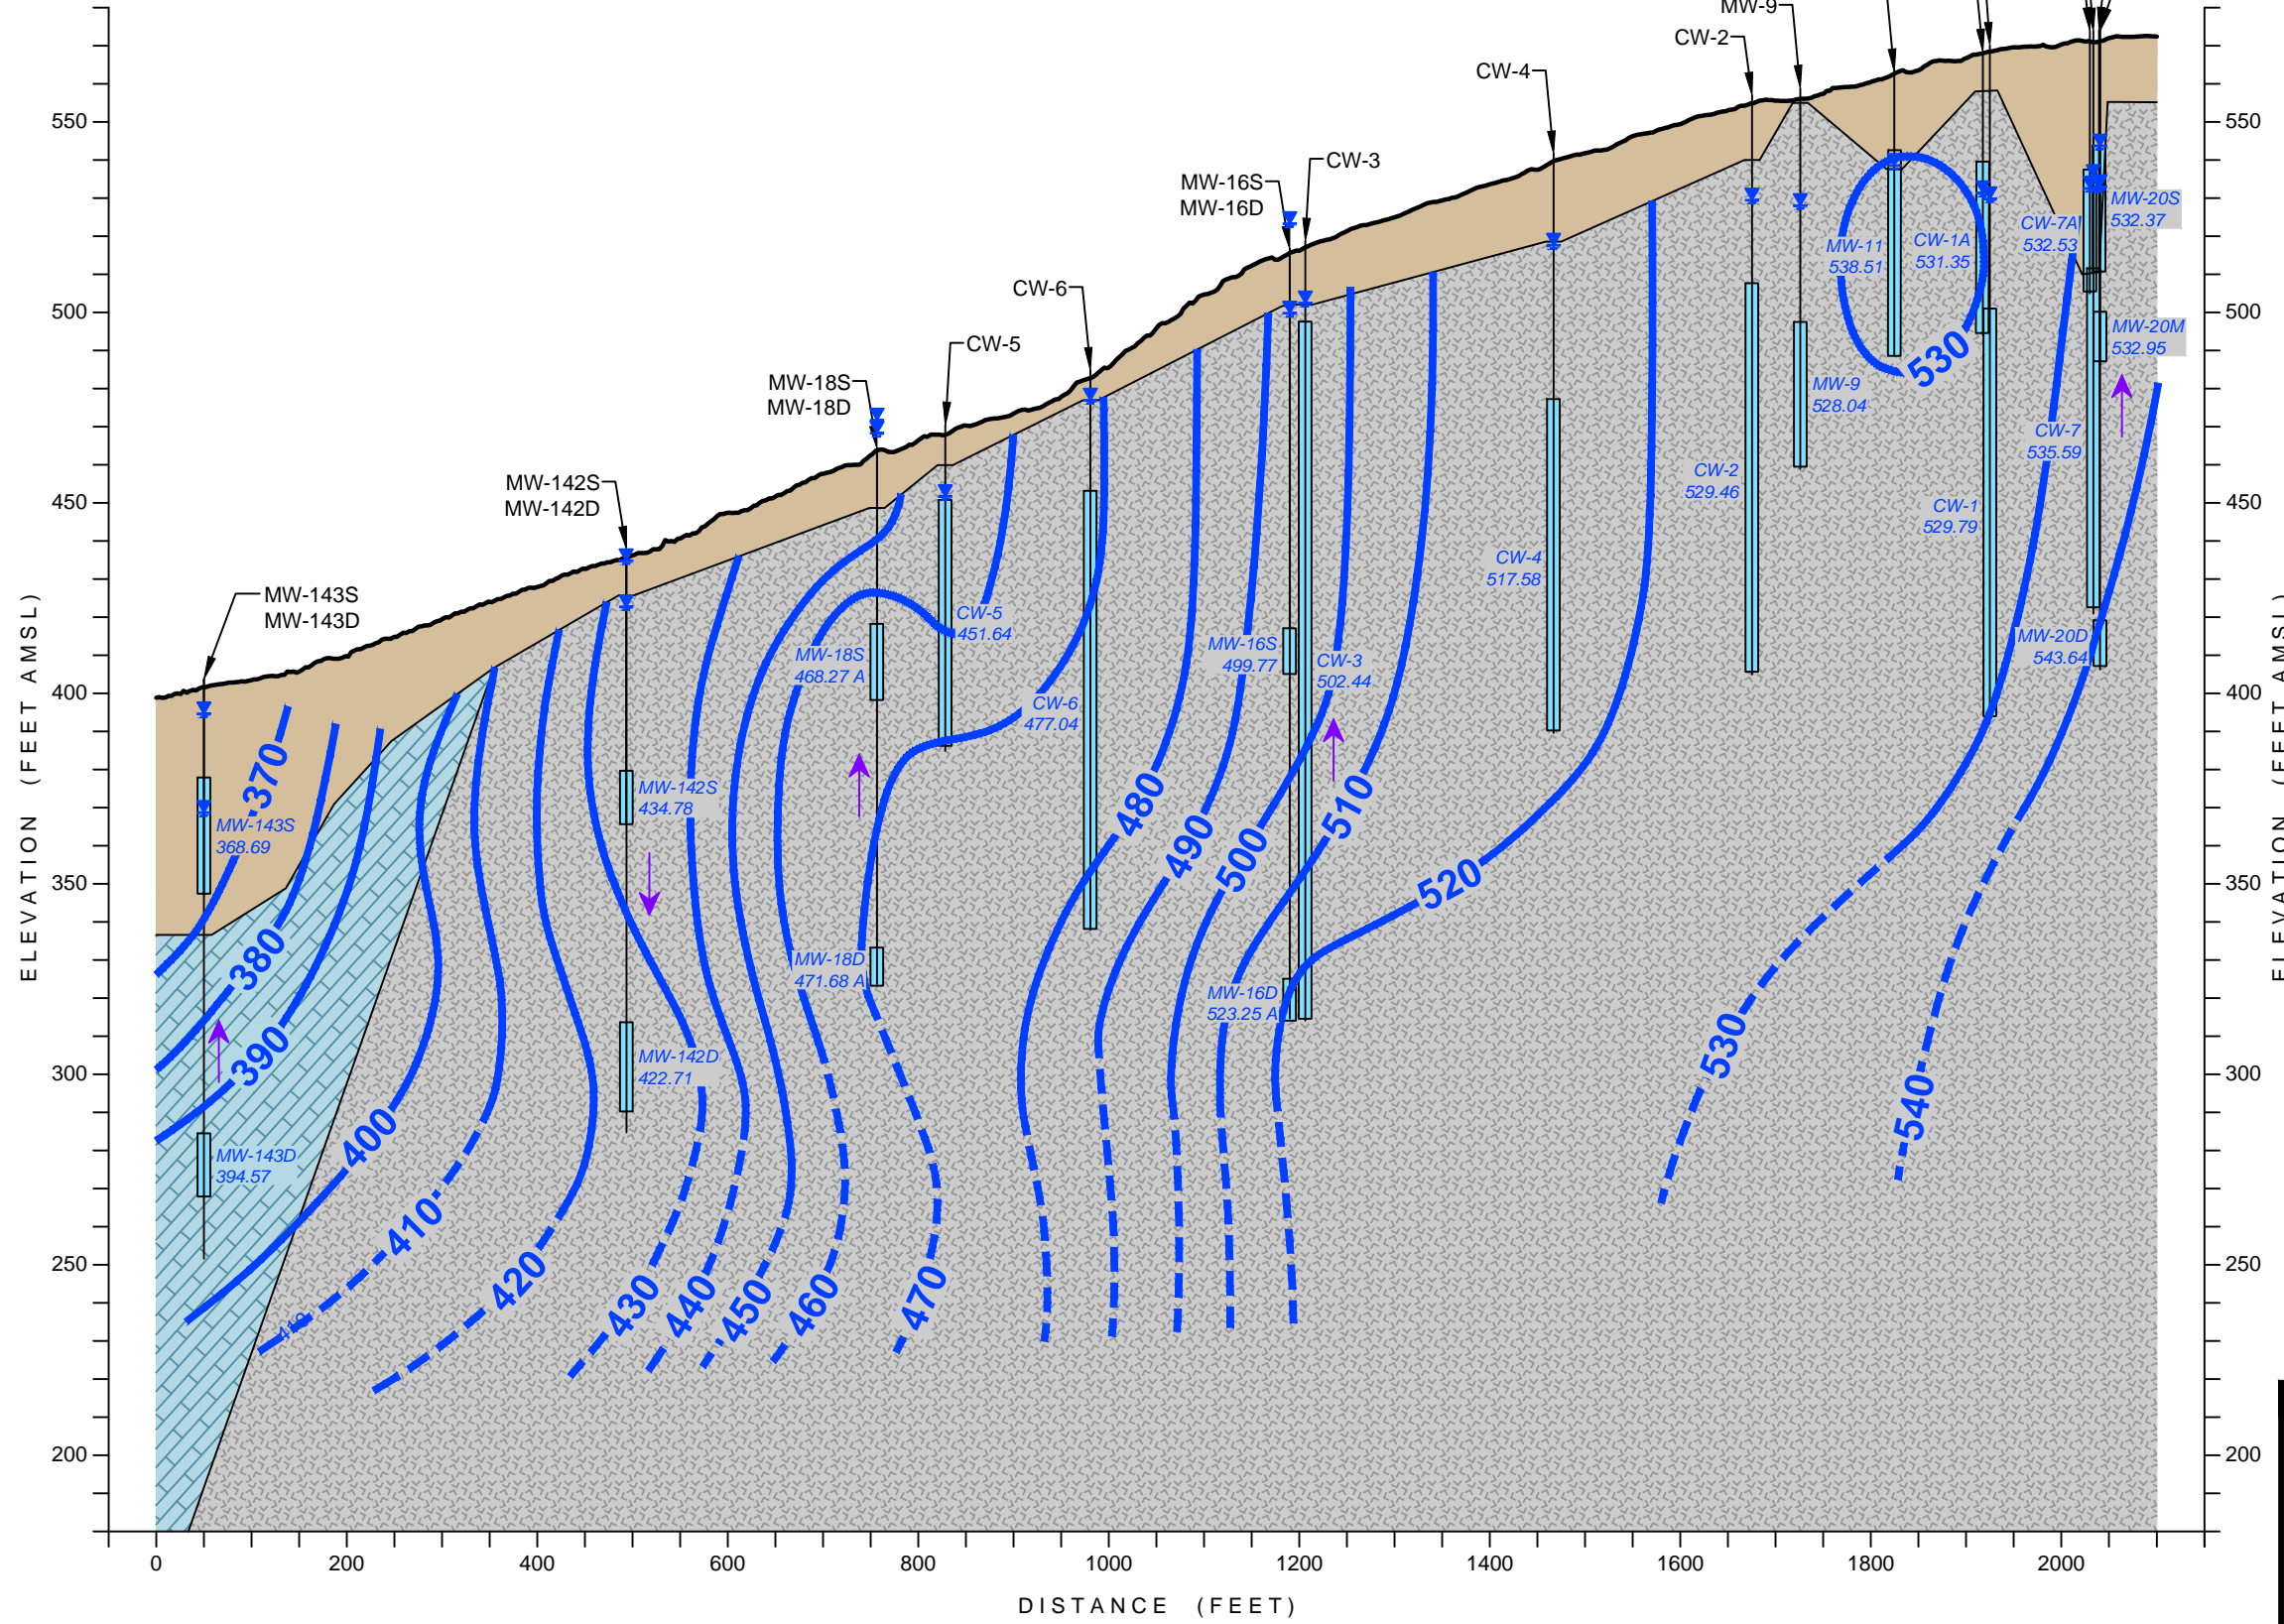
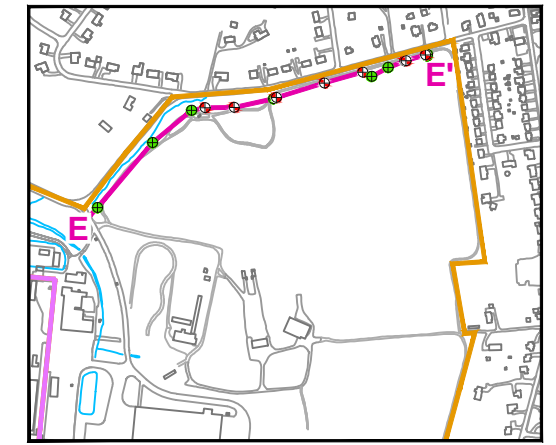
Northern Property Boundary Area (NPBA)
Cross Section E-E'
Piezometric Levels on October 16, 2017

Groundwater elevations and potentiometric contours from October 16, 2017 are shown in the cross section on **Figure 4**. Vertical groundwater gradients can be observed on the figure for nested wells MW-16S&D, MW-18S&D; MW-20S, M, & D; MW-142S&D; and MW-143S&D. In each of these wells except MW-142S&D, the groundwater elevation of the deeper well is higher than the elevation in the shallower well pair. This indicates that vertical groundwater flow is upward at these well locations under non-pumping conditions. Given this vertically upward flow gradient, dissolved COCs would not migrate deeper into the aquifer under natural (non-pumping) conditions.

The 2017 groundwater elevation contours in plan (**Figure 3**) and profile (**Figure 4**) views are essentially the same as the post-shutdown conditions in 2013, 2014, 2015 and 2016. No modification to the previous evaluation is warranted based on the 2017 water level data. Similarly, the 2017 groundwater chemistry results are consistent with the previous post-shutdown results, and show no indications of northward migration. Specifically, Site-related COCs continue to remain undetected or detected at concentrations below the PADEP groundwater MSCs in off-Site monitoring locations to the north of the NPBA at RW-2, RW-4 and Tate (S-6).

Comparing the October 2017 groundwater elevations and potentiometric contours to the previous post-shutdown elevations and contours from 2013 through 2016 indicates there is essentially no change in the lateral and vertical groundwater gradients in the NPBA area.

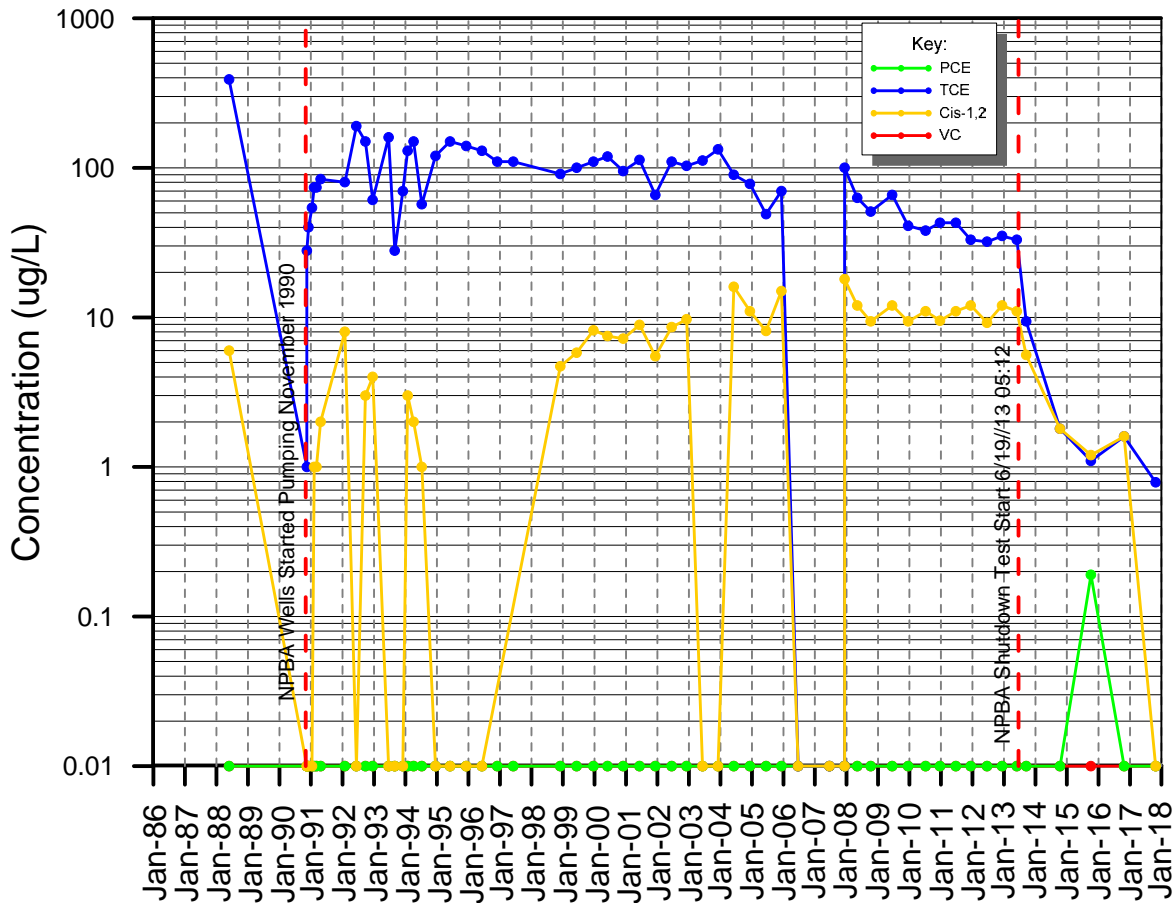
- Collection wells CW-1 and CW-1A are open to a depth of 68 feet – 175 feet and 29 feet – 74 feet, respectively. TCE concentrations in these wells prior to cessation of pumping were nearly the same at 33 µg/L and 35 µg/L, respectively. With the pumps off, concentrations in both wells dropped to 9.4 µg/L in CW-1 and 26 µg/L in CW-1A.

Four years later, the TCE concentration in CW-1 has decreased to its lowest concentration since shutdown (0.79 J $\mu\text{g/L}$) and the TCE concentrations in CW-1A remained nearly unchanged (53 $\mu\text{g/L}$).

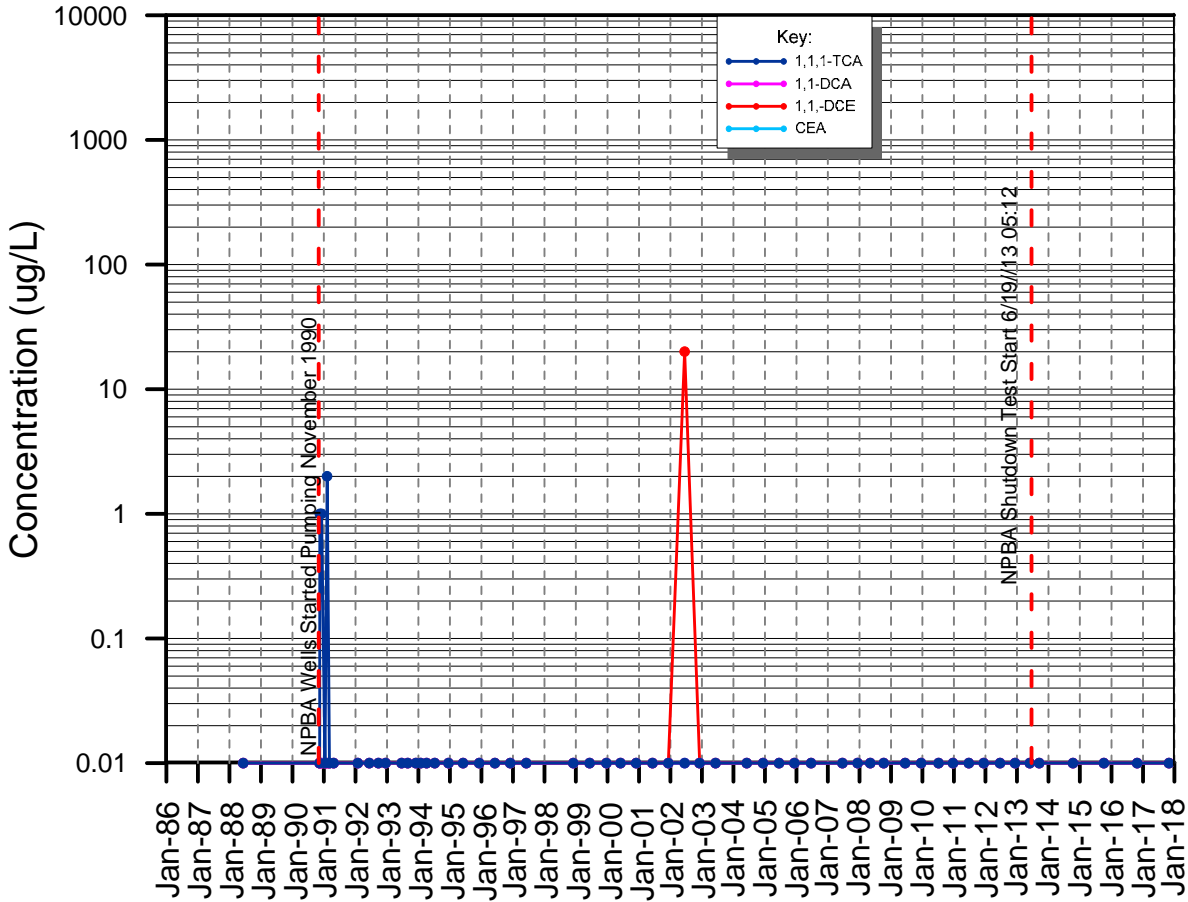
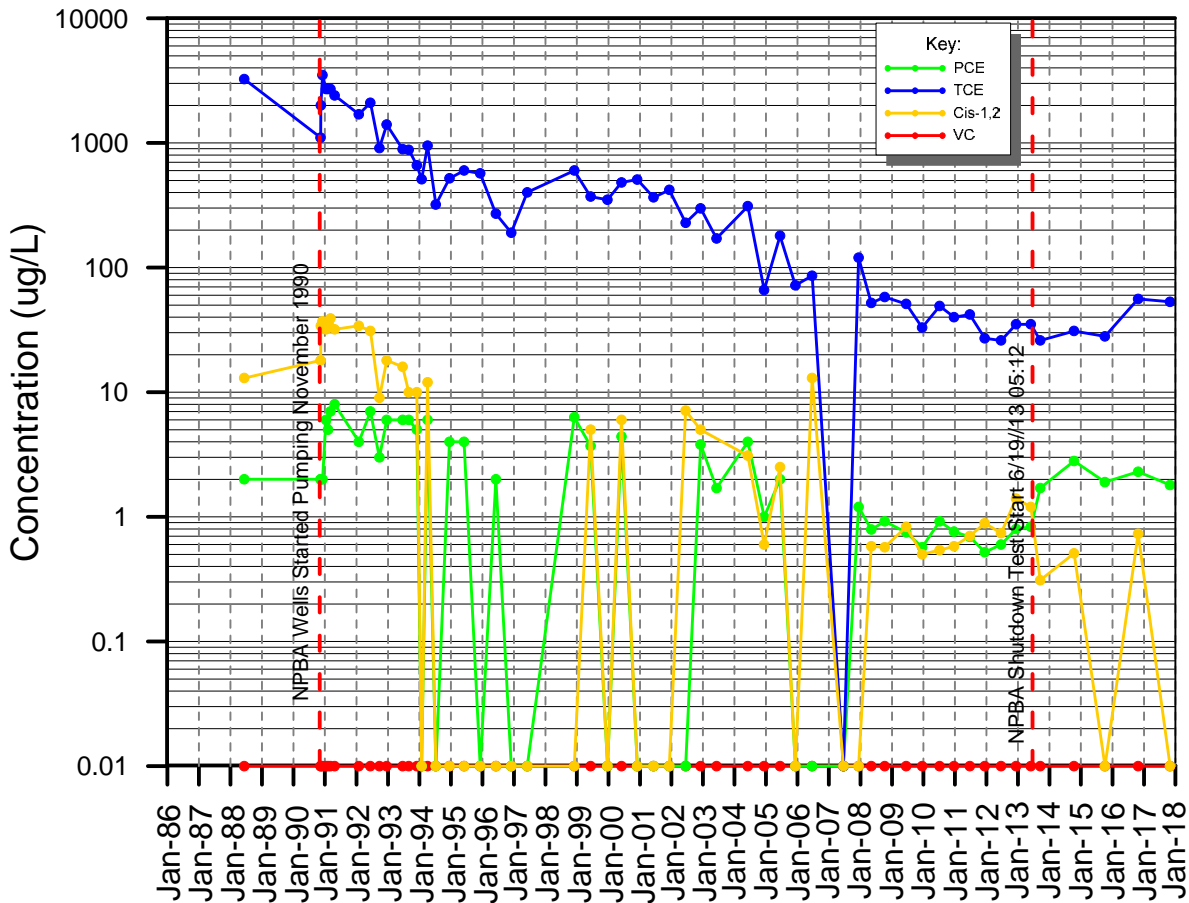
Three years later, the TCE concentration in CW-1 remained relatively unchanged (1.6 µg/L). The TCE concentration in CW-1A increased from 28 µg/L to 56 µg/L, which represents the highest detection since it was shut down.

A comparison of the pre- and post-shutdown TCE and PCE concentrations indicate they are generally stable or declining in 24 of the 26 SPBA wells being monitored. A gradual increase in TCE concentrations at collection well CW-1A was observed following shutdown through 2016 and then leveled off in 2017. CW-5 had an upward trend in TCE and PCE concentrations; however, the concentrations in 2017 were lower than the concentrations in 2016. Concentration fluctuations at CW-1A and CW-5 are expected to continue in the future due to desorption of VOCs from the aquifer matrix in these localized source areas and the change in groundwater flow direction caused by the return to natural (non-pumping) conditions.

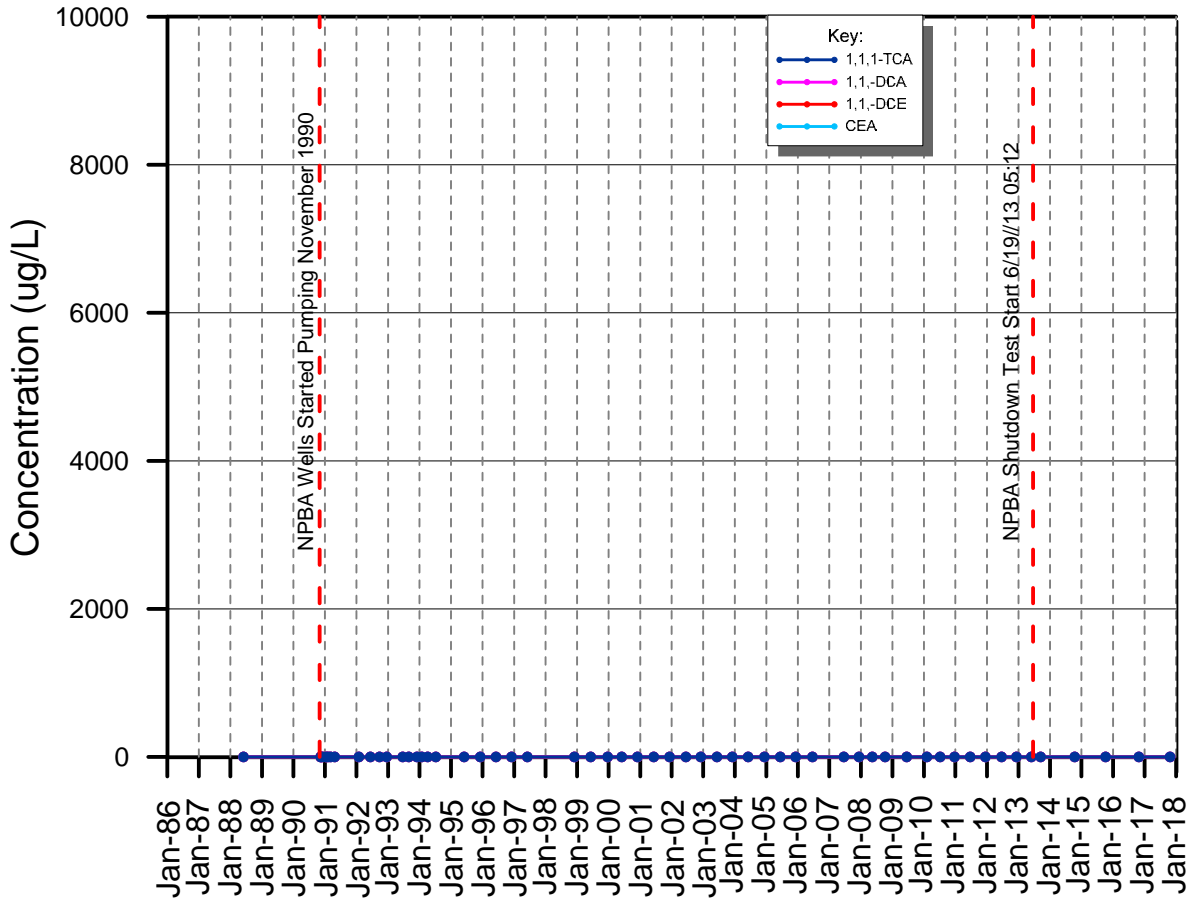
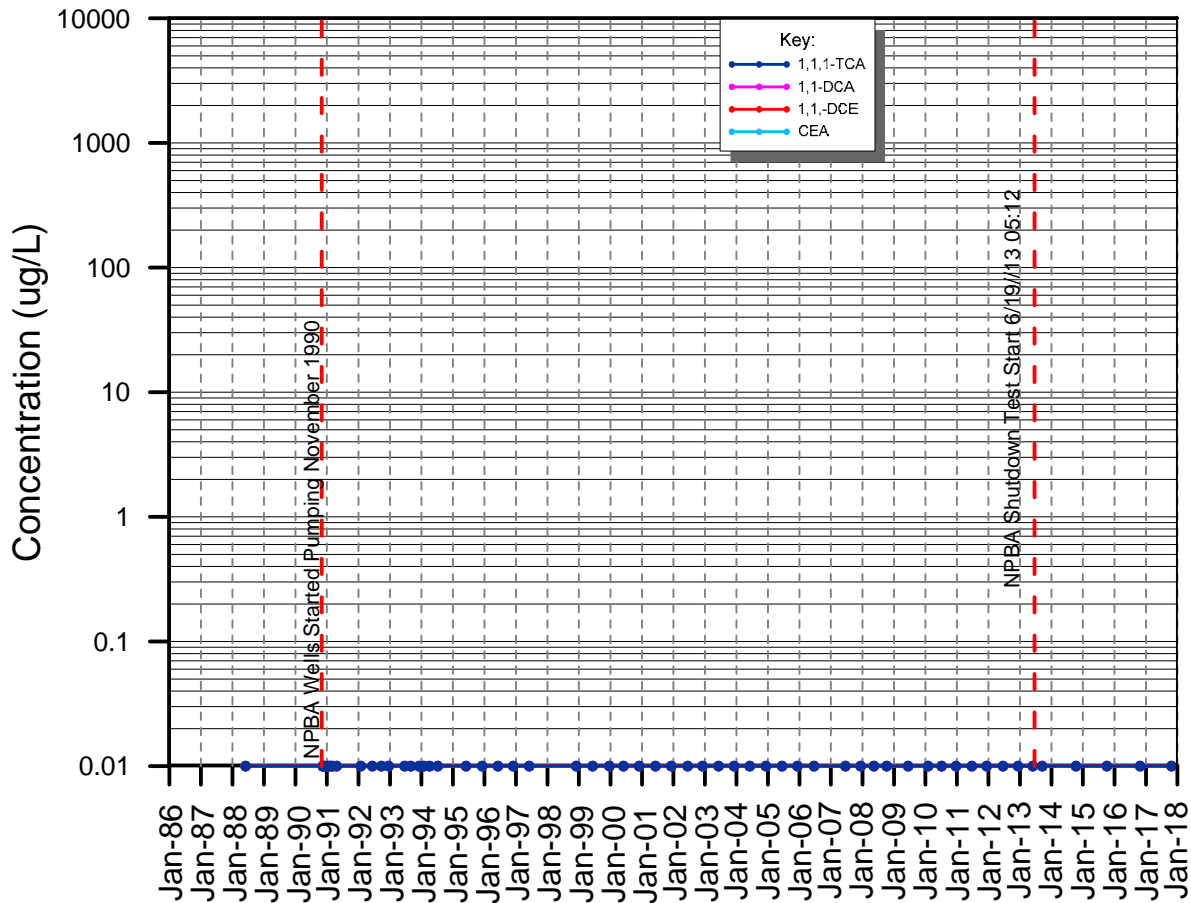
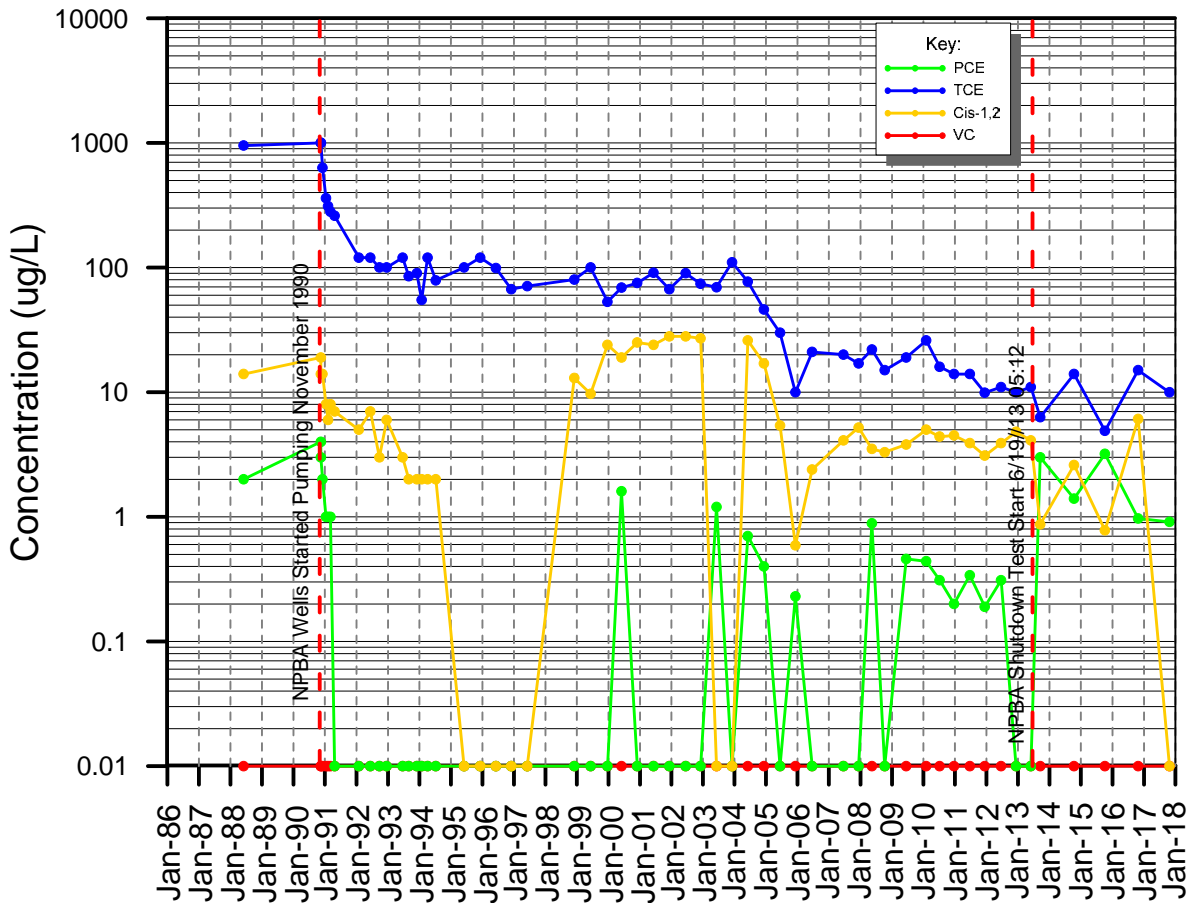
- Collection well CW-2 and adjacent monitoring well MW-9 decreased in TCE concentrations after cessation of pumping. Since the groundwater flow direction at MW-9 while pumping was toward the northwest, and that flow direction changed to southwestward when CW-2 stopped pumping, the change in chemistry indicates higher concentrations of TCE in groundwater being pulled from the southeast of MW-9. With the cessation of pumping, the concentration of PCE in CW-2 went from undetected (U) to 3 $\mu\text{g/L}$. PCE was detected in

The 2017 sample results for MW-9 show no significant changes from the above descriptions with a TCE concentration of 20 µg/L and an undetected (U) PCE concentration. PCE and TCE concentrations both decreased in CW-2 with PCE decreasing from 0.97 J µg/L to 0.91 J µg/L and TCE decreasing from 15 µg/L to 10 µg/L in 2016 and 2017, respectively.

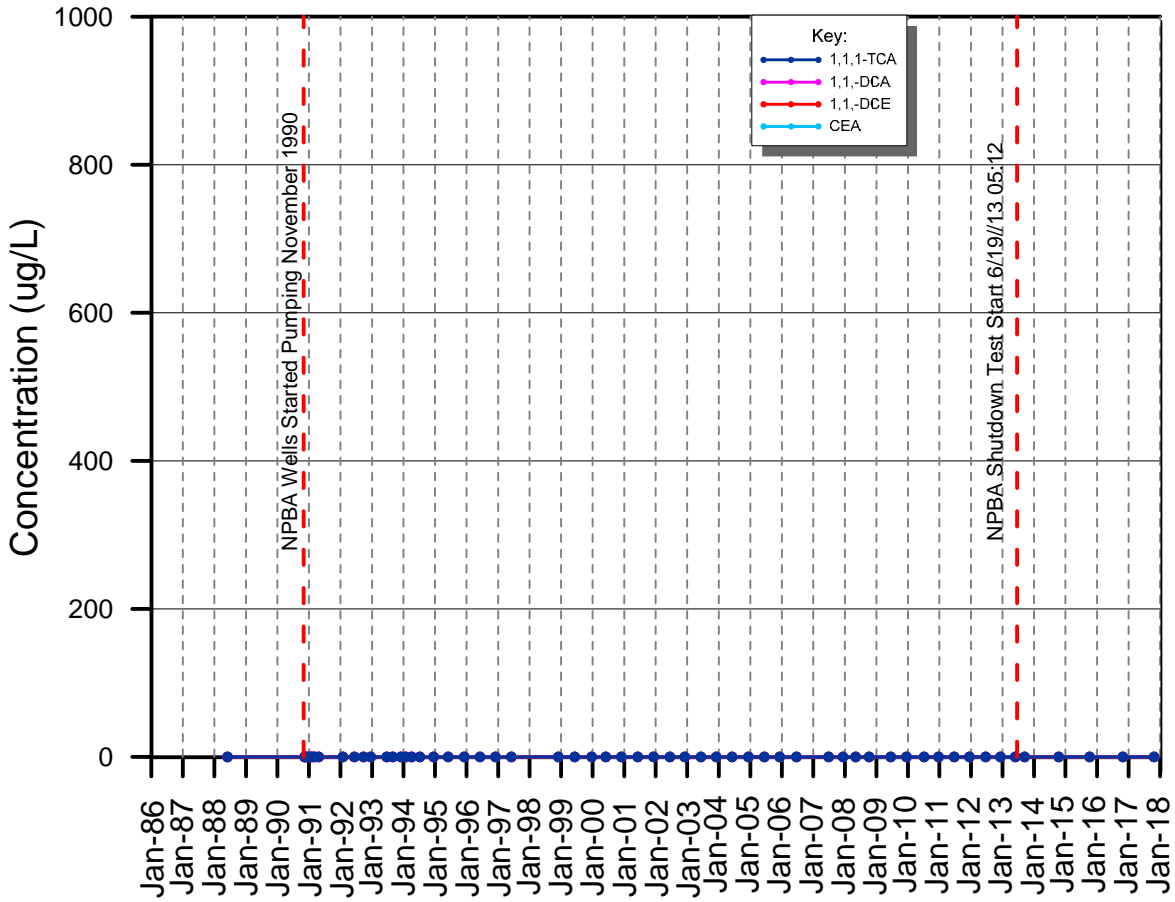
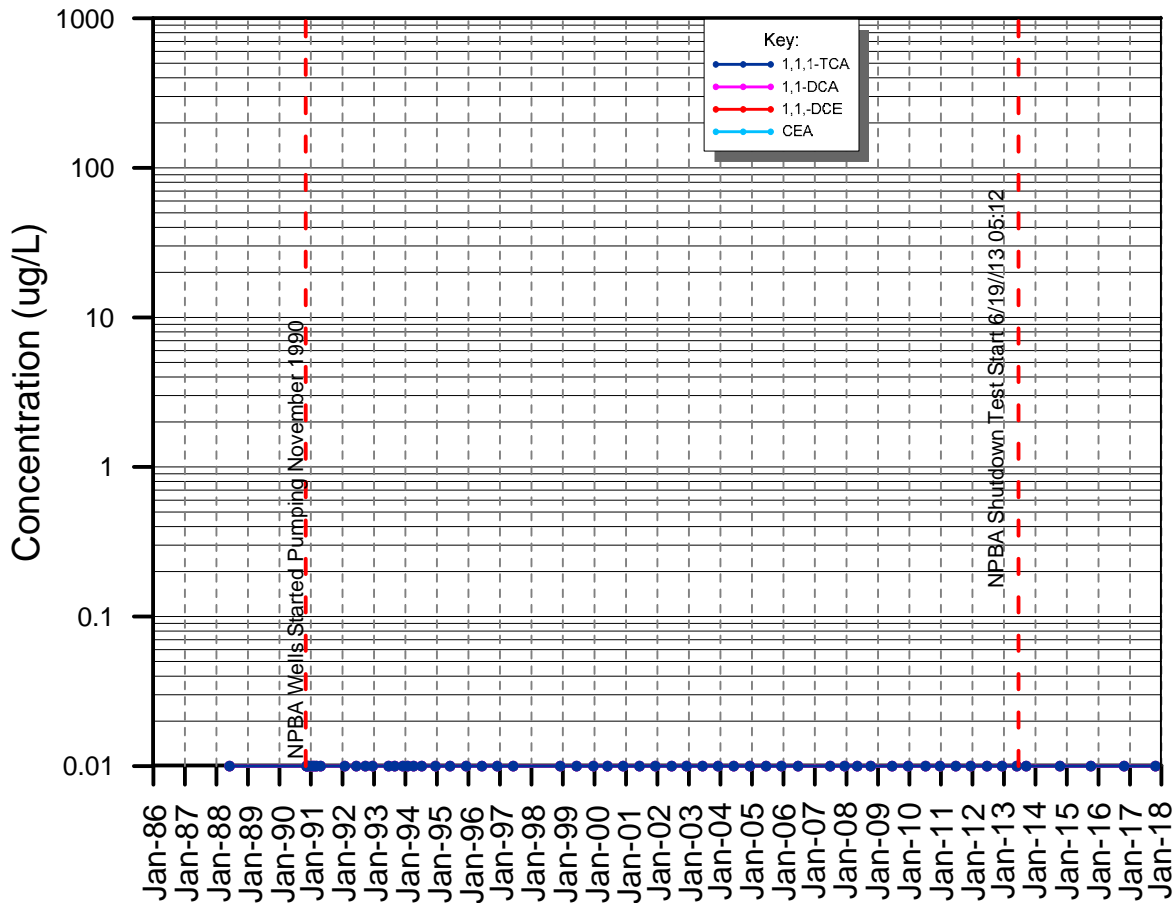
- TCE and PCE concentrations decreased in collection well CW-4 after cessation of pumping. Adjacent monitoring well MW-12, southwest of CW-4, more than doubled in TCE and PCE concentrations after pumping stopped. This suggests that higher concentrations of these COCs may be located south or southeast of CW-4 and northeast of MW-12, in a position that is upgradient from MW-12 under the static post-shutdown groundwater potentiometric surface conditions.

Concentrations in CW-4 have dropped to the lowest concentrations since pre- and post-shutdown sampling with both TCE and PCE results being undetected (U). TCE and PCE in MW-12 continue to decrease from 93 µg/L to 61 µg/L and 4.3 µg/L to 2.7 µg/L, in 2016 and 2017, respectively, with TCE detected at its lowest concentration since pre- and post-shutdown sampling.

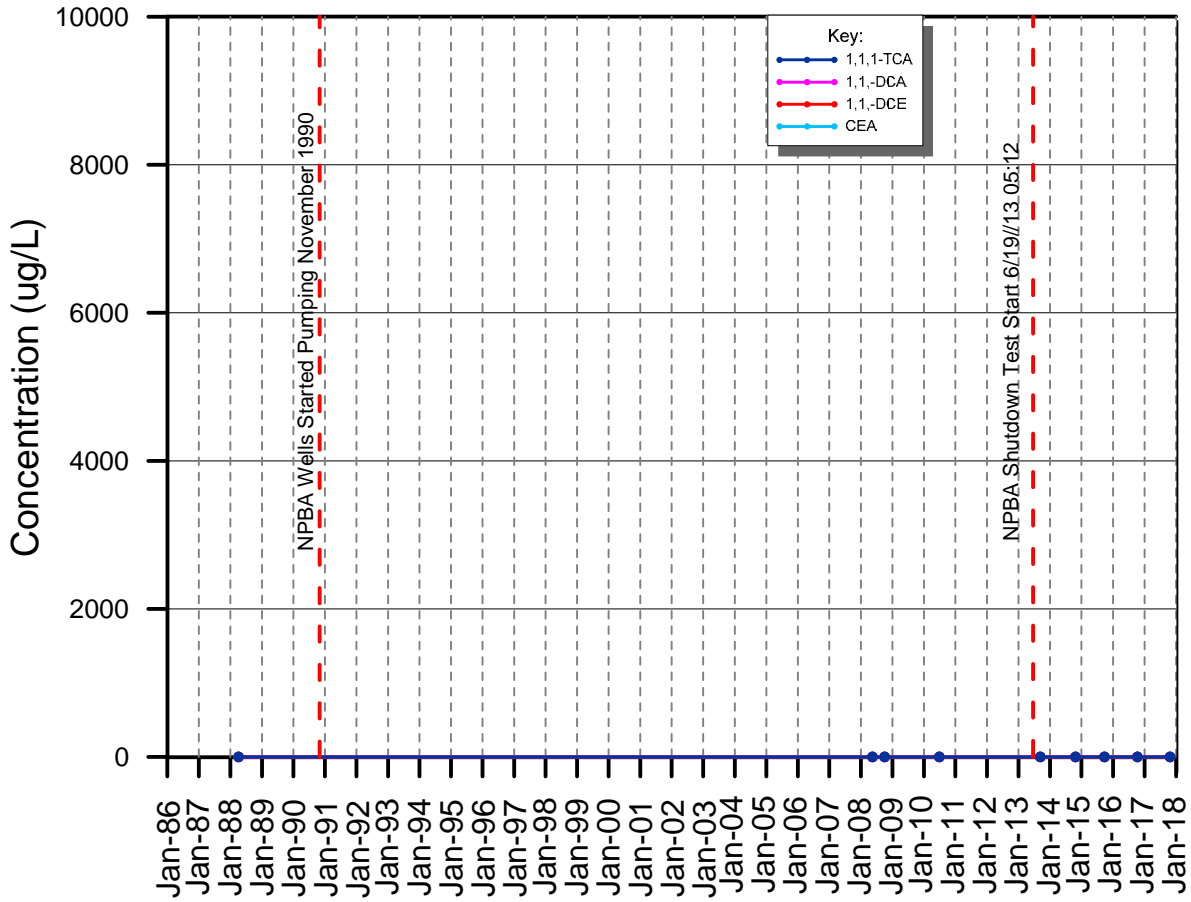
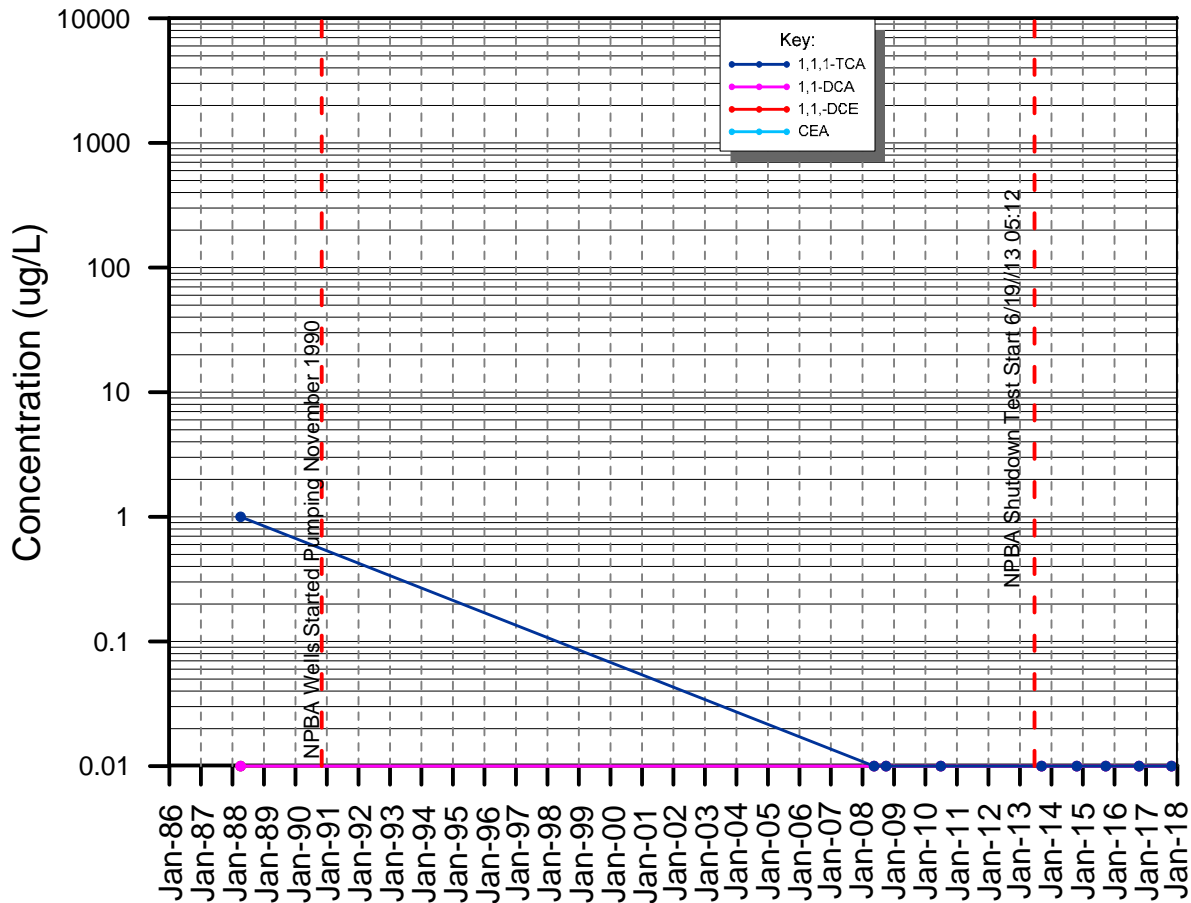
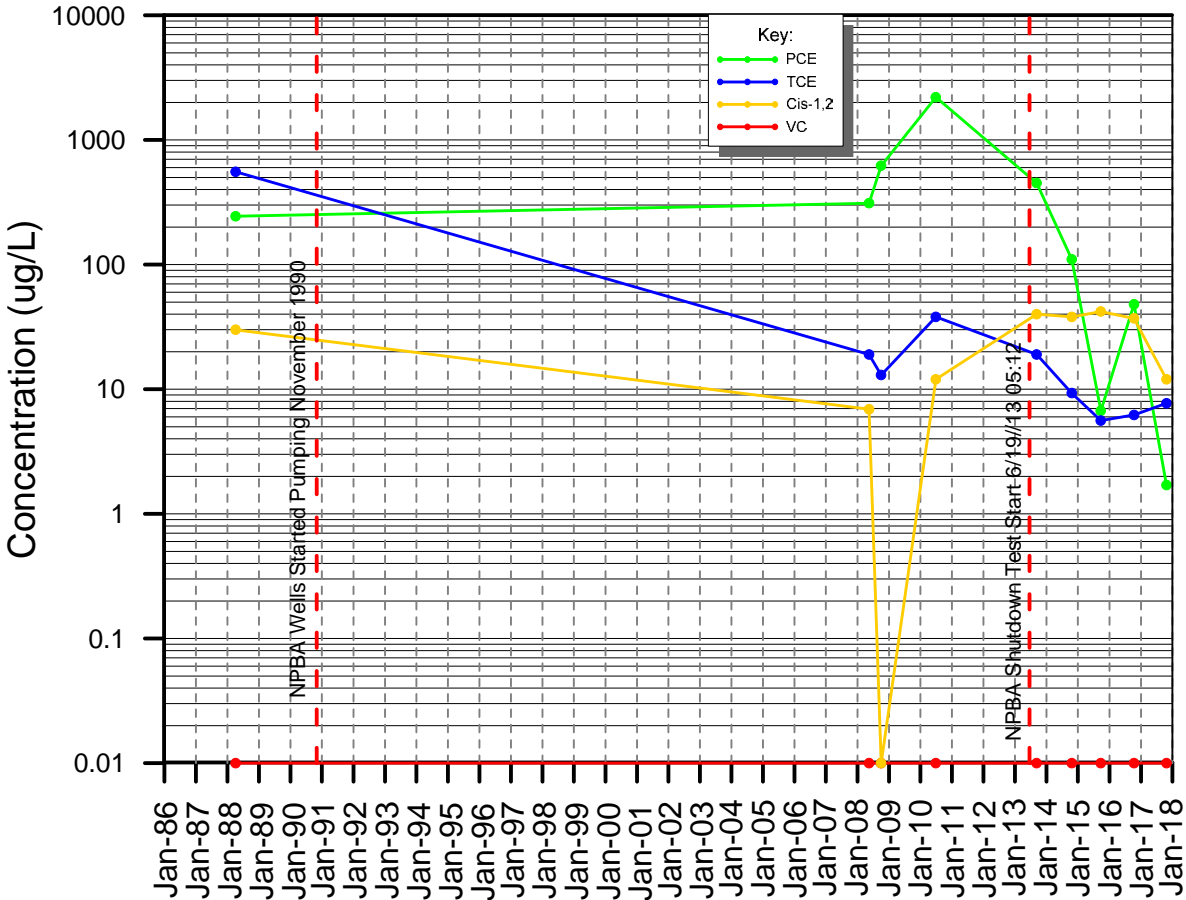
- Collection well CW-3 and adjacent well pair MW-16S and MW-16D are located near the center of the row of collection wells along the NPBA. The groundwater chemistry in MW-16S is notable in that it shows the highest concentration of PCE in the NPBA, where TCE is the dominant COC. CW-3 concentrations of TCE increased slightly, with the cessation of pumping, but remained in single digits. A pre-shutdown sample of MW-16S could not be analyzed due to excessive turbidity. However, compared to previous samples collected during pumping, the concentration appears to have reduced significantly under post-shutdown conditions. MW-16D, screened at a depth bgs of 190 feet – 201 feet, is artesian, and groundwater quality is minimally influenced by the COCs in the shallower zones in the immediate vicinity, indicated by PCE concentrations being undetected (U).

In 2017, TCE remained stable (7.7 J µg/L) in MW-16S, and the PCE concentration decreased significantly from 48 µg/L in 2016 to 1.7 J µg/L in 2017, which represents the lowest detected since shutdown. TCE concentrations in MW-16D have continued to consistently decrease with the lowest post-shutdown concentration detected in 2017 (8.7 J µg/L). TCE and PCE remain undetected (U) in CW-3 in 2017.
