**2017 ANNUAL MONITORING PROGRESS REPORT FOR THE
NPBA EXTRACTION SYSTEM SHUTDOWN
Former York Naval Ordnance Plant
1425 Eden Road, Springettsbury Township
York, Pennsylvania**

April 2018

Groundwater Sciences Corporation

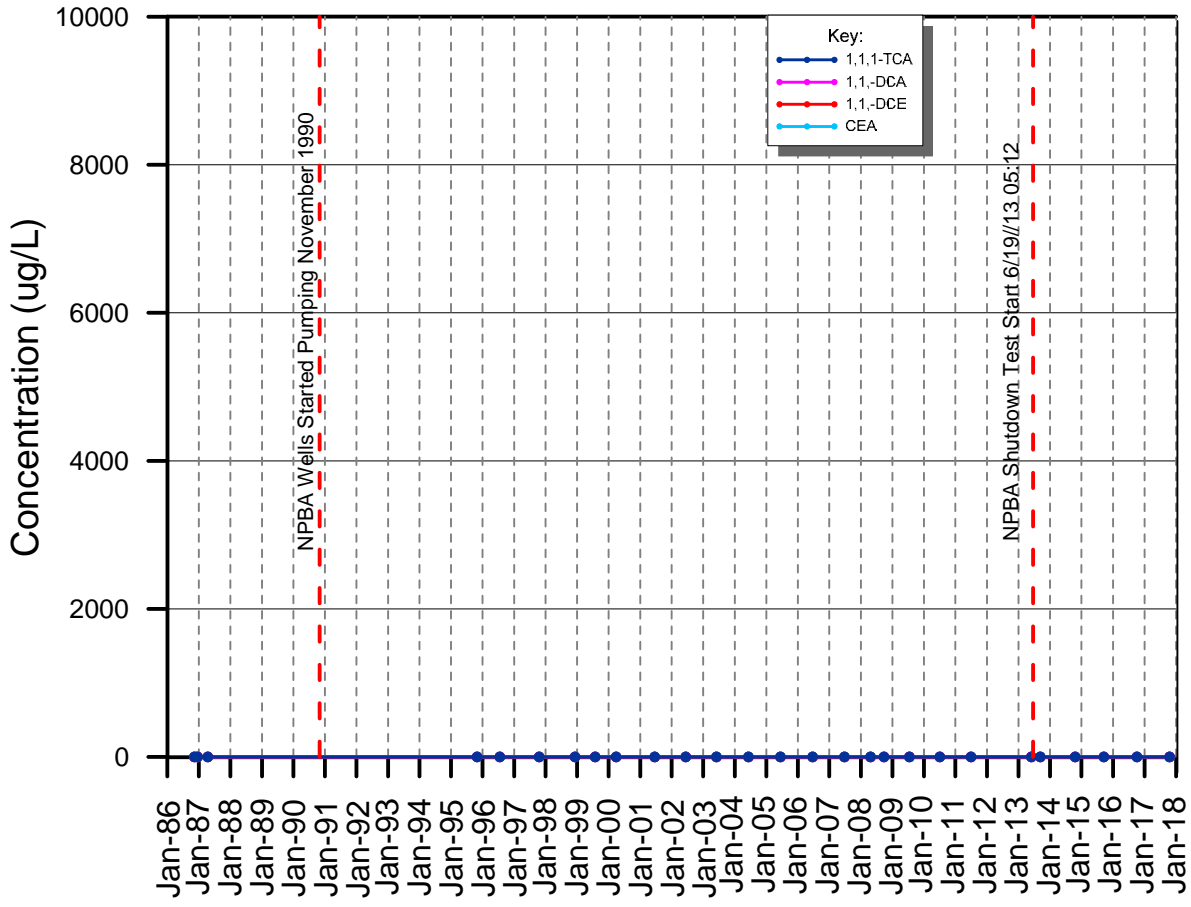
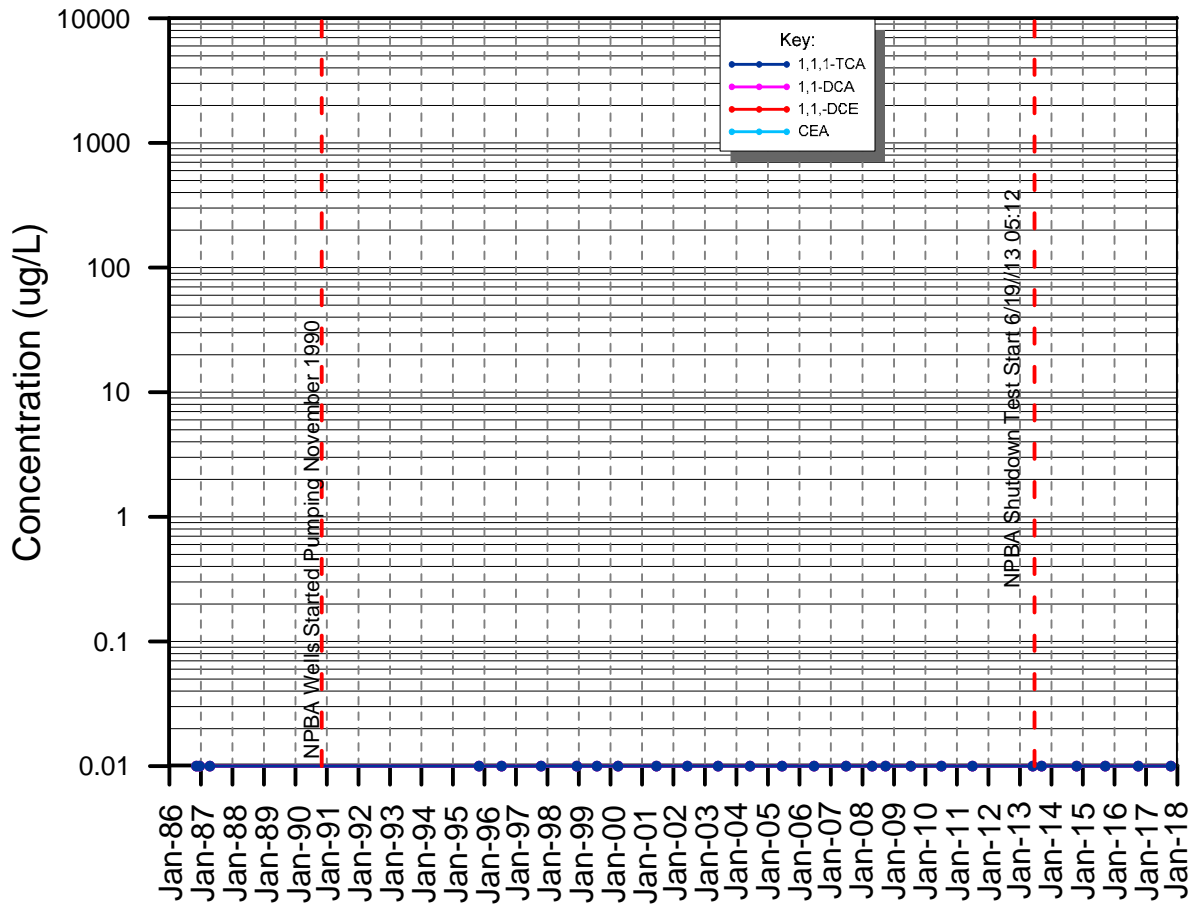
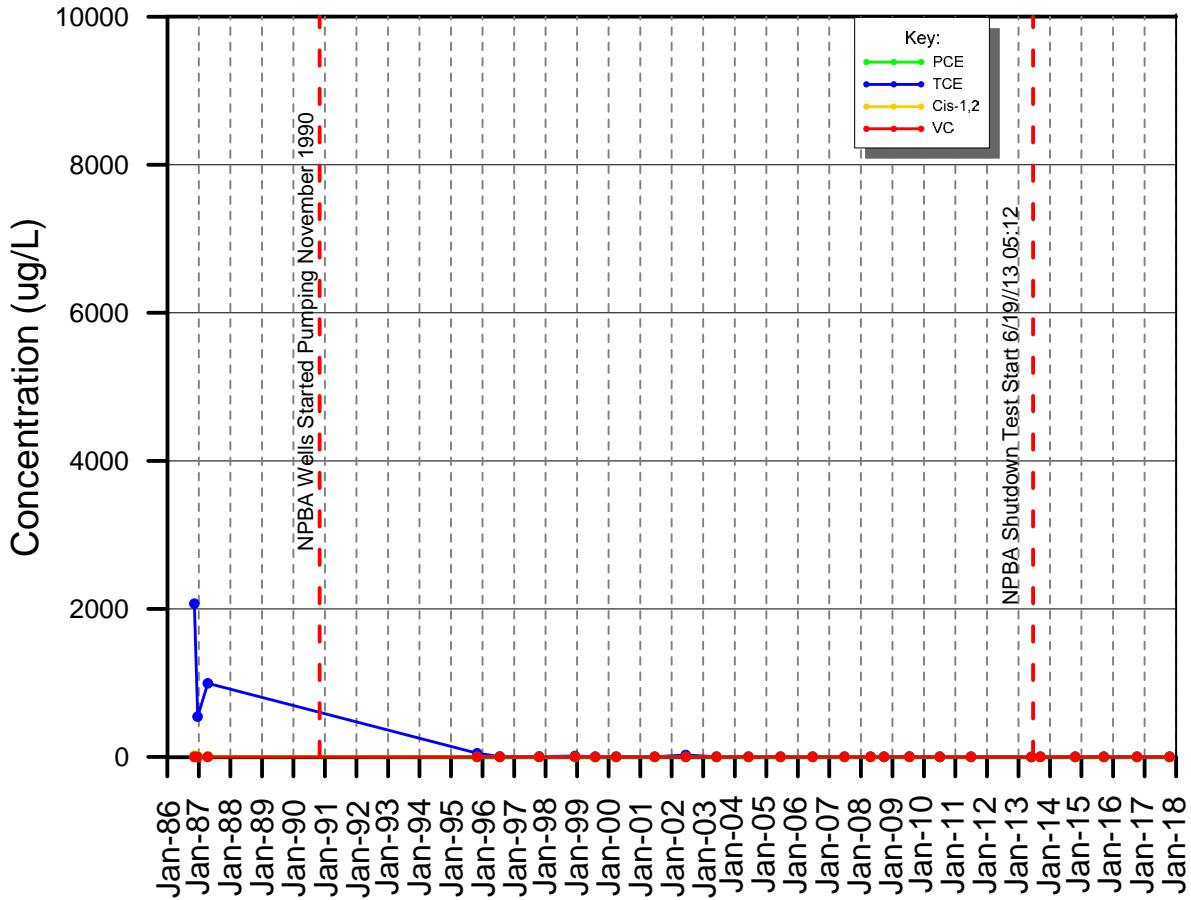
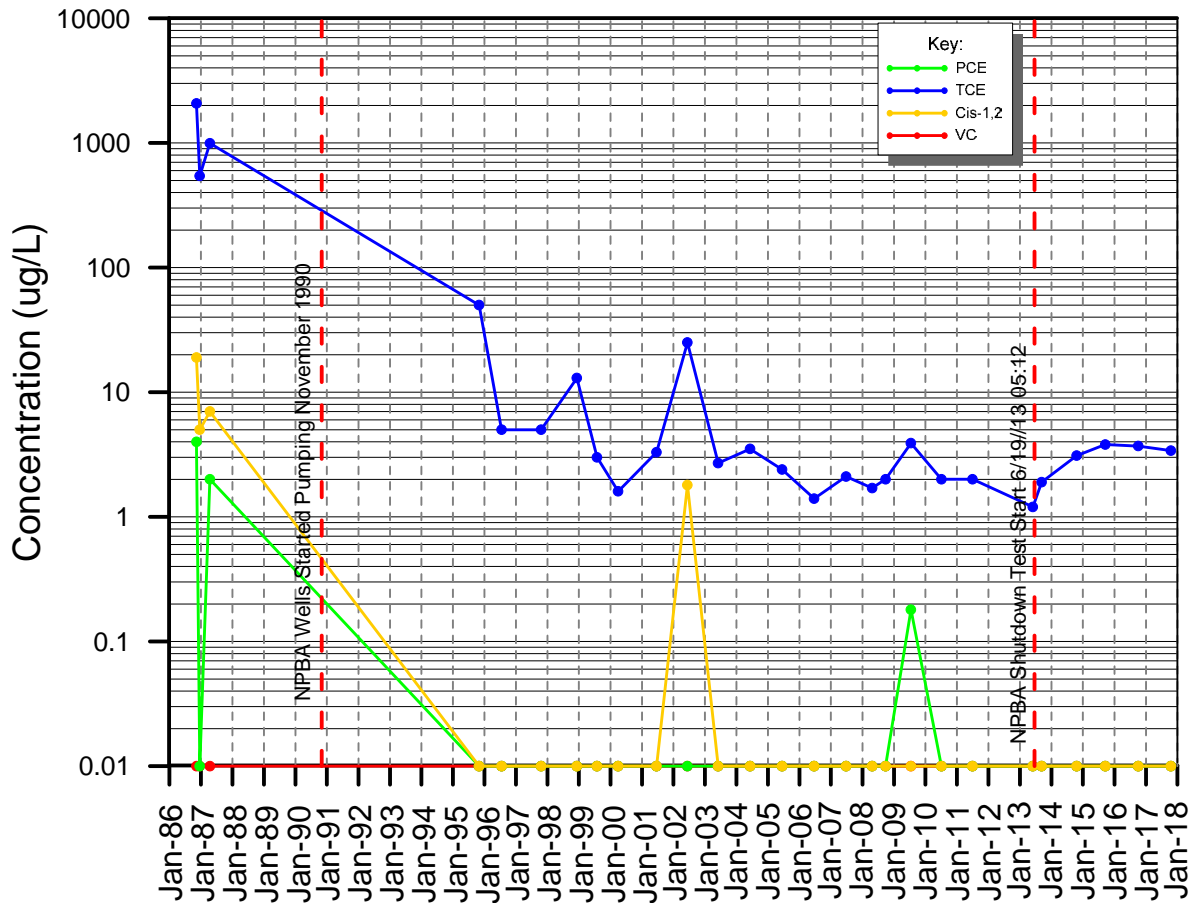
- The TCE concentration in off-Site former residential supply well RW-2, located 150 feet northwest of CW-2 rose slightly between pre- (1.2 µg/L) and post- (1.9 µg/L) shutdown sampling. The change is within its normal range of TCE concentrations during pumping. This well has been below applicable PADEP Medium-Specific Concentrations (MSCs) for Residential Used Aquifers (RUA) with total dissolved solids less than or equal to 2,500 milligrams per liter (mg/L) for all Site-related COCs since 2003 and the TCE concentrations have ranged from 1.4 µg/L (in 2006) to 3.9 µg/L (in 2009) over the last seven years of annual sampling.

The 2017 sample results show no significant changes from the description above. The TCE concentration measured in 2017 was 3.4 µg/L. RW-2 is still not being used as a supply well since prior to fYNOP investigations in 1986. Concentrations of TCE and PCE continue to remain undetected (U) in the other former residential supply well, RW-4 (Folk), currently connected to an outdoor spigot, and not used as a potable supply.
