**BUILDING 51 PIT CLOSURE REPORT  
FORMER YORK NAVAL ORDNANCE PLANT**

**SAIC Project 166345.00.08232.6072.00**

**Harley-Davidson  
Motor Company Operations, Inc.  
York, PA**

**December 2009**

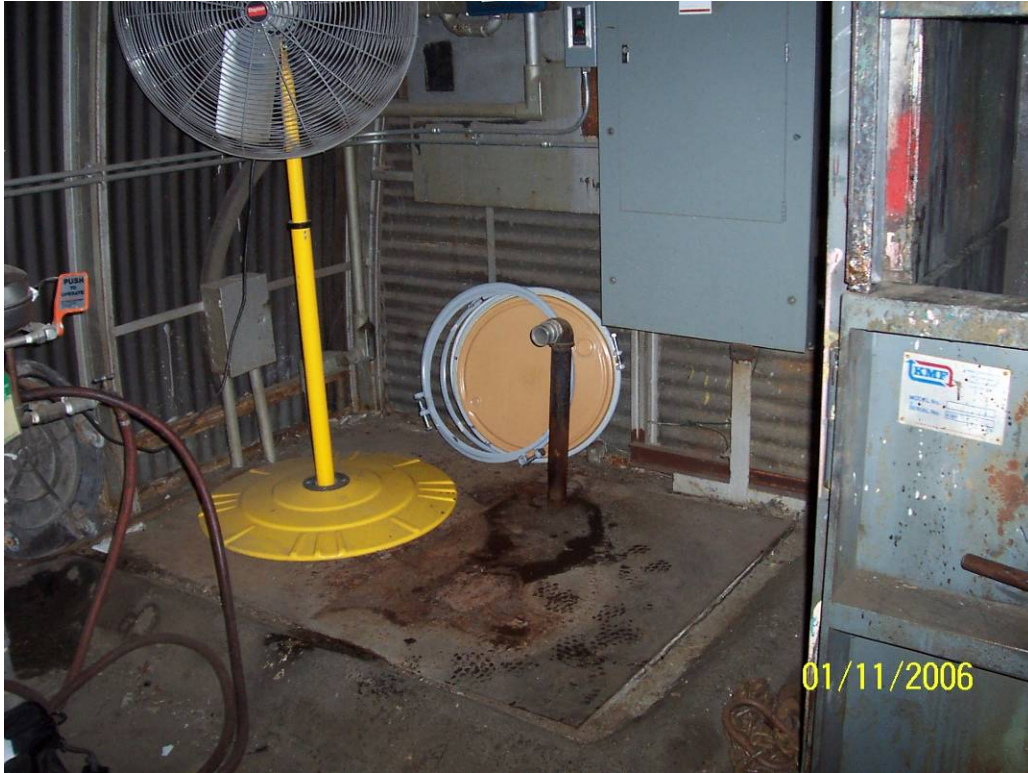
Photo 1 – Location of Pit #1 in the southeast corner of Building 51. View facing southeast.

The first pit (Pit #1) was located inside the southeastern corner of Building 51. Pit #1 was separated from the remainder of the building by a six-inch-high berm. Pit #1, approximately 4 feet wide x 5½ feet long x 6½ feet deep, was constructed of concrete and covered by a metal lid. A smaller recessed sump was located in the eastern half of the bottom of Pit #1. A small channel containing a two-inch-diameter steel pipe that connected Pit #1 to the second pit (Pit #2) was located outside the southeast corner of the building (see photographs in Appendix A).

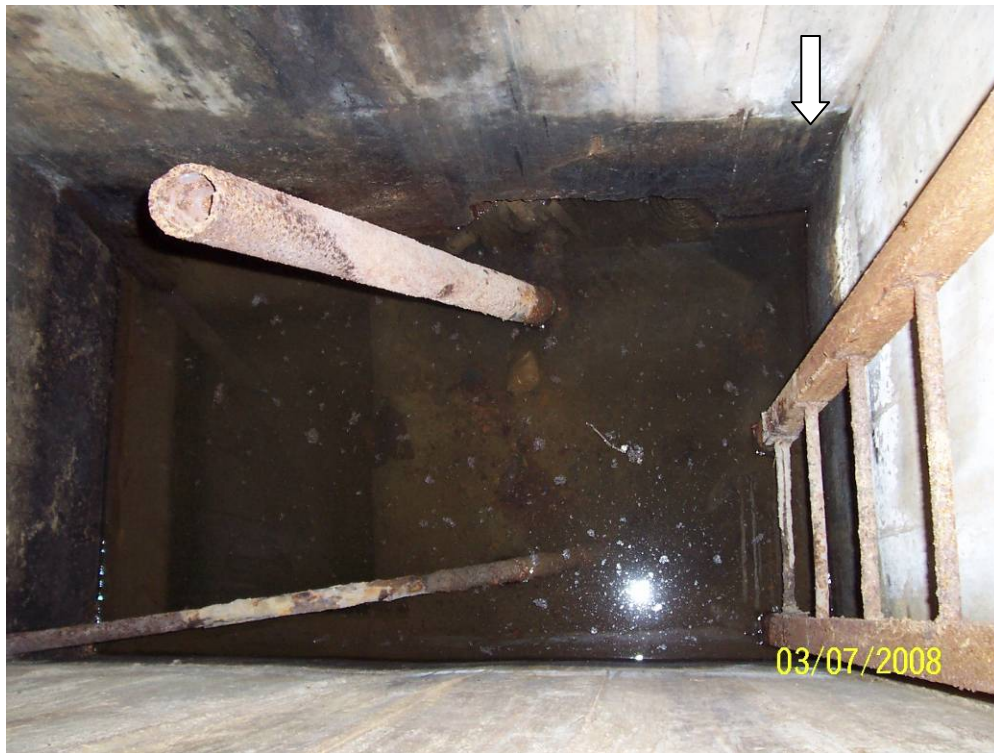
Photo 2-View of Pit#1 and sump inside Building 51 prior to cleaning and pipe removal. North indicated by white arrow.

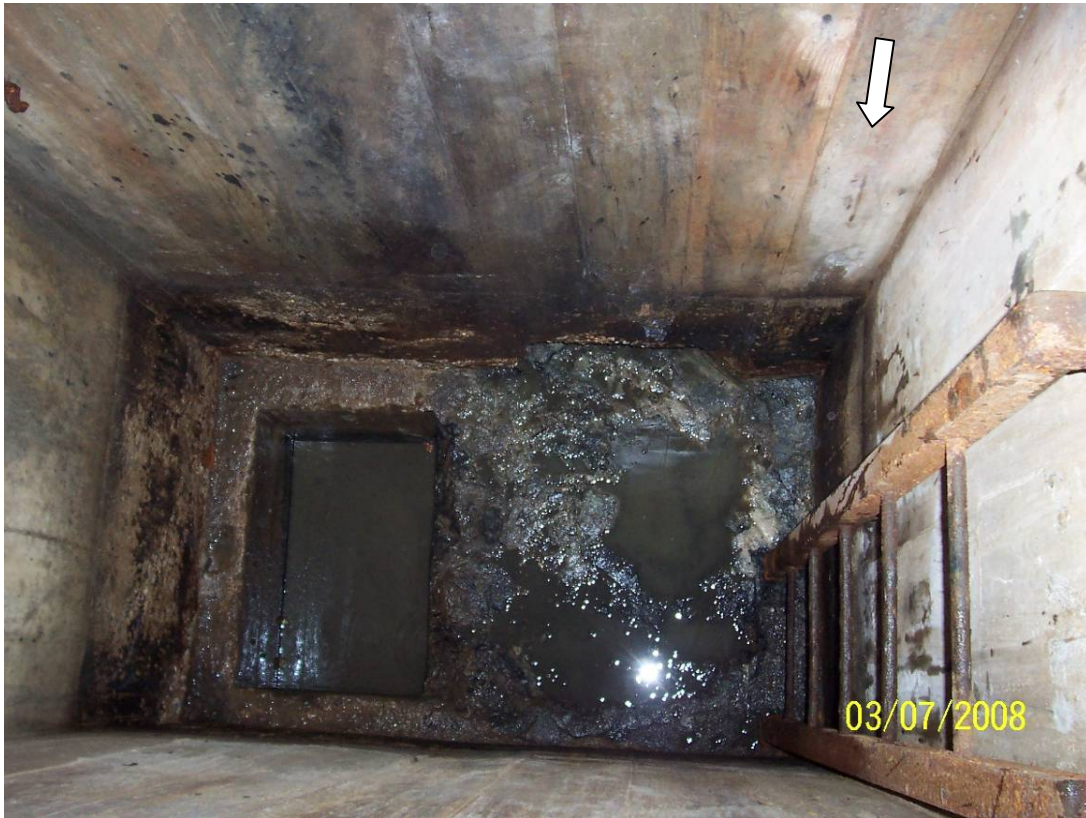
Photo 3-View of Pit#1 and sump inside Building 51 after pipe removal. Sludge was removed prior to closure. North indicated by white arrow.

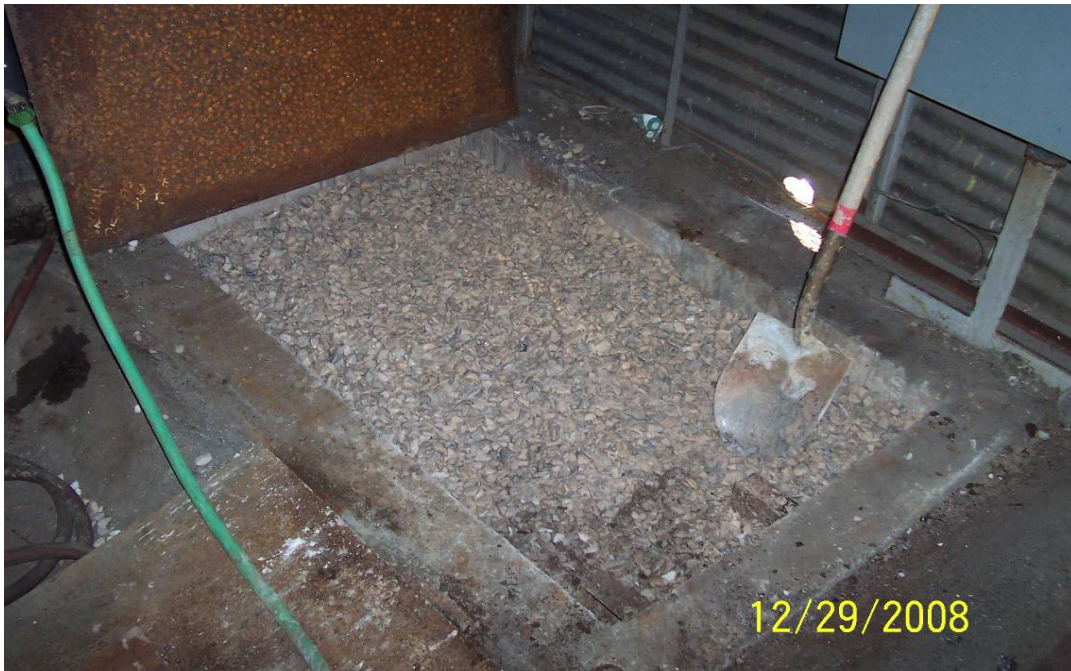
Photo 4-View of Pit#1 and sump inside Building 51 after backfilling. View facing southeast.

At Pit #1, the pipe chase that led south from Pit #1 to Pit #2 was plugged with concrete. The pit was then closed in place with crushed stone to approximately four inches below floor grade. Concrete was placed on top of the crushed stone and finished flush with the floor (see photographs in Appendix A).

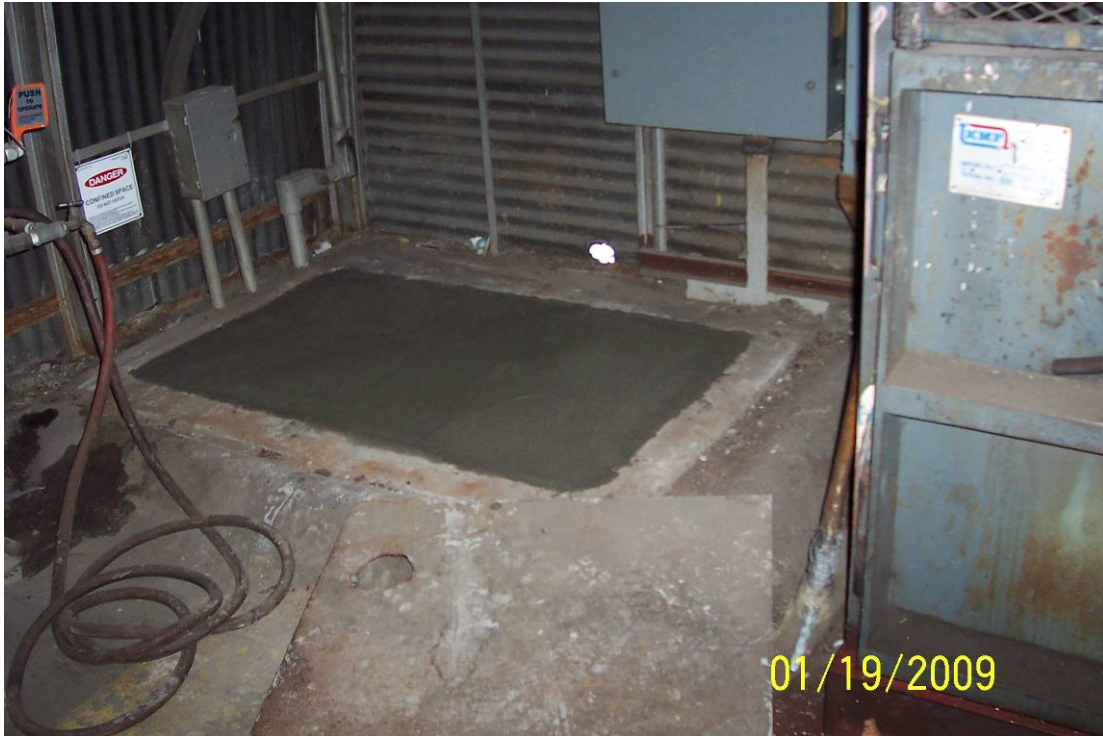
Photo 5-View of Pit#1 and sump inside Building 51 finished to grade with concrete. View facing southeast.

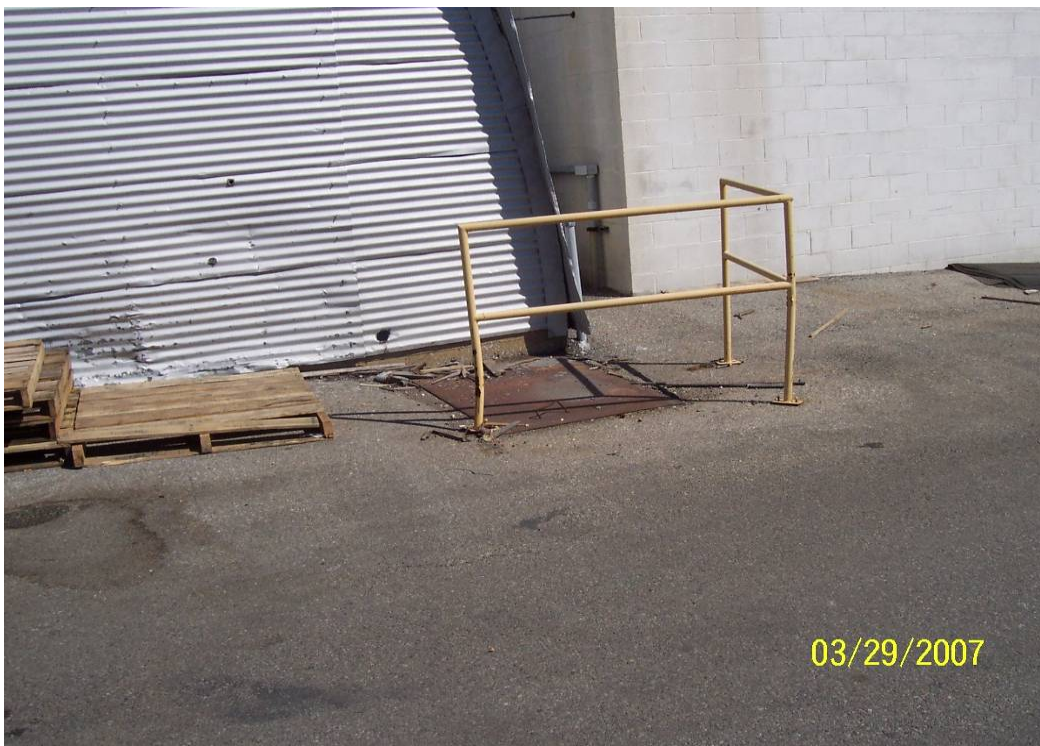
Photo 6 – View of Pit #2 at exterior southeast corner of Building 51. View facing north.

The dimensions and construction of Pit #2 were similar to those of Pit #1, and Pit #2 was also covered by a metal lid. Another recessed sump was observed in the bottom of the southern end of Pit #2. A three-inch metallic pipe trending southeast and a two-inch metallic conduit trending northeast were observed at the bottom of Pit #2 (see photographs in Appendix A). SAIC used utility locating methods to trace the three-inch conduit near a storm drain approximately 40 feet to the southeast, where the signal strength diminished. Review of a 1947 Naval Ordnance Plant drawing entitled “Steam Conduit, Bldg #43 to supply Storehouses” showed a buried steam line trending from the southeast corner of Building 51 to the southwest corner of Building 43. Both buildings currently receive steam from overhead conduits. Based on the above observation, the three-inch conduit is assumed to be an abandoned steam line and condensate return. Hence, the use of Pit #1 and Pit #2 was assumed to be for a former steam utility pit for Building 51. Utility locating methods were unsuccessful in determining the origin of the two-inch metallic pipe trending to the northeast from Pit #2. The pipe was empty, and its former use is unknown. Sections 2.0 and 3.0 provide detail on piping removal and capping.

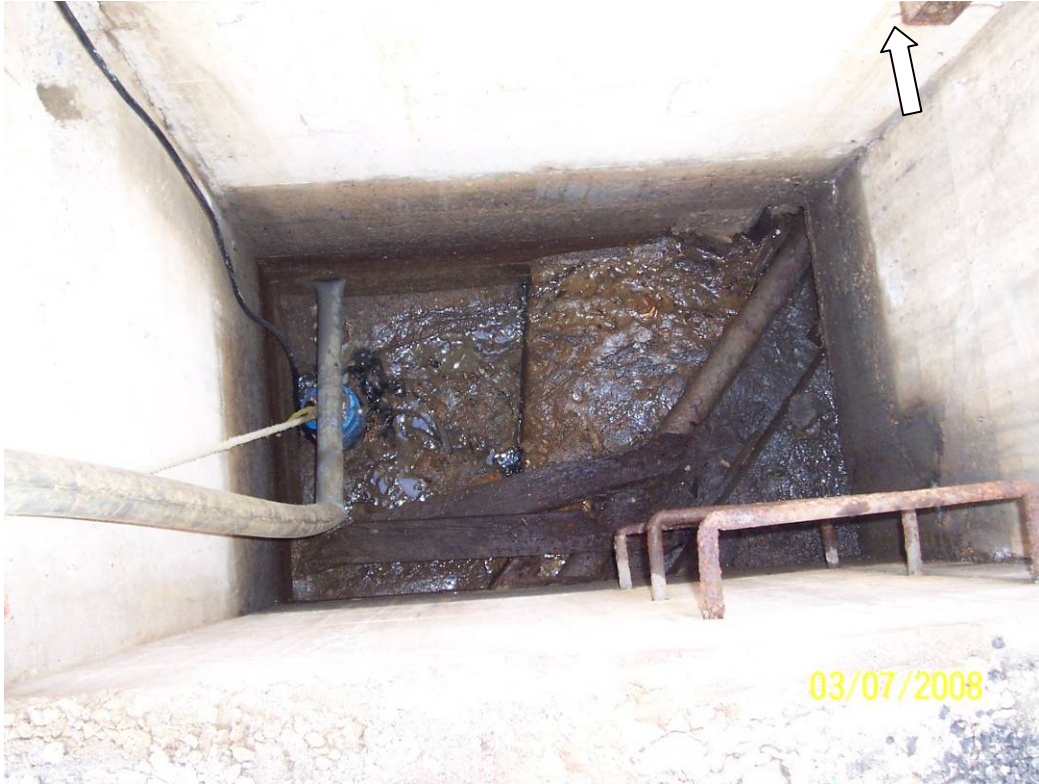
Photo 7-View of Pit#2 and sump outside Building 51 prior to cleaning and pipe removal. North indicated by white arrow.

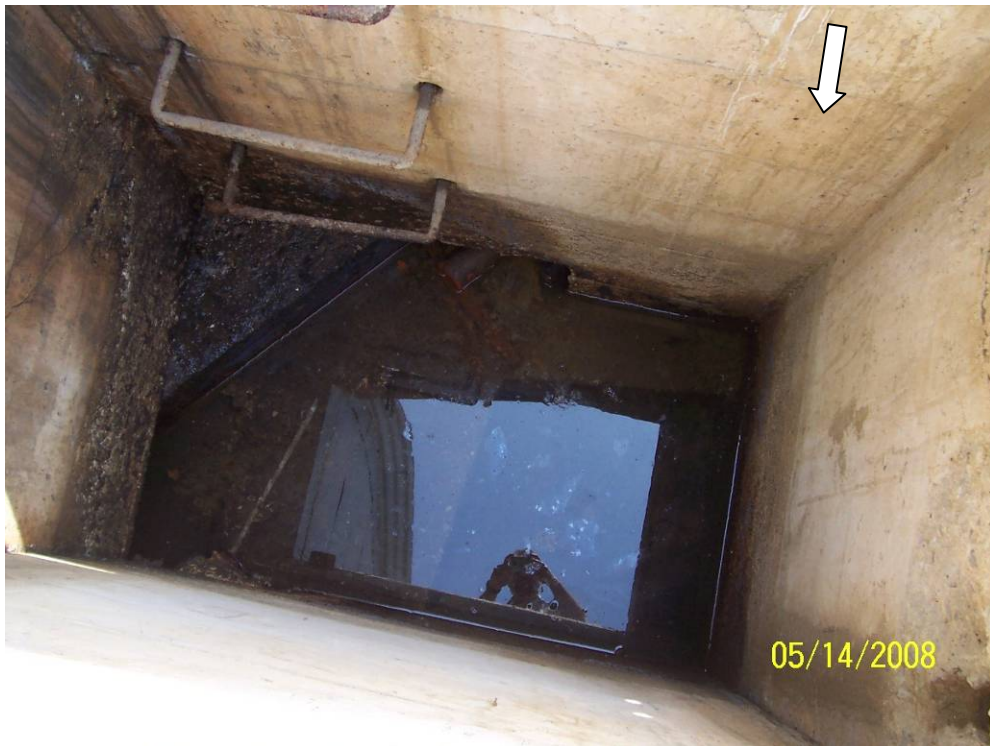
Photo 8- View of Pit#2 and sump outside Building 51 after cleaning and pipe removal (note rainwater has partially filled pit). North indicated by white arrow.

The exterior pit on the southeast corner of Building 51 (Pit #2) had two openings at the bottom where formerly used pipes once entered the pits. These were possible release points to the environment. For this reason, the exterior pit was cleaned out and then demolished and excavated in order to collect subsurface soil samples beneath the pit. At Pit #2, a saw was used to cut through the asphalt around the perimeter of the concrete pit. The saw was also used to cut the east and west walls of the pit away from the building foundation. Soil was excavated using a backhoe three feet beyond the west, south, and east sides to a depth slightly below the bottom of the pit (excavation to the north was prevented by the building). The three-inch steam line exiting the southeast corner of the pit was cut on the exterior side of the pit and plugged with concrete. The pit was then demolished using a backhoe bucket and a hydraulic hammer attachment. Additional soil was then excavated three feet below the pit, making the total depth of the excavation nine feet below grade level. Visual and photoionization detector (PID) screening of excavated soil did not indicate evidence of contamination within the excavation. All excavated material was staged on plastic pending disposal. Post-excavation soil samples were then collected from the bottom of the excavation (see Section 4.0), and a temporary safety/security fence was installed around the excavation.

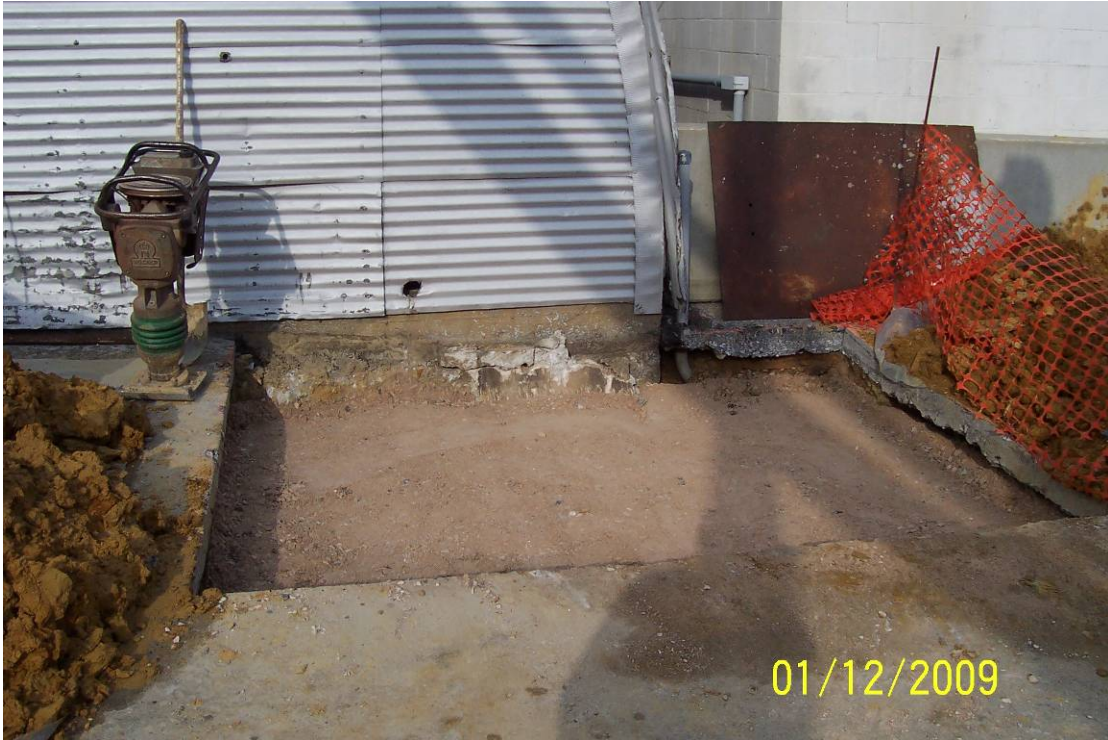
Photo 9- View of Pit#2 and sump outside Building 51 after backfilling. View facing north.

Based on the results of the post-excavation soil sampling, no additional soil was removed from the excavation at Pit #2. The excavation was backfilled with a combination of the staged soil and crushed stone. The remaining soil was disposed off-site as nonhazardous waste (see Appendix B). Backfilled material was compacted with the backhoe bucket to a depth of approximately four feet below ground surface. From this point to the surface, backfilled material was compacted in one-foot lifts using a vibratory compactor. The excavation was completed at grade to match the surrounding surface conditions (see photographs in Appendix A).

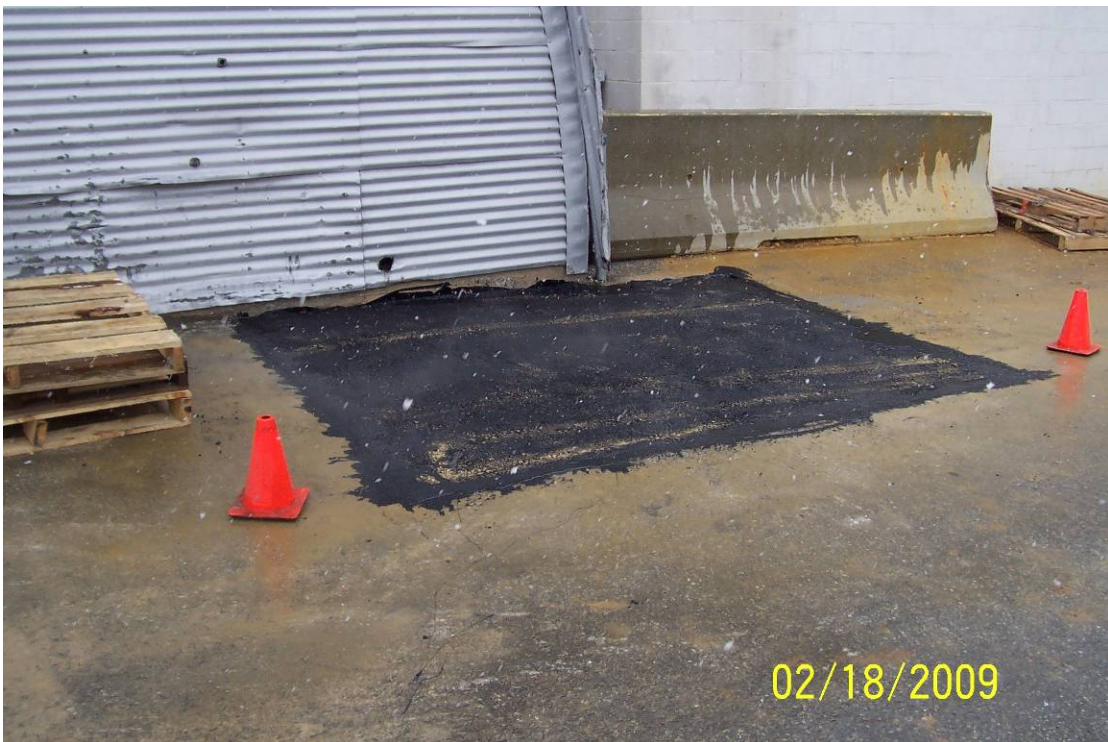
Photo 10- View of Pit#2 and sump outside Building 51 finished to grade with asphalt. View facing northeast.

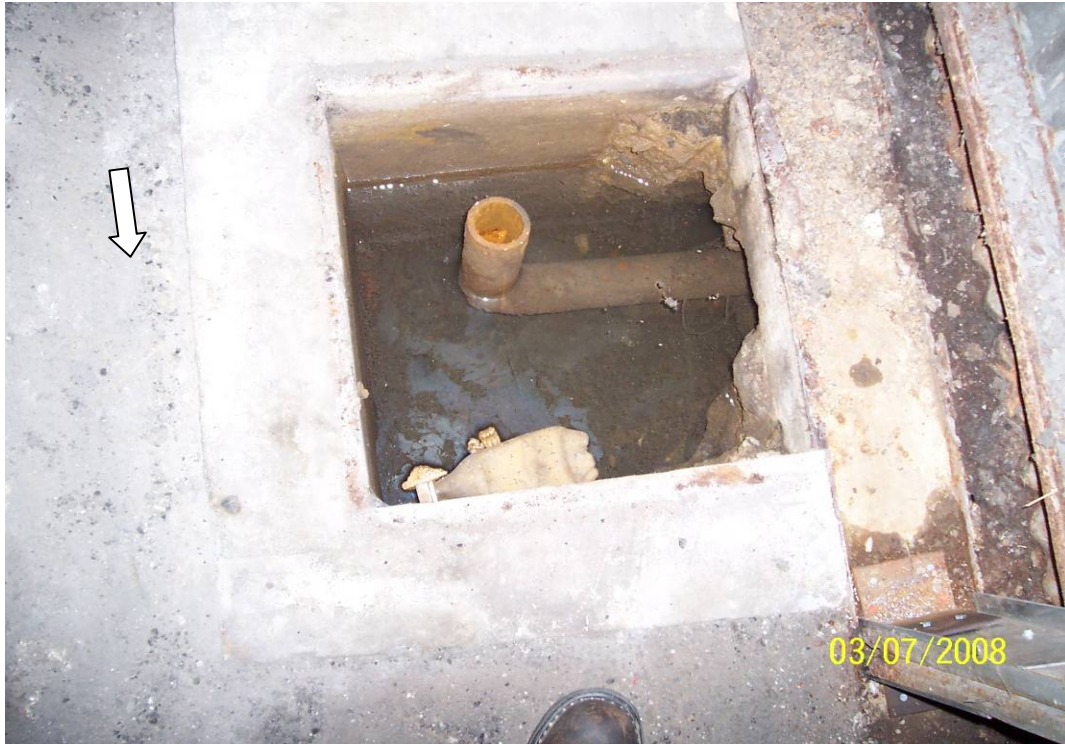
Photo 11- View of Pit#3 inside Building 51 prior to cleaning and pipe removal. North indicated by white arrow.

The third pit (Pit #3) was a small concrete electrical utility pit located inside the southwest corner of Building 51, covered with a metal lid. The dimensions of Pit #3 were approximately 18 inches square by 18 inches deep. The pit contained an empty two-inch metallic pipe (see photographs in Appendix A). SAIC used utility locating methods to trace the conduit for approximately 20 feet to the west to a square asphalt patch where the locating signal was lost. The asphalt patch is assumed to be the location of a previously closed electrical pit where the conduit terminated at a former adjacent building (former Building 52).

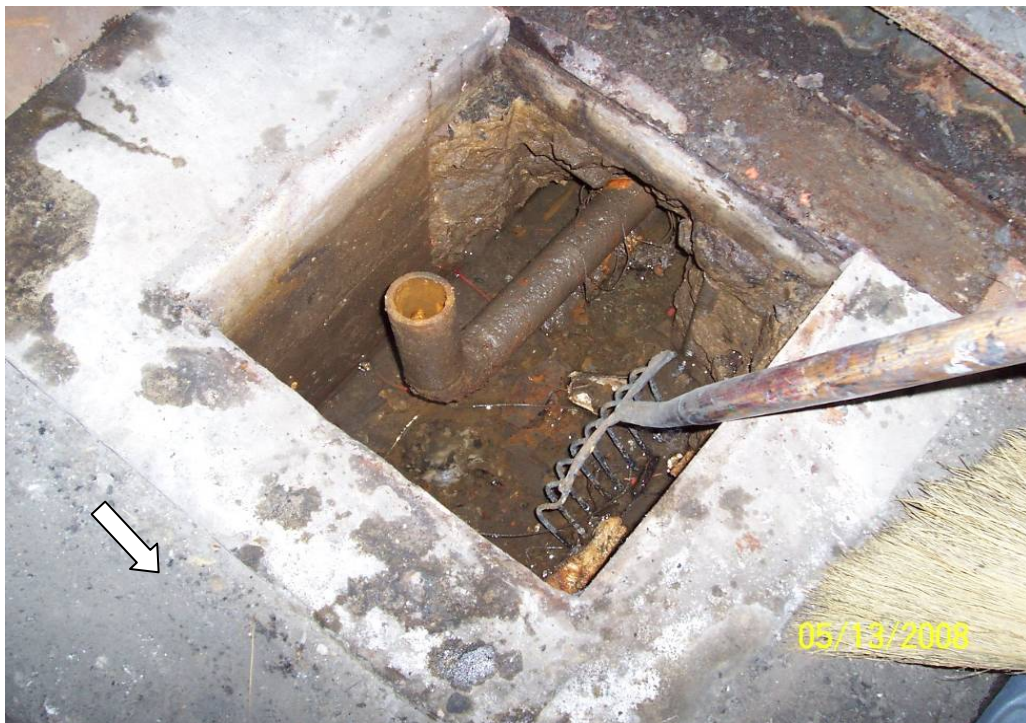
Photo 12 – View of Pit#3 during cleaning and prior to pipe removal. North indicated by white arrow.

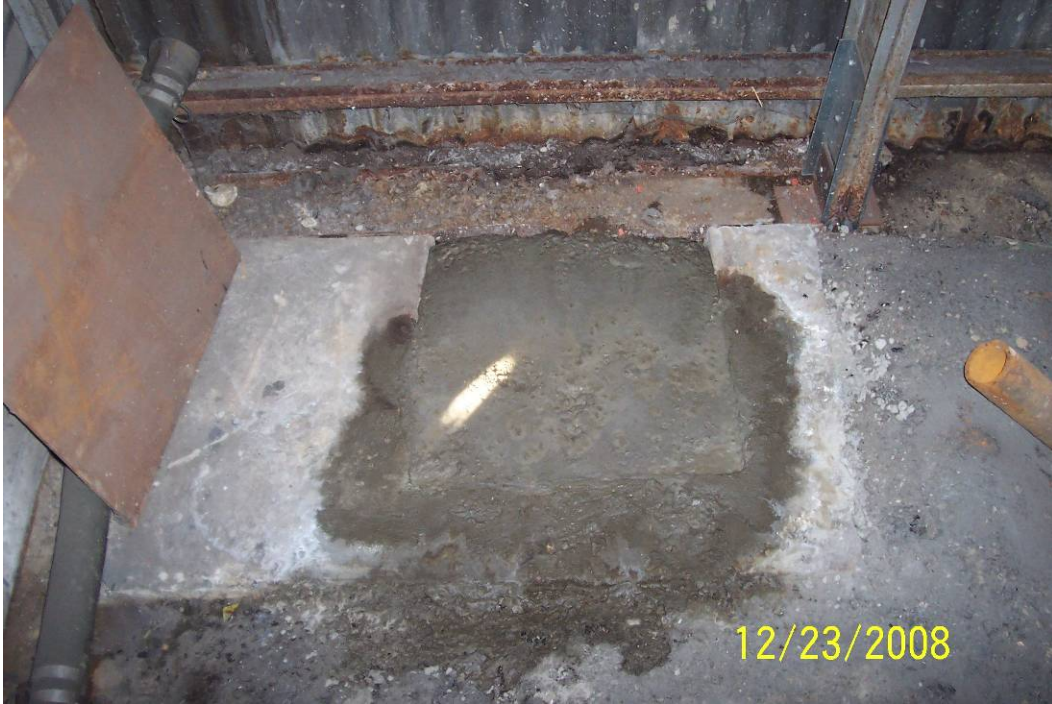
Photo 13- View of Pit#3 inside Building 51 finished to grade with concrete. View facing west.

Pit #3 was closed by removing the water and the two-inch metallic conduit, filling the pit with crushed stone to approximately four inches below floor grade, and placing concrete on top of the stone (see Appendix A photographs).

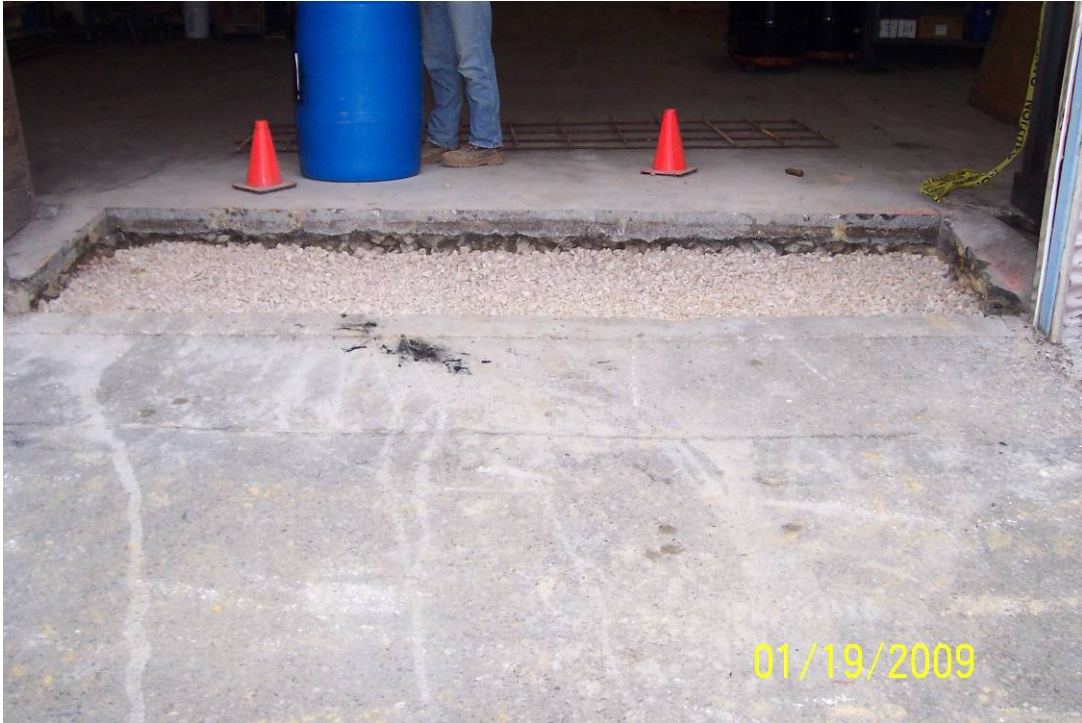
Photo 15- View of entrance slab to Building 51 after backfilling. View facing north.

As part of the spill containment system at Building 51, the southern entranceway was equipped with an approximate four-inch raised asphalt entrance “bump” over the building’s concrete slab. The bump had deteriorated and was causing rough forklift travel. A design for the excavation and construction of a new concrete pad over a portion of the bump was completed by the engineering firm, NuTec. In January 2009, Stewart & Tate removed the southern half of the bump (just inside the southern entrance of the building) and excavated subbase material and soil to approximately two feet below grade level (see photograph in Appendix A).

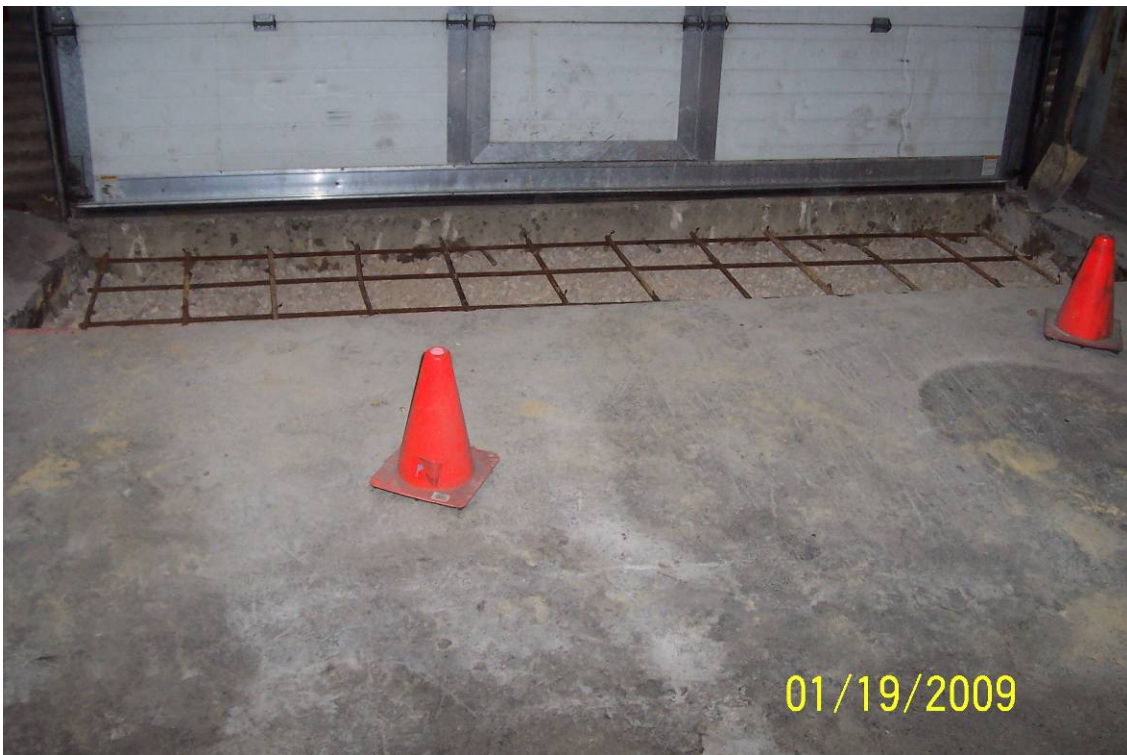
Photo 16- View of entrance slab to Building 51 with rebar. View facing south.

Based on the results of the post-excavation soil sampling, no additional soil was removed from the Building 51 doorway excavation area. Excavated macadam and stone from this excavation were disposed off-site as nonhazardous waste (see Appendix B). The excavation was backfilled and compacted with crushed stone. A rebar grid was placed on top of the compacted stone and finished to grade with concrete (see photographs in Appendix A).

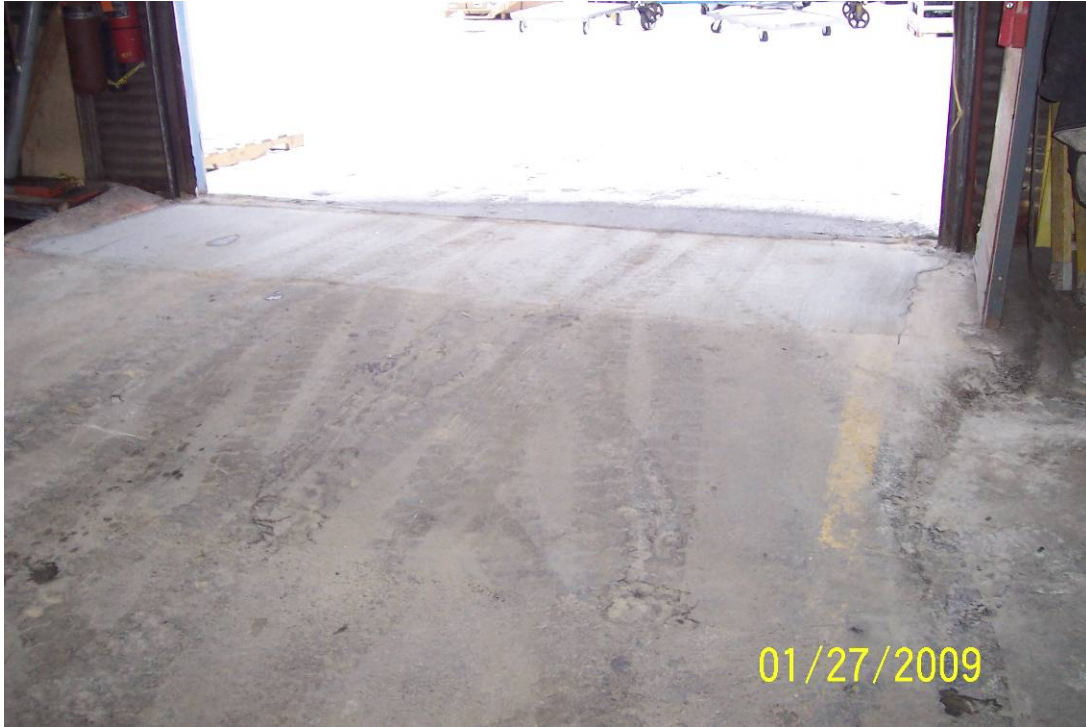
Photo 17- View of entrance slab to Building 51 completed to grade with concrete. View facing south.
