Re: Building 51 Closure Report
Harley-Davidson Motor Company (York Facility)
SAIC Project 2603100069/3000/100

**BUILDING 51 CLOSURE REPORT
FORMER LESS THAN 90-DAY HAZARDOUS WASTE
STORAGE FACILITY
FORMER YORK NAVAL ORDNANCE PLANT**

SAIC Project 2603100069 / 3000 / 100

Building 51 Closure Report
Former Less Than 90-Day Hazardous Waste Storage Facility
Former York Naval Ordnance Plant

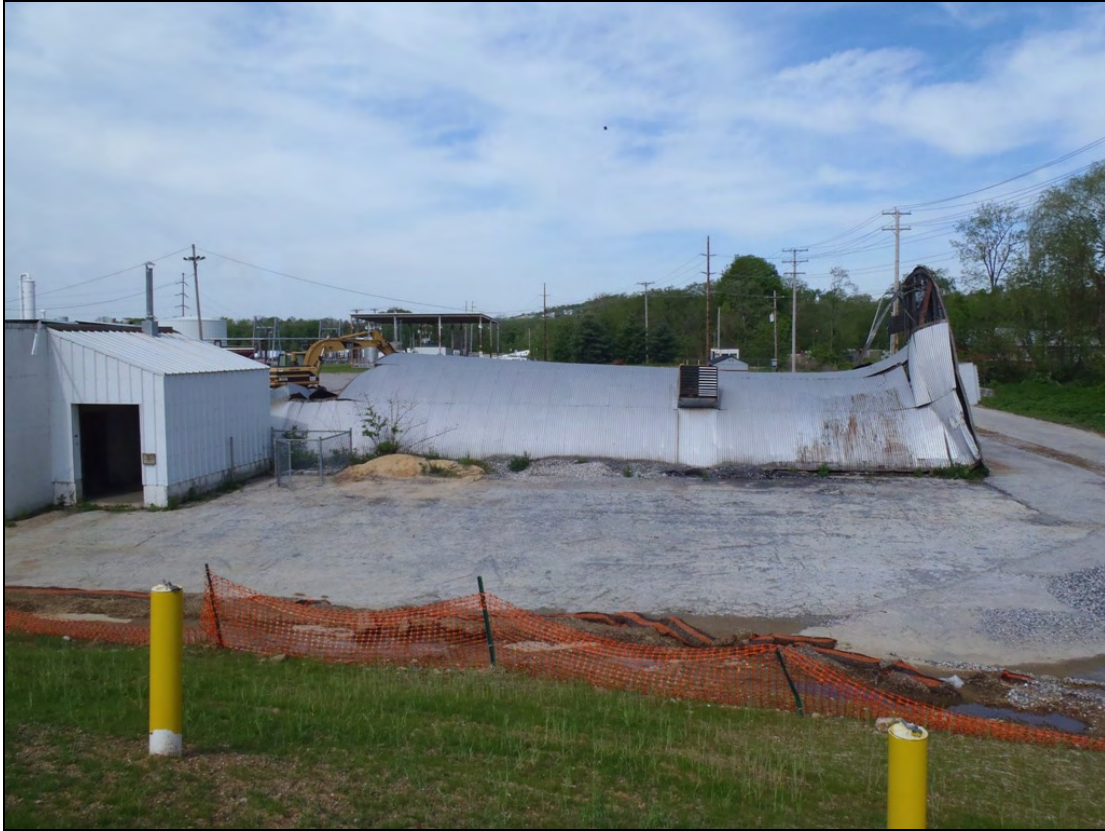
Photo 1: Building 51 (view looking west) during initial demolition (May 2011).

The above-grade structure of Building 51 was demolished by Harley-Davidson in May 2011. Only the building slab (see Photos 1 and 2, **Appendix A**) remained following demolition. The building footprint measured approximately 100 feet by 40 feet wide.

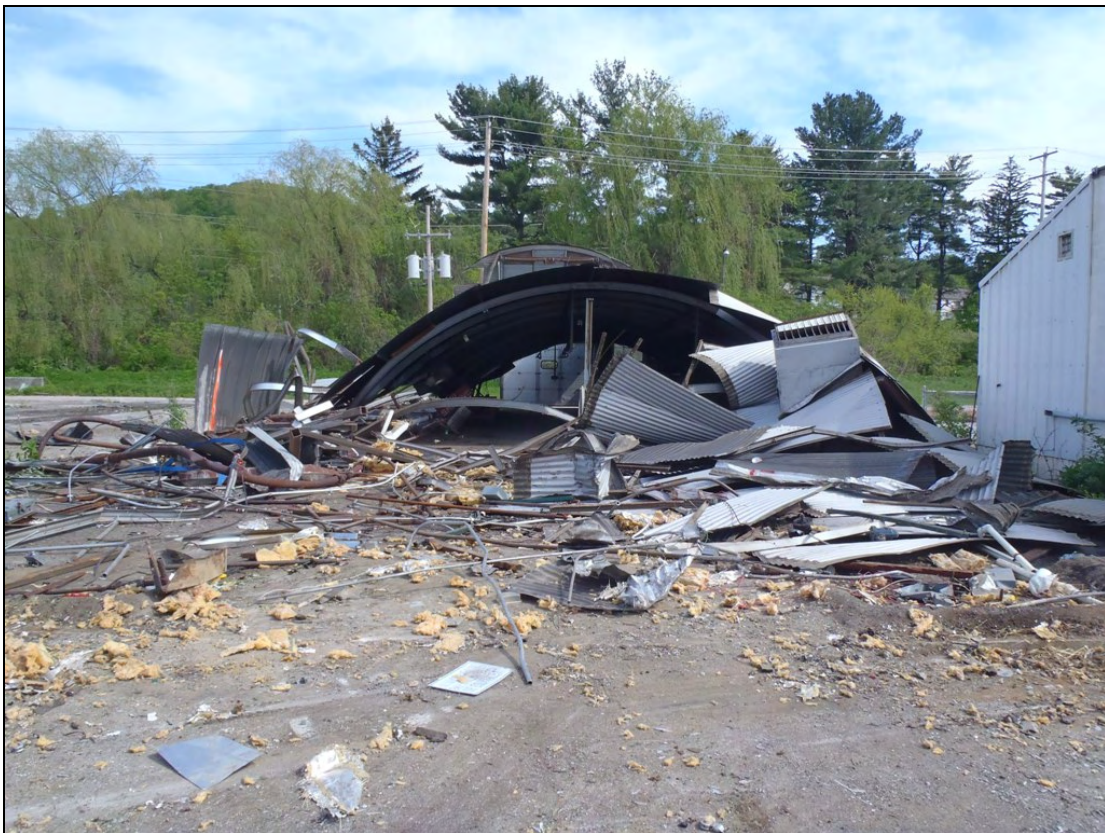
Photo 2: View looking north of demolition of former Building 51 (May 2011).

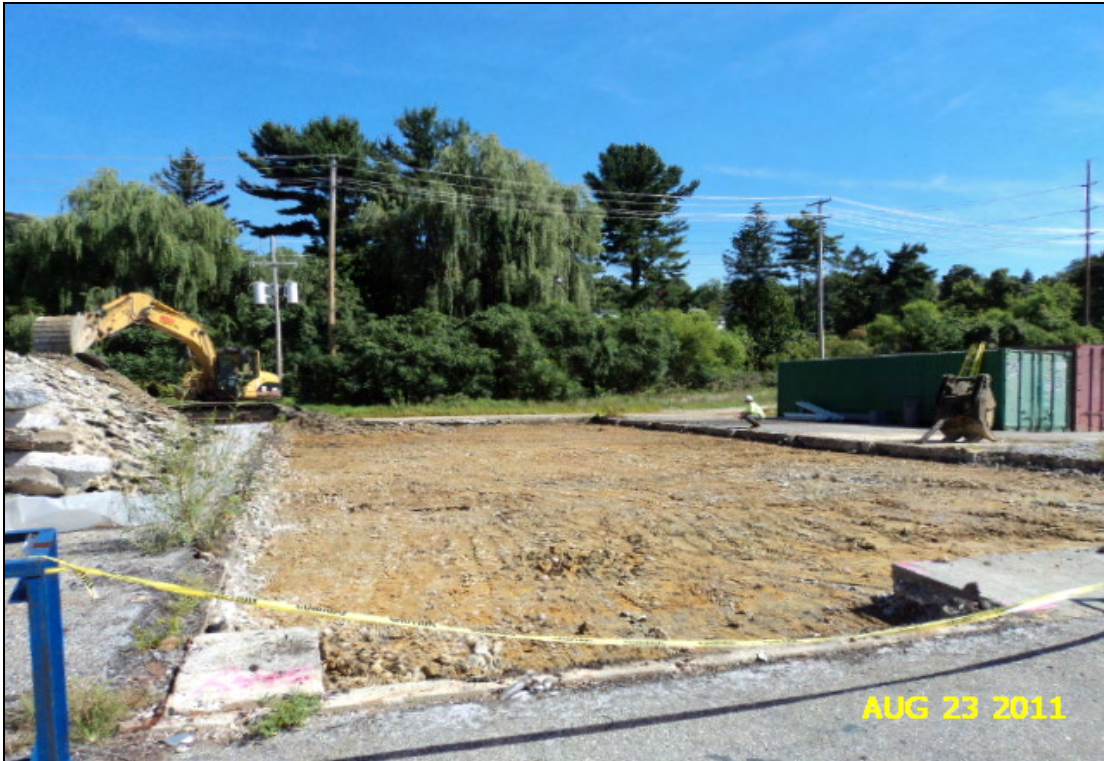
Photo 3: View looking north at Building 51 following demolition and removal of former hazardous waste storage pad and underlying gravel, and prior to confirmation sampling.

Closure activities began at the former Building 51 hazardous waste storage pad in August 2011. BrightFields Inc. of Wilmington, Delaware, performed the excavation and backfill activities, and EQ Environmental Inc. performed the waste transportation and disposal activities. Approximately one foot of bituminous concrete, concrete pads, and underlying gravel was removed and staged on, and covered with plastic (see Photos 3 and 4, **Appendix A**). The bituminous concrete, gravel, soil, and concrete were sampled for off-site disposal.

The soil below the bituminous concrete and concrete pads was scanned with a photoionization detector (PID) and visually inspected. No additional soil was removed since there were no elevated PID readings above background, and no staining or unusual odors were observed.

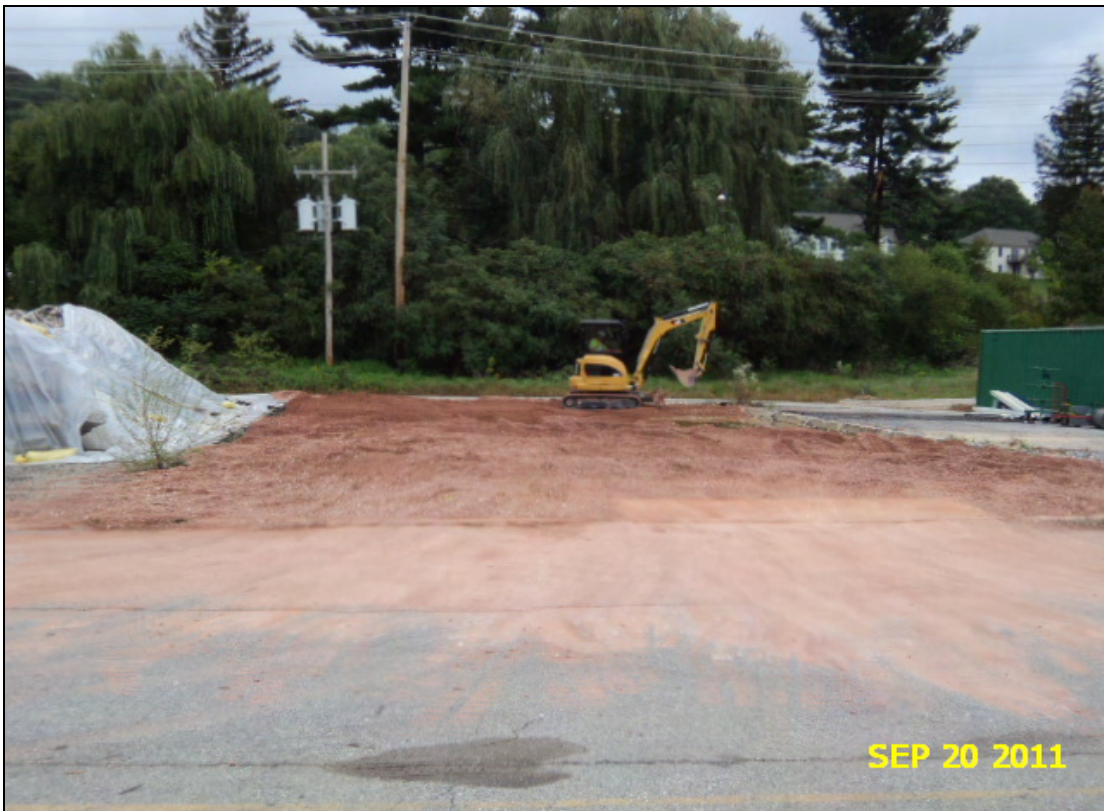
Photo 4: View looking north at backfilled excavation of former Building 51 area.

Following confirmation results, the building pad was backfilled with stone to the original floor grade (see Photo 4, **Appendix A**). Subsequently, the former building area was covered with approximately six inches of additional topsoil and grass seed (see Photo 5, **Appendix A**).

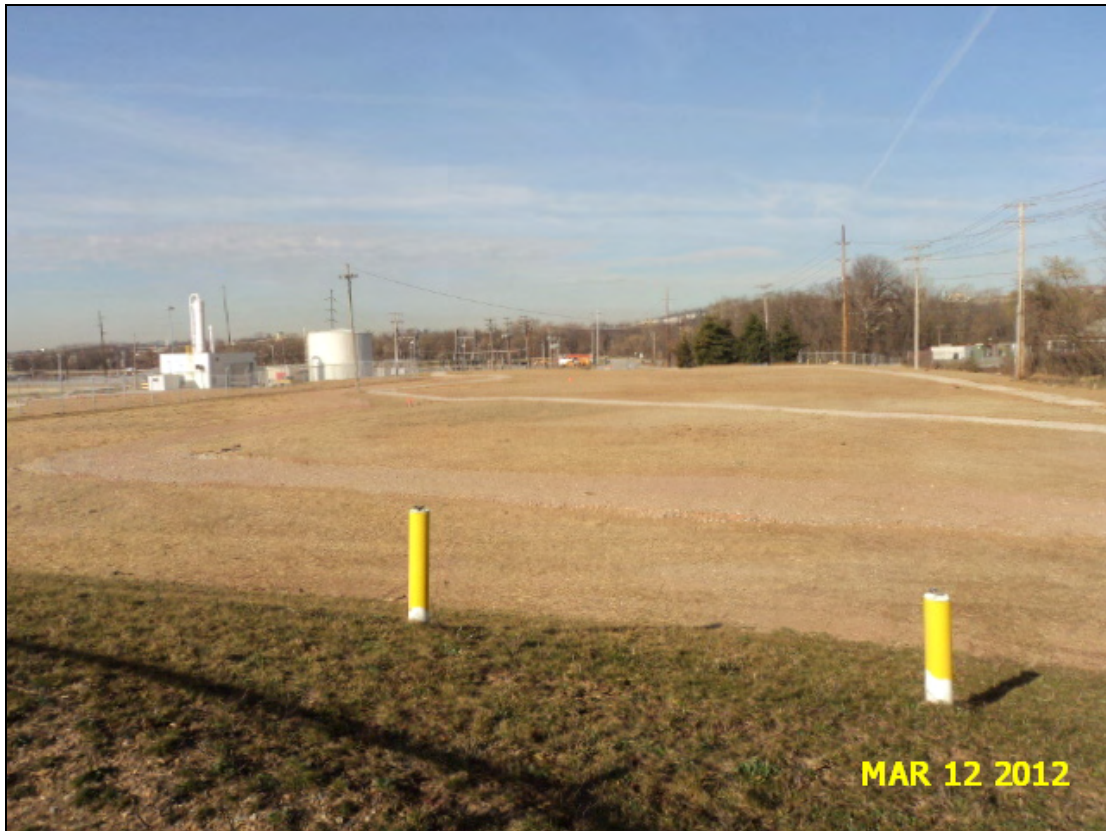
Photo 5: View looking west across restored area of former Building 51 (note walking path, gravel drive, and topsoil/seeded restorations).

There are no known environmental impacts to soil or groundwater remaining from the removal and off-site disposal of the floor/subfloor at Building 51. The completed remedial work at Building 51 can be seen in **Appendix A** (Photo 5). The concentrations of regulated substances detected in the confirmation soil samples collected from beneath the excavation area were less than the PADEP Act 2 MSCs. Although arsenic was detected at concentrations greater than the EPA industrial soil RSL in several of the confirmation samples, it is considered within typical background levels for this site and is nonetheless in concentrations below the PADEP Act 2 MSCs. In addition, hexavalent chromium was detected at concentrations greater than the EPA industrial soil RSL in two of the confirmation samples (B51H-CS-008 and -009), but hexavalent chromium was not detected at concentrations greater than the PADEP direct contact or soil-to-groundwater MSCs in these samples. Further, the EPA RSLs constitute screening levels used to identify areas where further investigation may be warranted, and the soil investigation in the Building 51 footprint constitutes adequate further investigation that meets the applicable, required soil sampling regime established under Act 2.

Clean, compacted stone backfill has been placed over the excavation area, and Harley-Davidson has installed additional topsoil (and seeded) over the backfill material.
