FORM A
MONITORING AND MAINTANCE OF CAP AREAS FOR fYNOP ANNUAL
POST-REMEDATION CARE PLAN ACTIVITIES

This form is used to document the results of annual post-remediation care activities for engineering and institutional controls at the Former York Naval Ordnance Plant (fYNOP) in York, Pennsylvania. These activities are to be performed in accordance with the procedures in the approved Pennsylvania Land Recycling and Environmental Remediation Standards Act (Act 2) Final Report and Post-Remediation Care Plan (PRCP) contained in Appendix J of the Final Report.

**Re: Building 3 Stormwater Utility Soil Characterization
Harley-Davidson Motor Company Operations, Inc.
1425 Eden Road, York Pennsylvania**

**Re: Building 70 Sinkhole Repair and Soil Characterization
Harley-Davidson Motor Company Operations, Inc.
1425 Eden Road, York Pennsylvania**

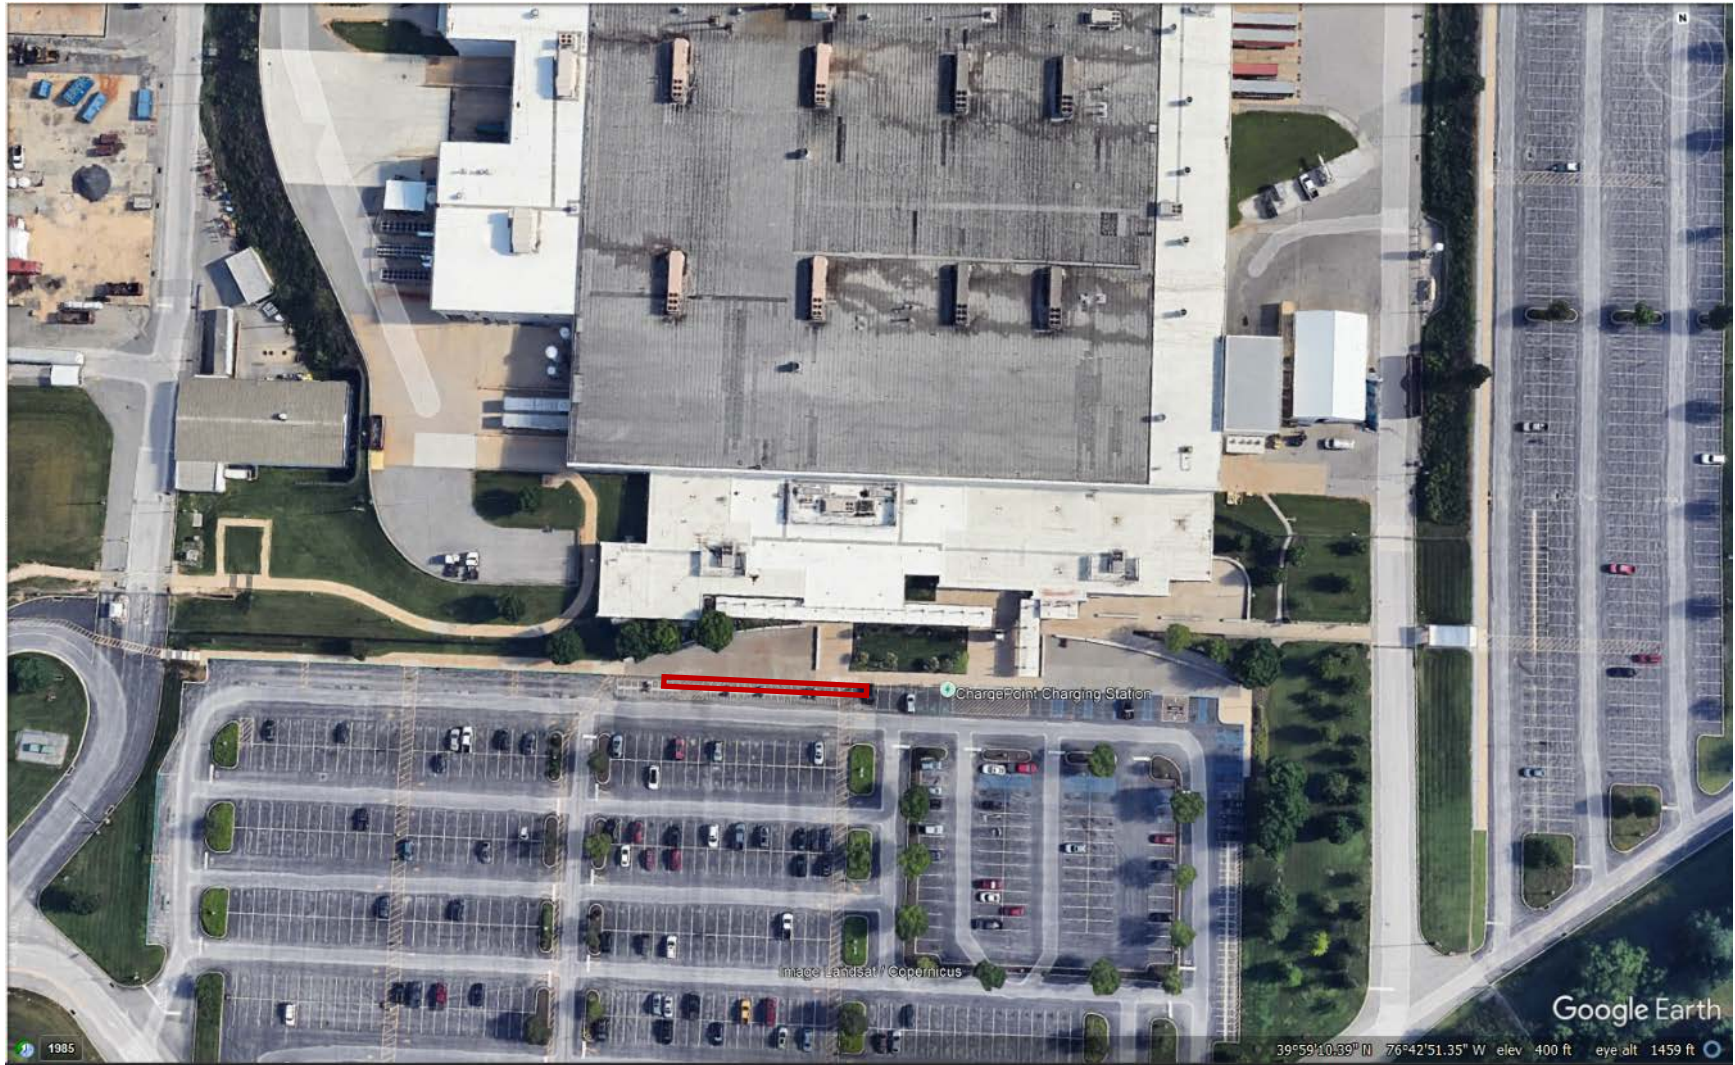
The Building 3 stormwater utility work included the installation of a new stormwater inlet and stormwater piping along the sidewalk curb south of Building 3 (**Figure 1**). The utility and excavation work was conducted by Kinsley Construction, a Harley-Davidson contractor. Emily Wade (HTG) was the qualified environmental professional who monitored worker activity, inspected and scanned the excavated soil with a photoionization detector (PID), which is used to detect volatile organic compounds (VOCs) in the soil, and collected a representative sample of the excess soil for characterization. Contractors conducting this work excavated and stockpiled excess soil on-site following the utility installation work (**Figure 2**).

The contractor installed a new stormwater inlet and piping to connect the new inlet to an existing inlet to the west (**Figure 1**). The utility installation area is located south of the main plant entrance. After the stormwater utilities were installed, the excavation area was backfilled with ten inches of stone and topped with six inches of asphalt (binder and topcoat). The cap area that was removed for the installation work was replaced with acceptable cap material meeting the minimum thickness and quality for direct contact prevention identified in the PRCP. Excavated soil was stockpile in the upper 80 (northern portion of the site) (**Figure 2**). Photos of the stormwater utility work and asphalt installation are provided in **Appendix A**.

Figure 1 – Stormwater inlet and pipe installation area shown in red rectangle.

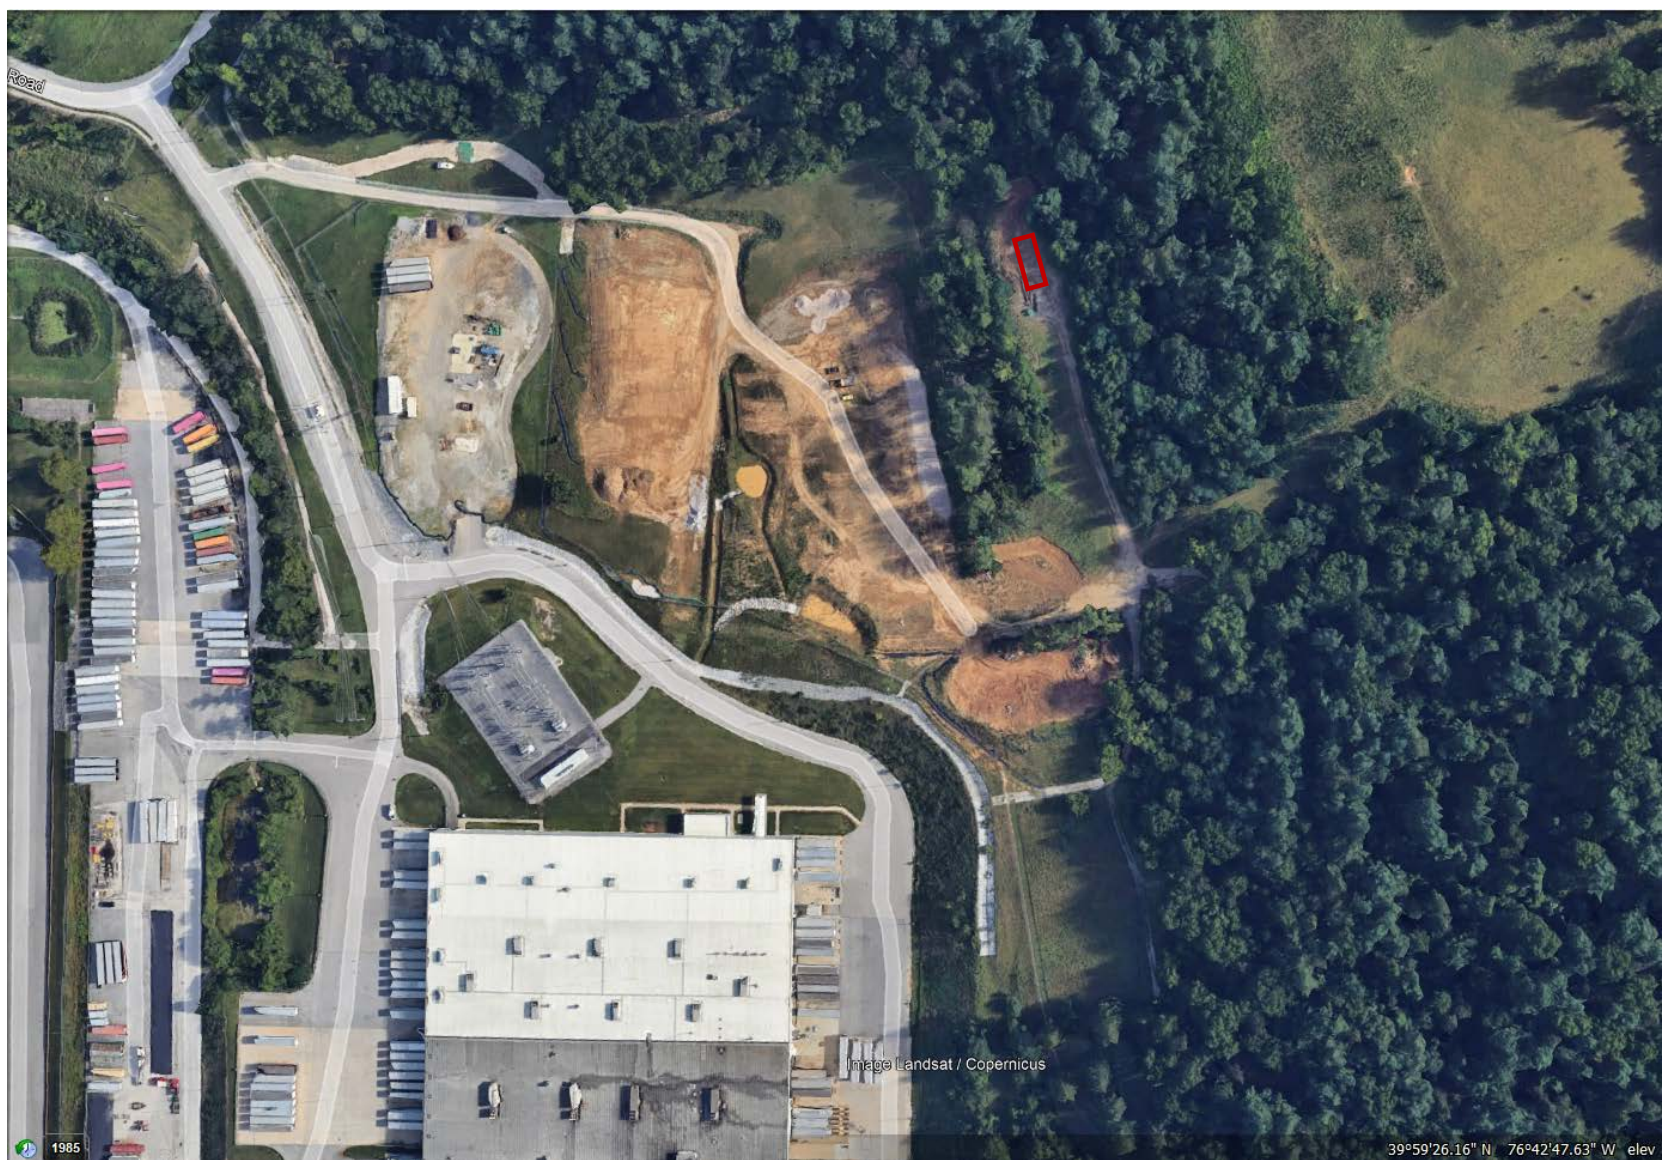
Figure 2 – Excavated soil stockpile location shown in red rectangle.

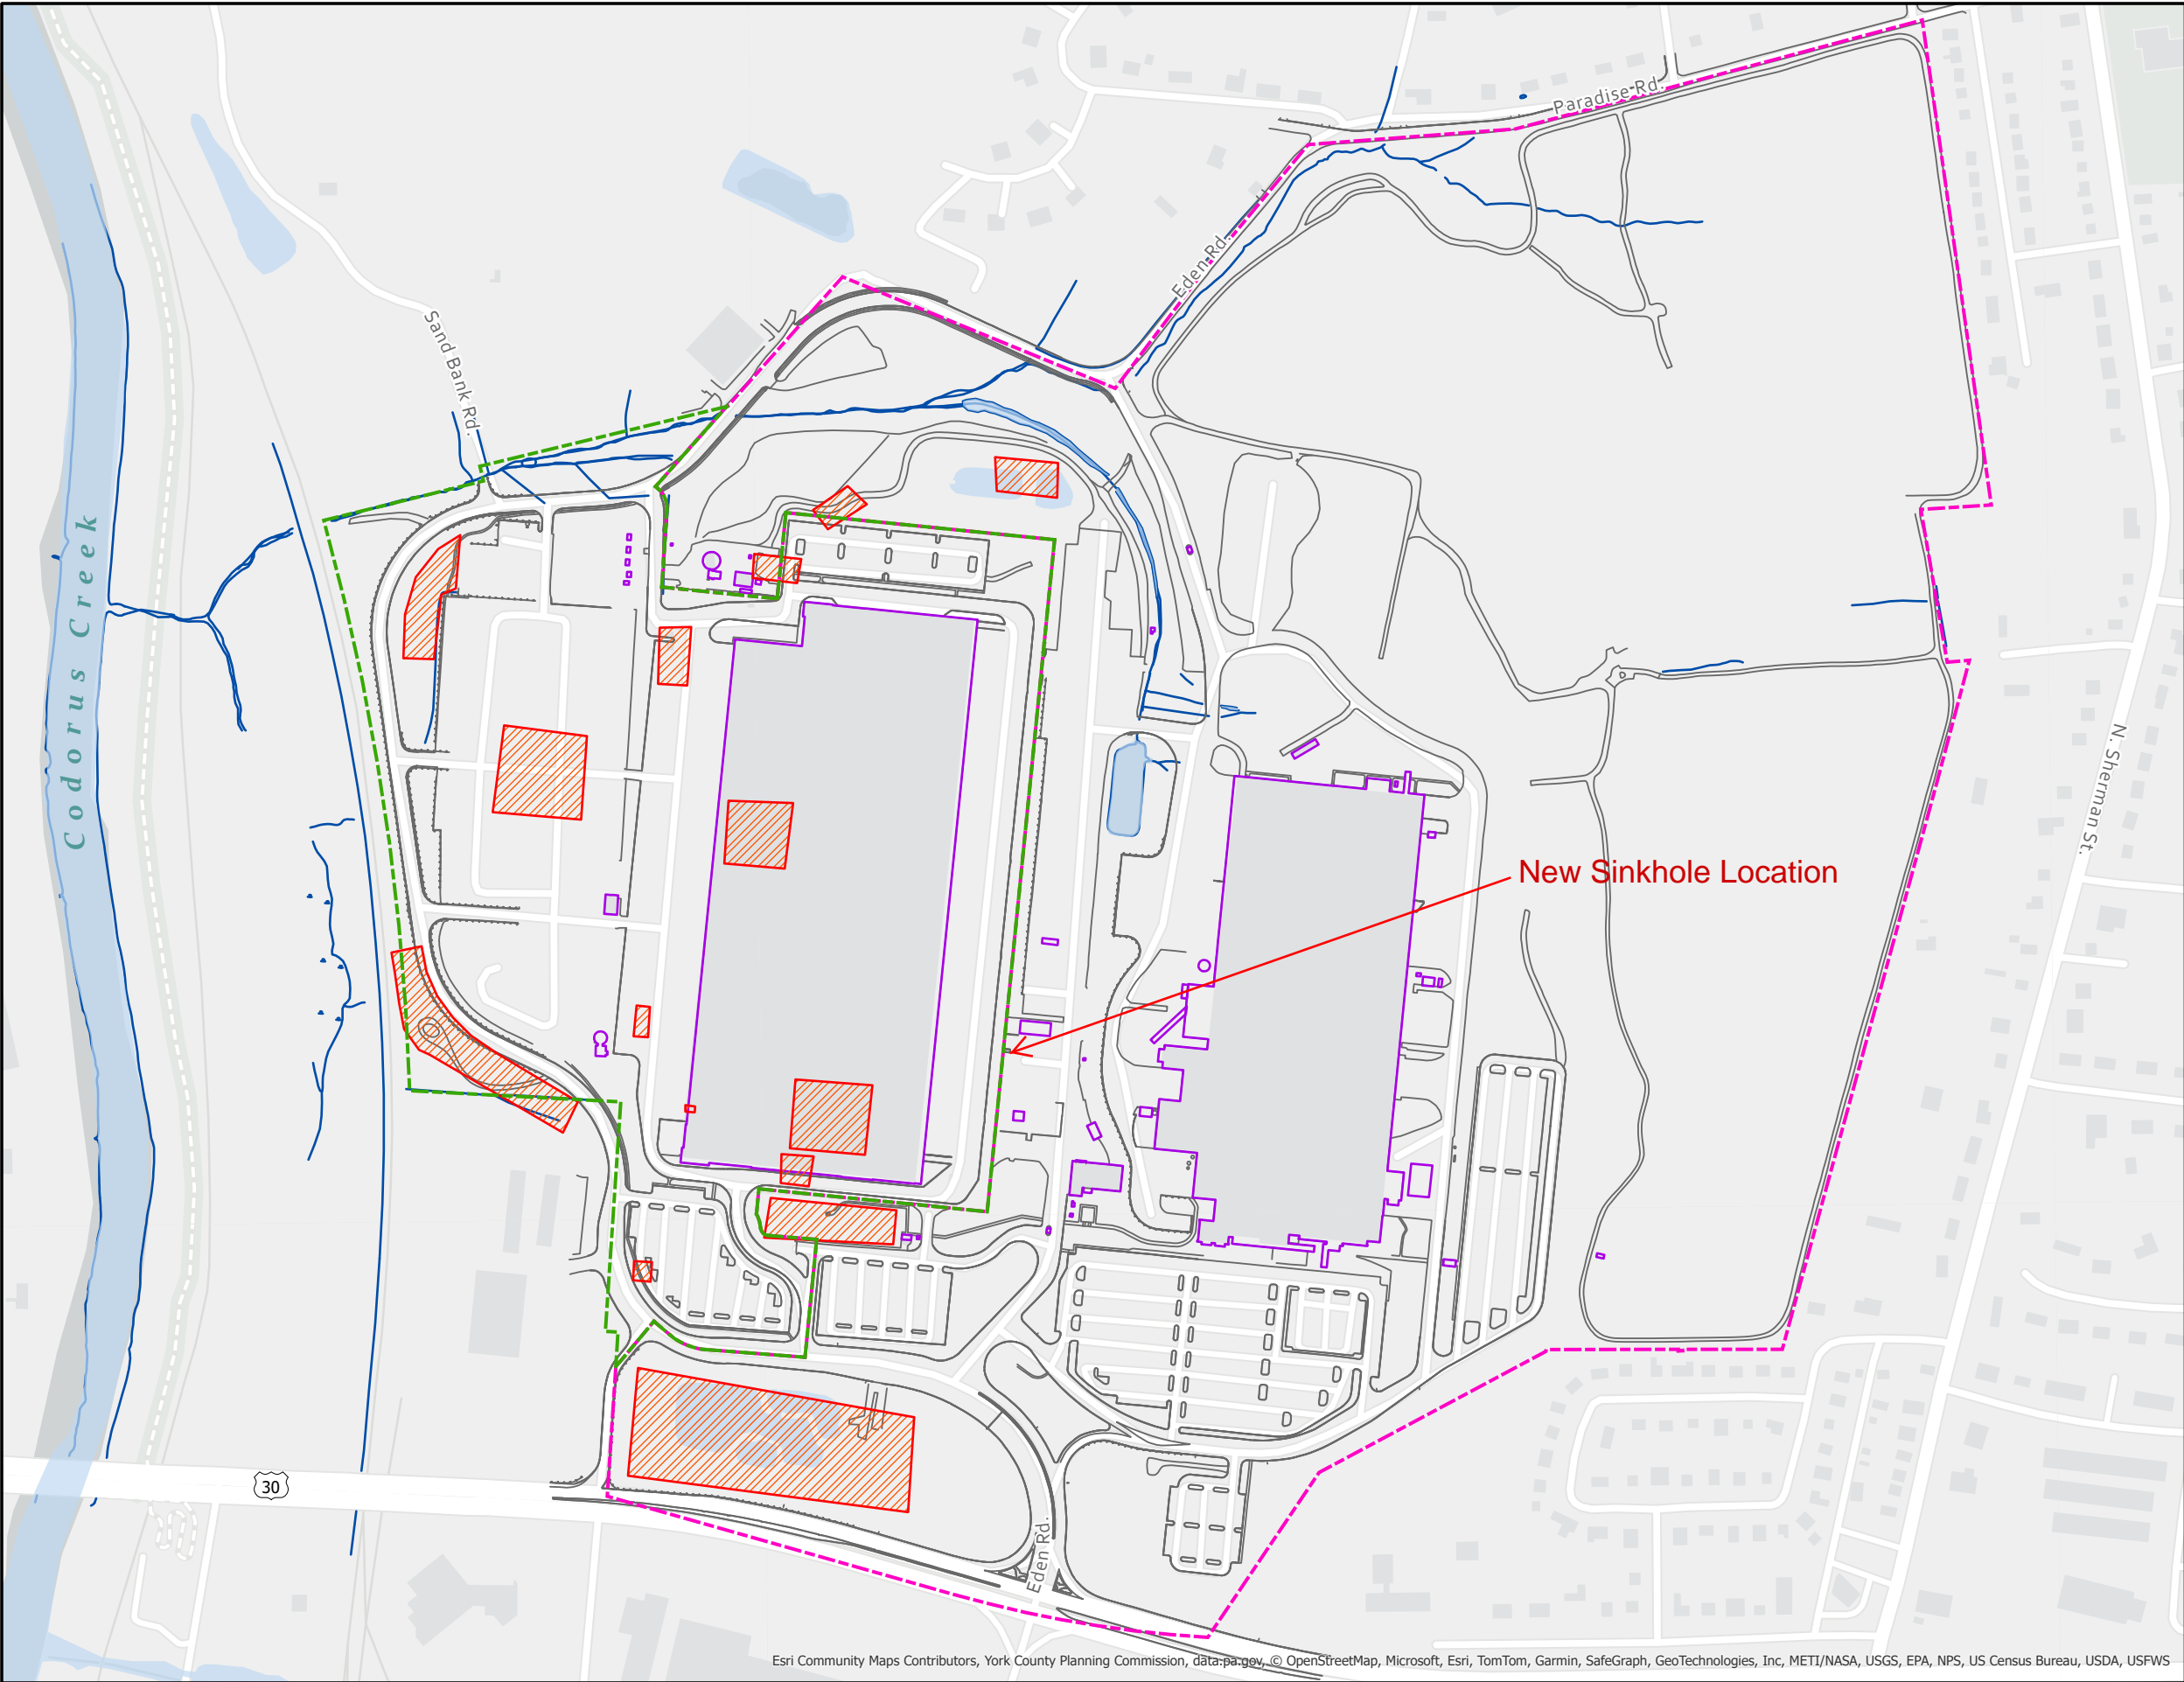
Hydro-Terra Group (HTG) provided qualified environmental professional and environmental soil characterization services in response to a sinkhole that developed near Building 70 at the Harley-Davidson Motor Company Operations, Inc. (Harley-Davidson) facility in York, Pennsylvania (**Figure 1**). This report provides the results of the repair/restoration and qualified environmental professional monitoring and soil characterization activities.

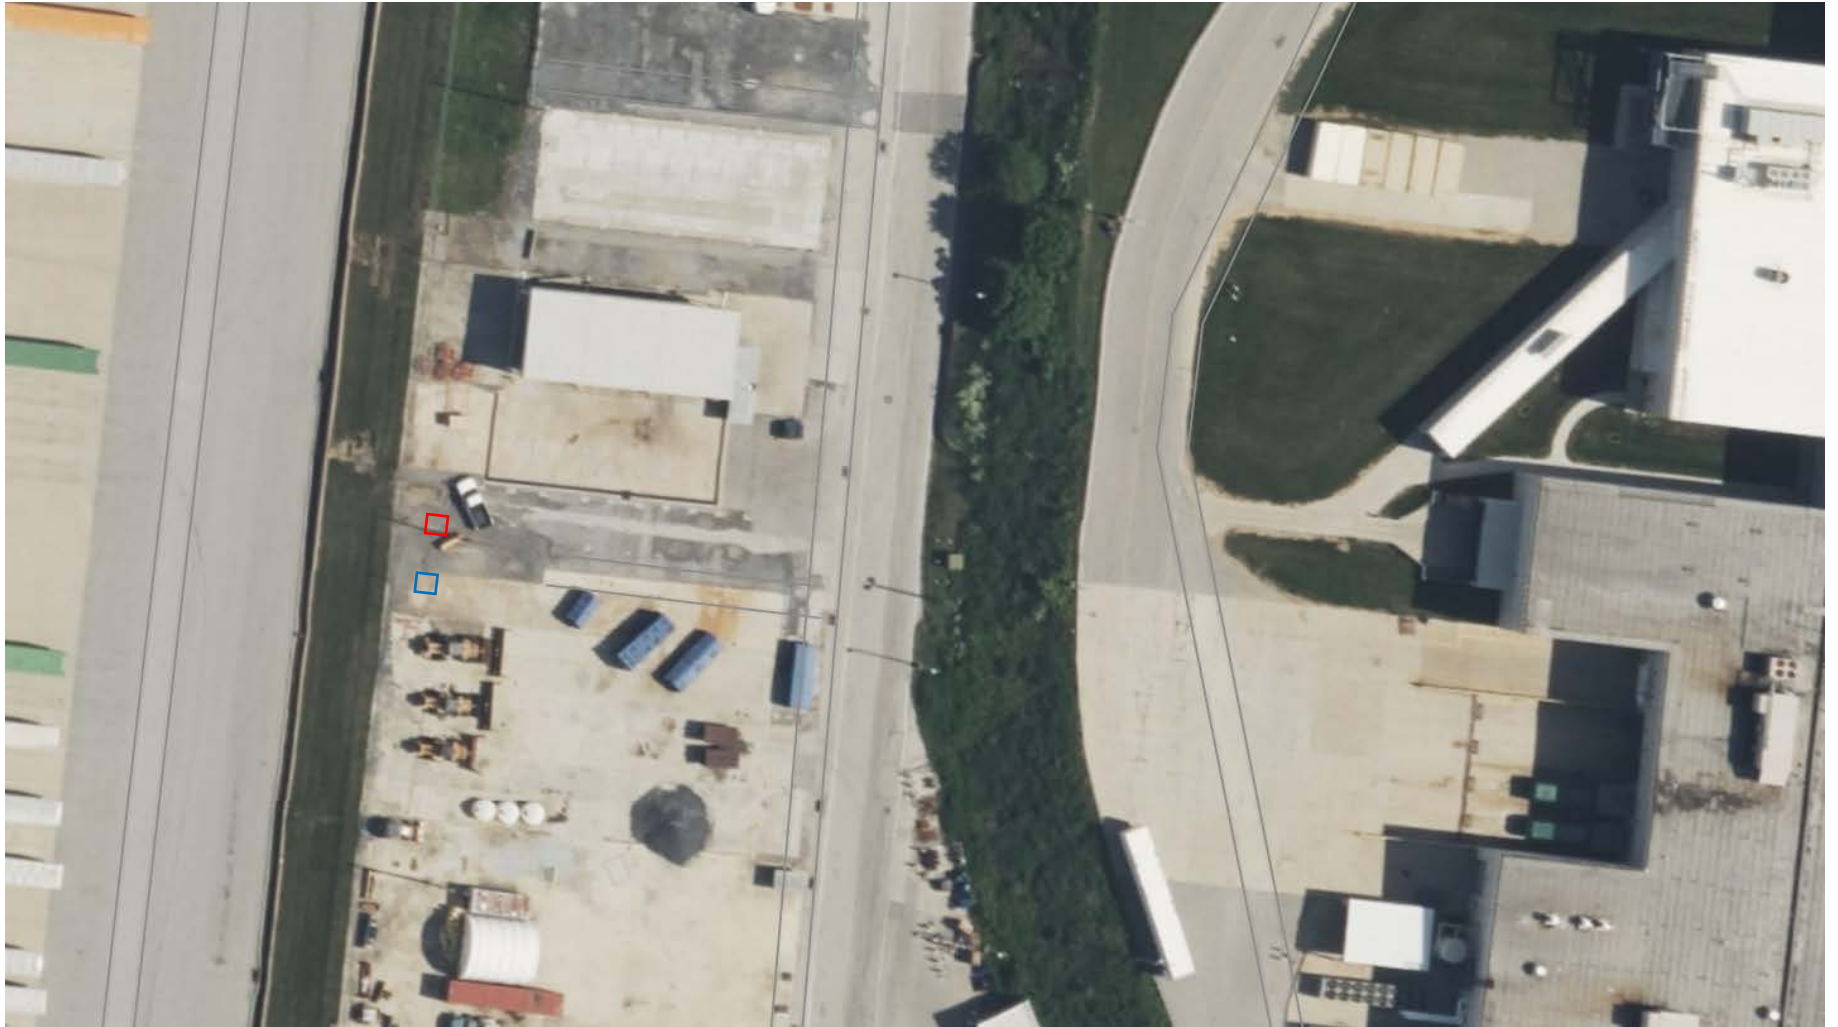
The Building 70 sinkhole repair work included excavation of soil until structurally stable soil was encountered. Non-woven geotextile fabric was placed along the limits of the excavation area, the excavation area was backfilled with reverse grade rock backfill, and the asphalt cap was replaced. The sinkhole repair work was conducted by Stewart & Tate, Inc. (Stewart & Tate). Emily Wade (HTG) was the qualified environmental professional who monitored worker activity, inspected and scanned the excavated soil with a photoionization detector (PID), which is used to detect volatile organic compounds (VOCs) in the soil, and collected a representative sample of the excess soil for characterization. Contractors conducting this work excavated and stockpiled excess soil on-site near the sinkhole repair work area. The location of the Building 70 repair area is shown on **Figure 2**.

Figure 2 – Sinkhole Repair area shown in Red box. Location of excavated soil stockpile show in Blue box.
