**FORM A**  
**MONITORING AND MAINTANCE OF CAP AREAS FOR fYNOP ANNUAL**  
**POST-REMEDATION CARE PLAN ACTIVITIES**

This form is used to document the results of annual post-remediation care activities for engineering and institutional controls at the Former York Naval Ordnance Plant (fYNOP) in York, Pennsylvania. These activities are to be performed in accordance with the procedures in the approved Pennsylvania Land Recycling and Environmental Remediation Standards Act (Act 2) Final Report and Post-Remediation Care Plan (PRCP) contained in Appendix J of the Final Report.

The activities covered by this form include reviewing low altitude aerial photographs using unmanned aircraft system (drone) technology and conducting a walk-over inspection to monitor integrity of cap areas in accordance with Section 4.3.1 in the PRCP. This form also includes interviewing property representatives to document maintenance of cap areas in accordance with Section 5.2 in the PRCP.

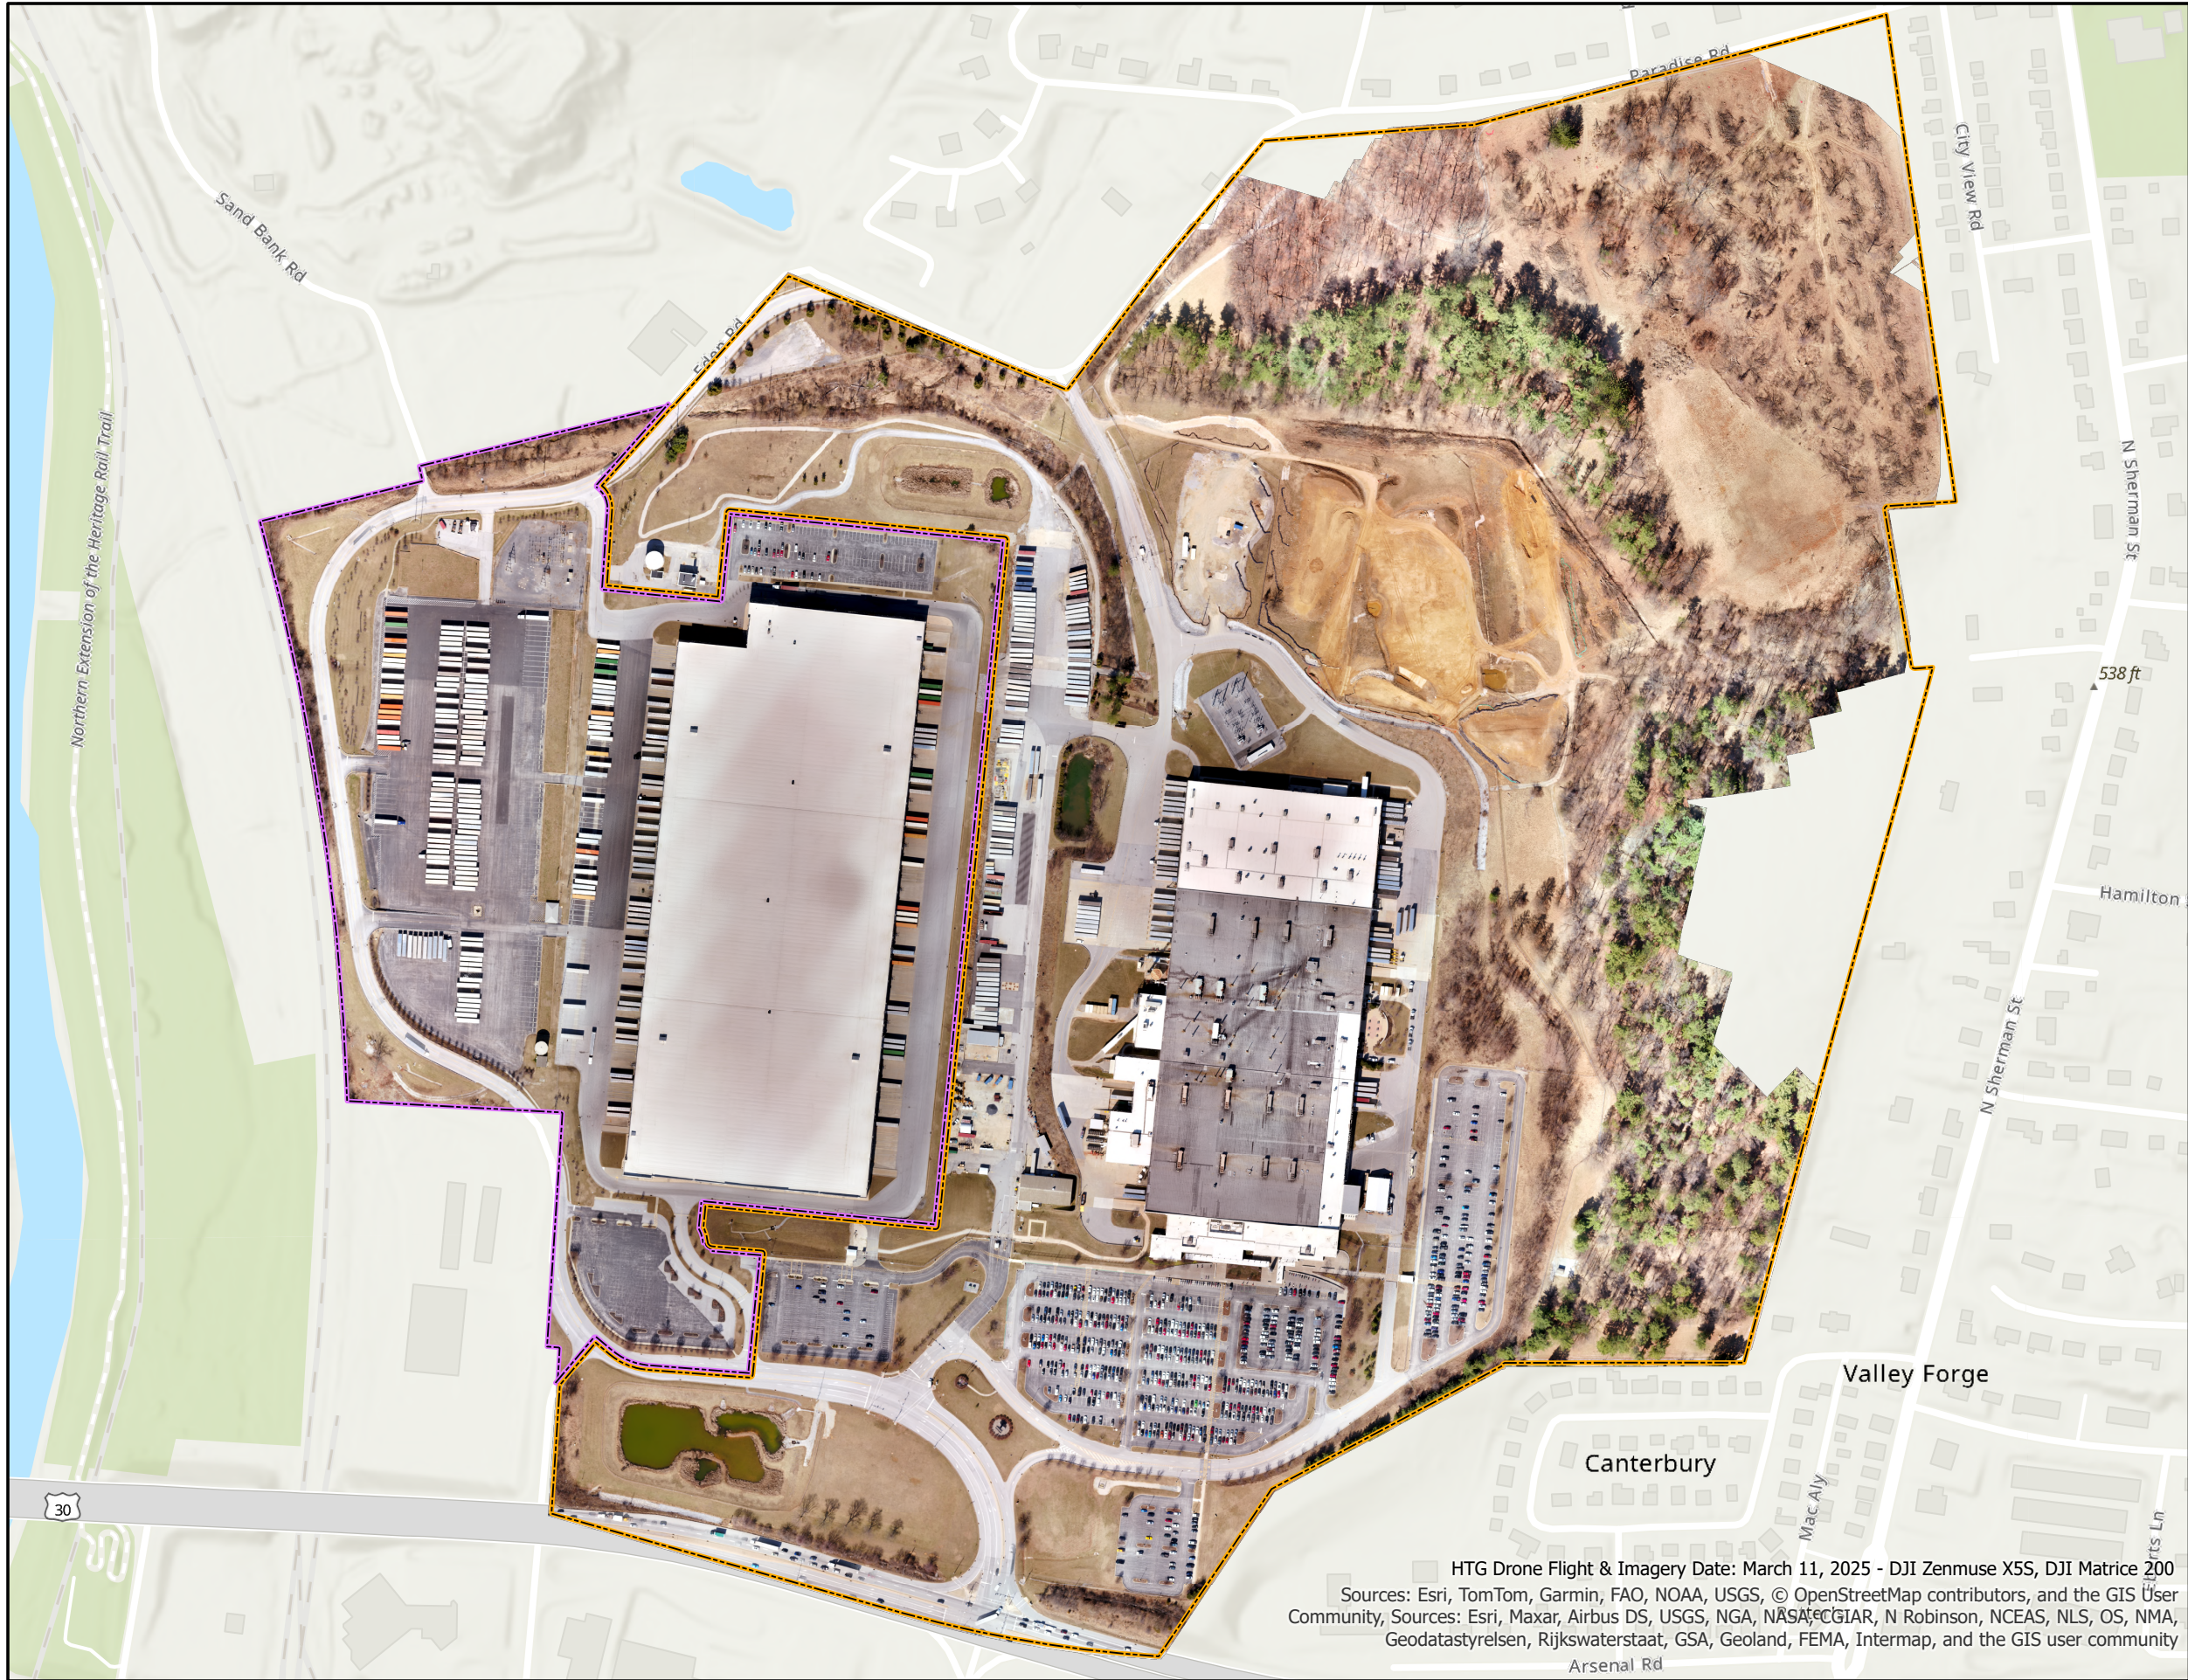
| | | | figure:<br><b>5</b> |

No new changes to cap areas were observed beyond those already recorded in previous annual PRCP reports.

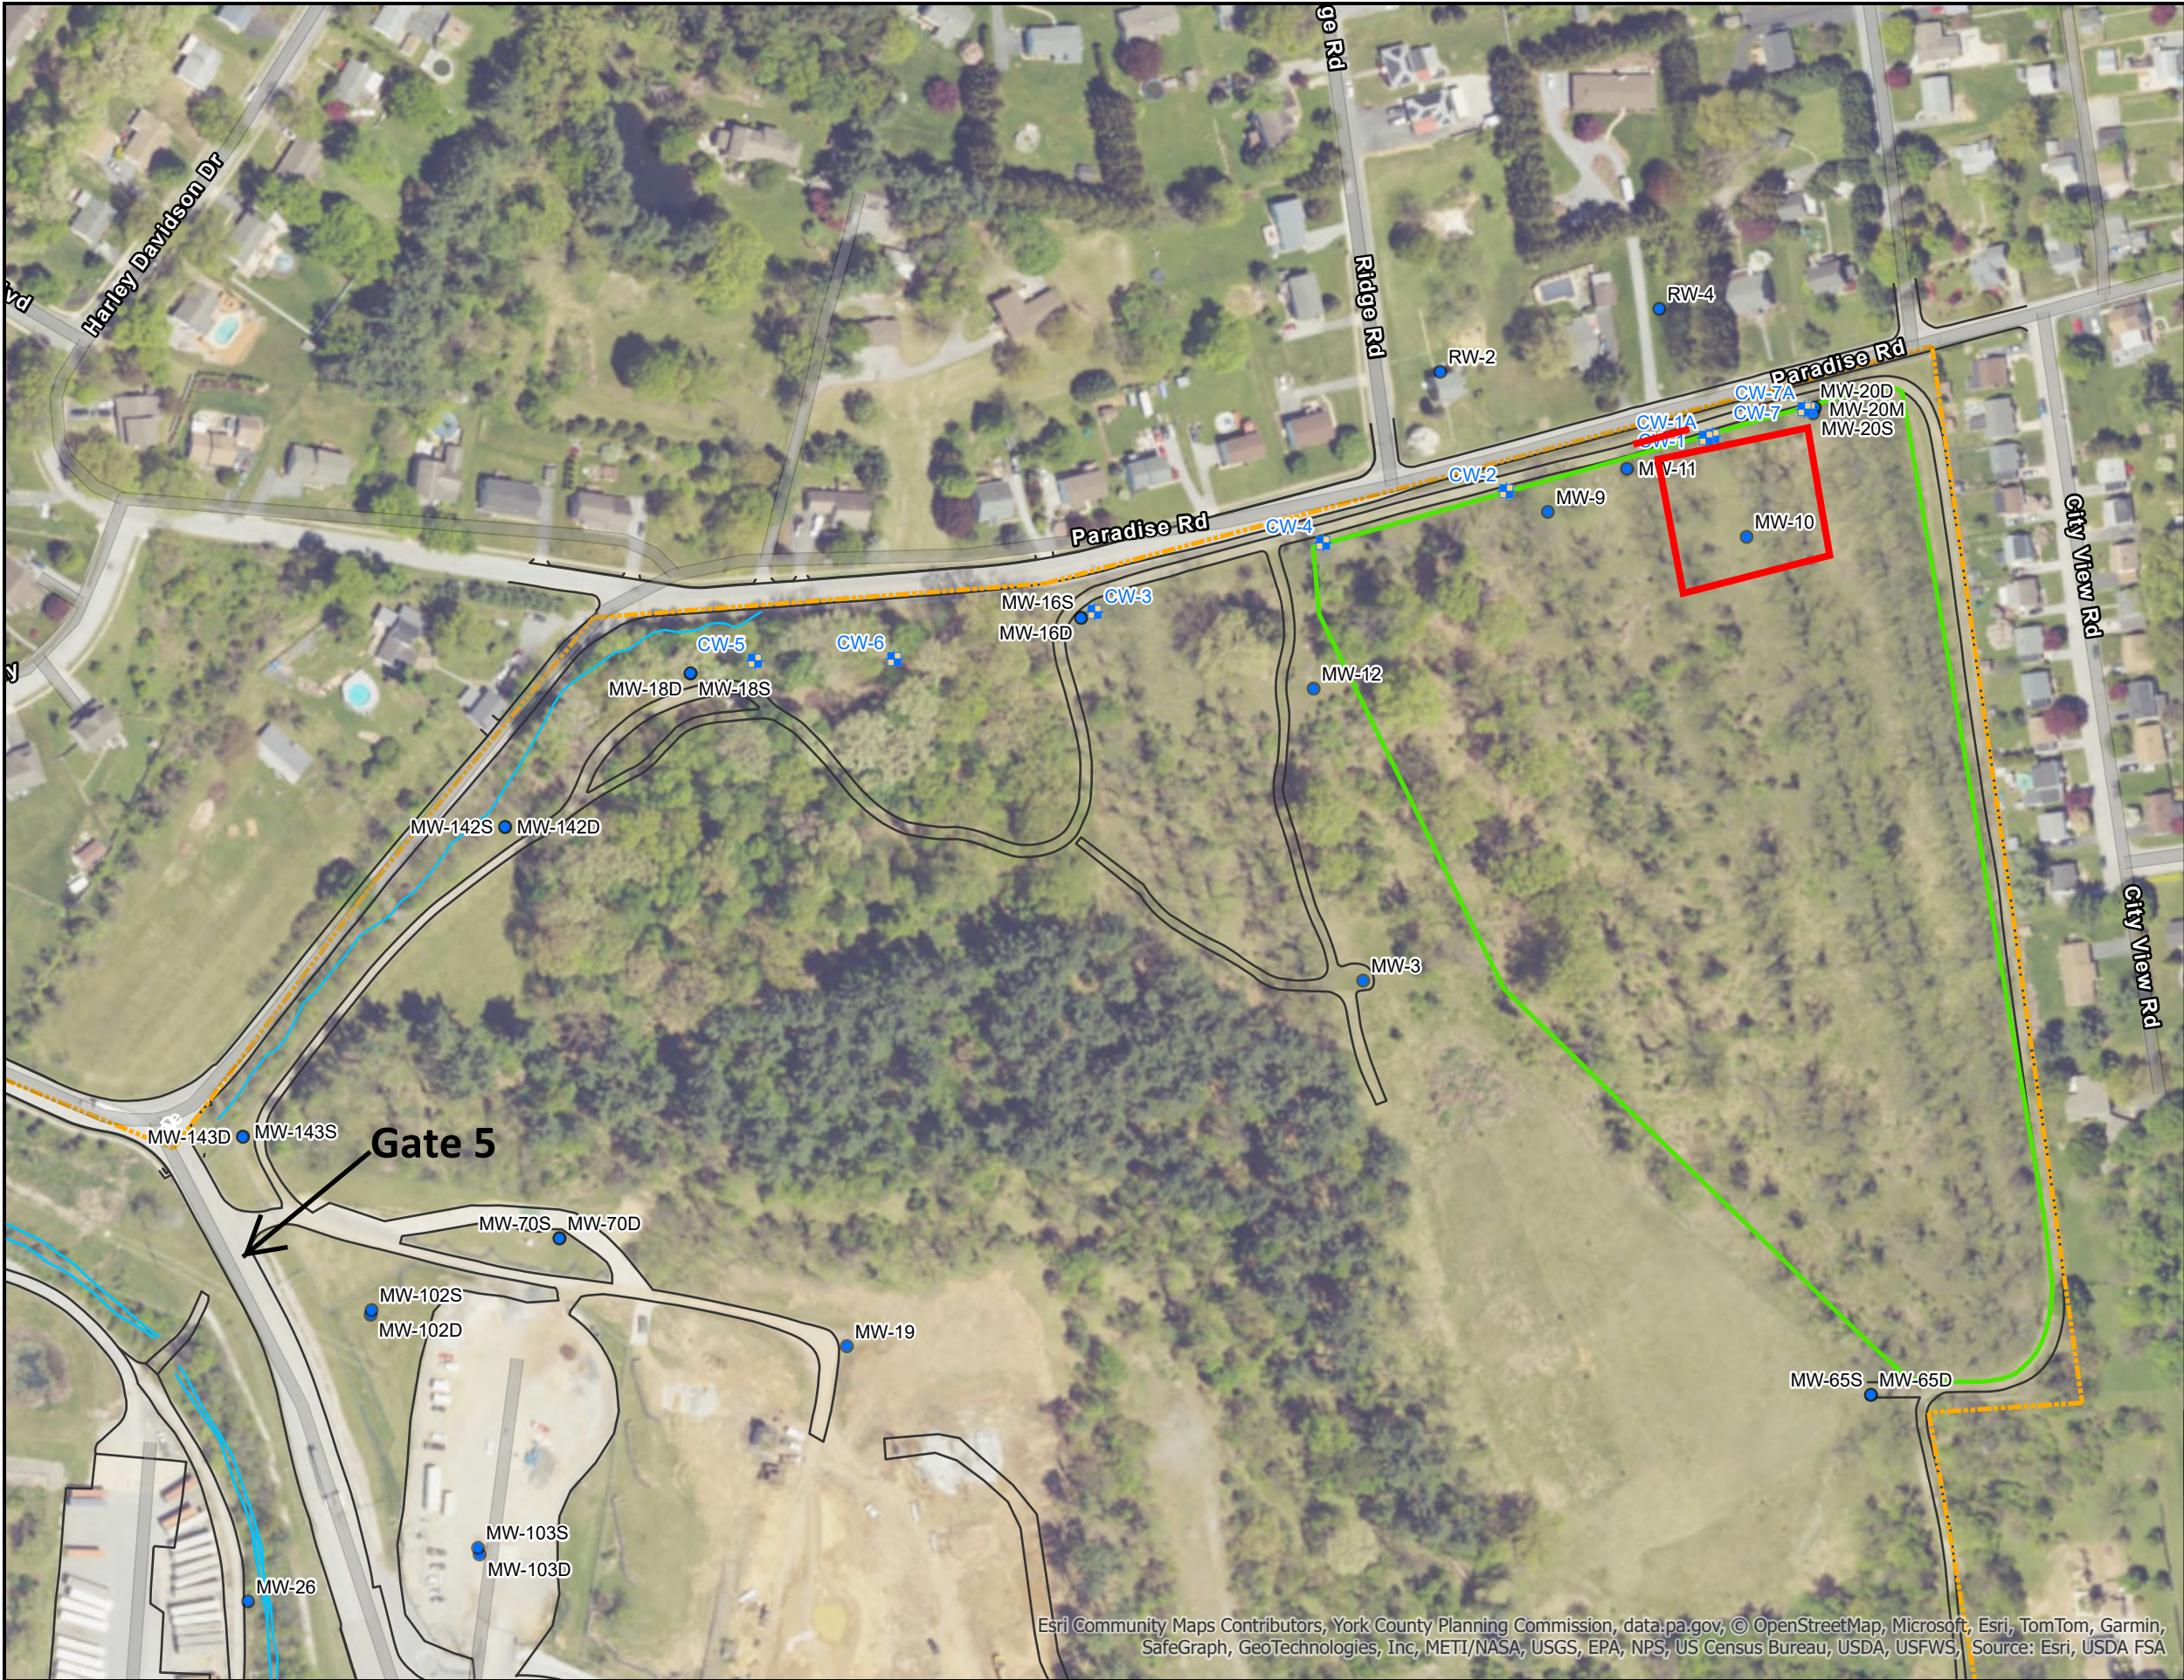
Walnut tree harvest boundry circled in red in NE corner of the property. Site Address 1425 Eden Road, York, PA 17402.
